CHAPTER 6

THERE ARE TO BE NO VILLAINS, JUST HUMAN ERROR

6.1 Introduction

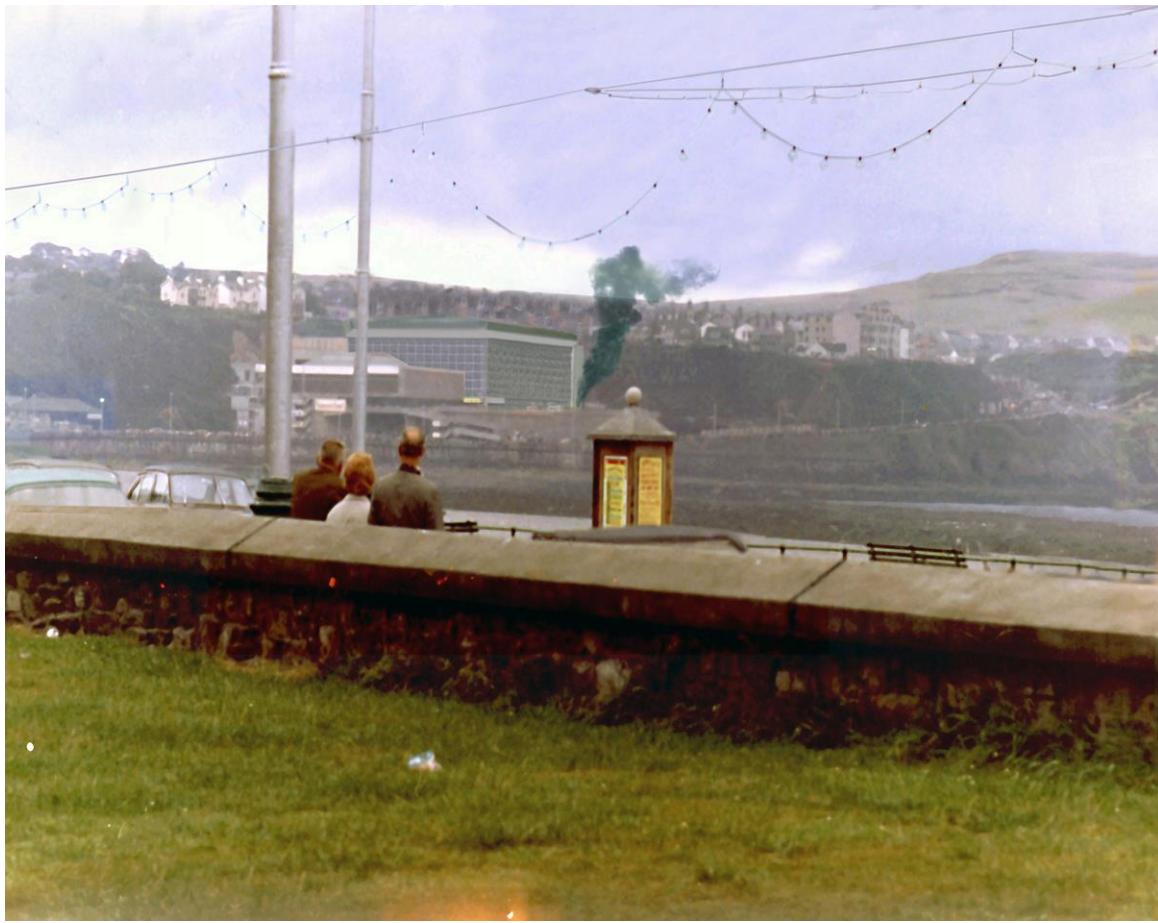
Figure 7.1: Smoke and flames rising from the kiosk fire
(Copyright: Noel Howarth. This photograph appears with the kind permission of Mr Howarth)

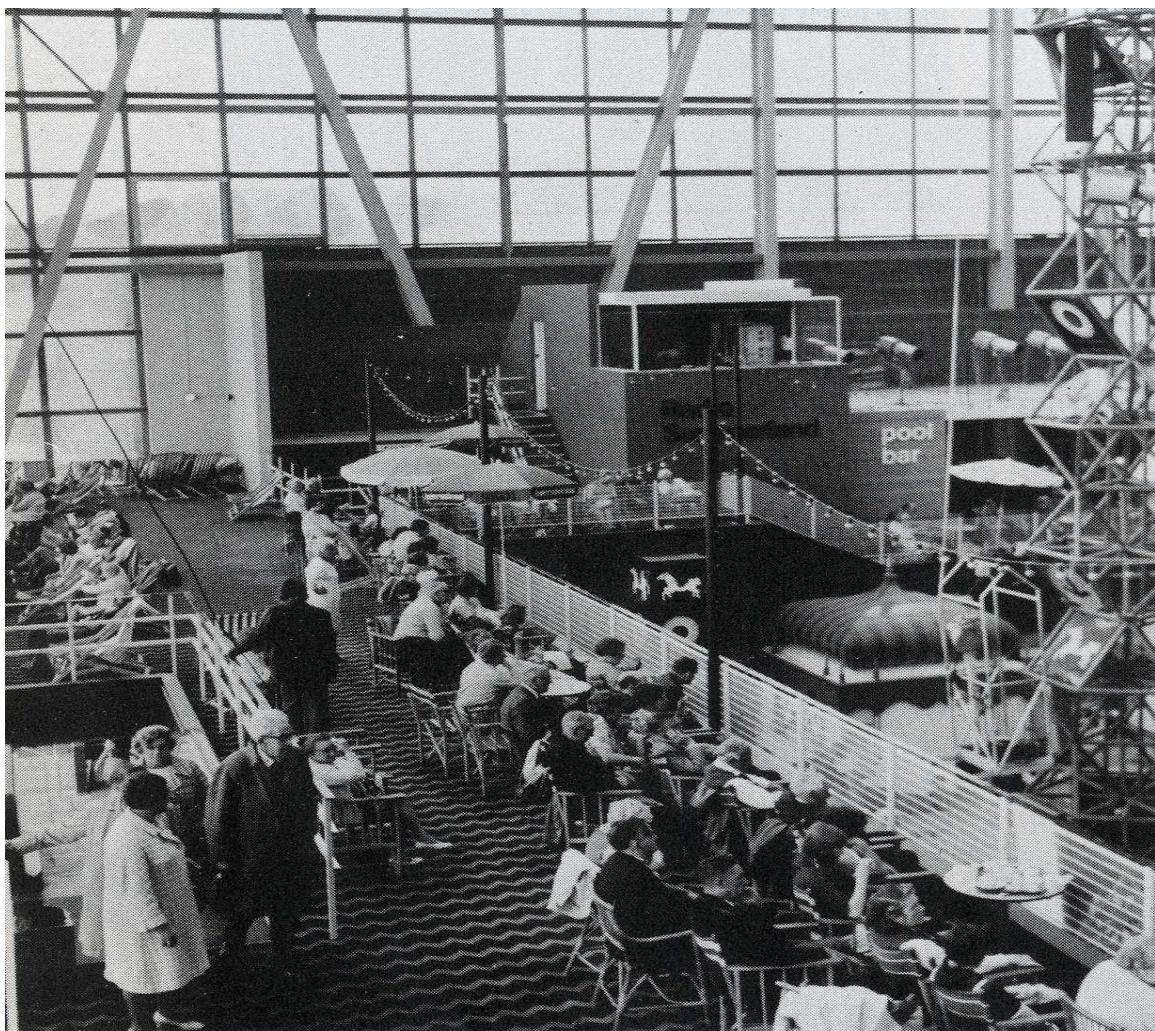
It is now necessary to consider the actions of the person in the Control Room on the night of the fire. This glass-fronted room (**figure 6.2**) was reached by a single flight of stairs at the western end of the first terrace; the remains of the Control Room can be seen in **figure 5.9**. The person in the Control Room had an uninterrupted view of the Solarium floor and the three terraces at the other end of the building.

Figure 6.2: The Control Room is the glass-fronted room immediately to the left of where 'pool bar' is written

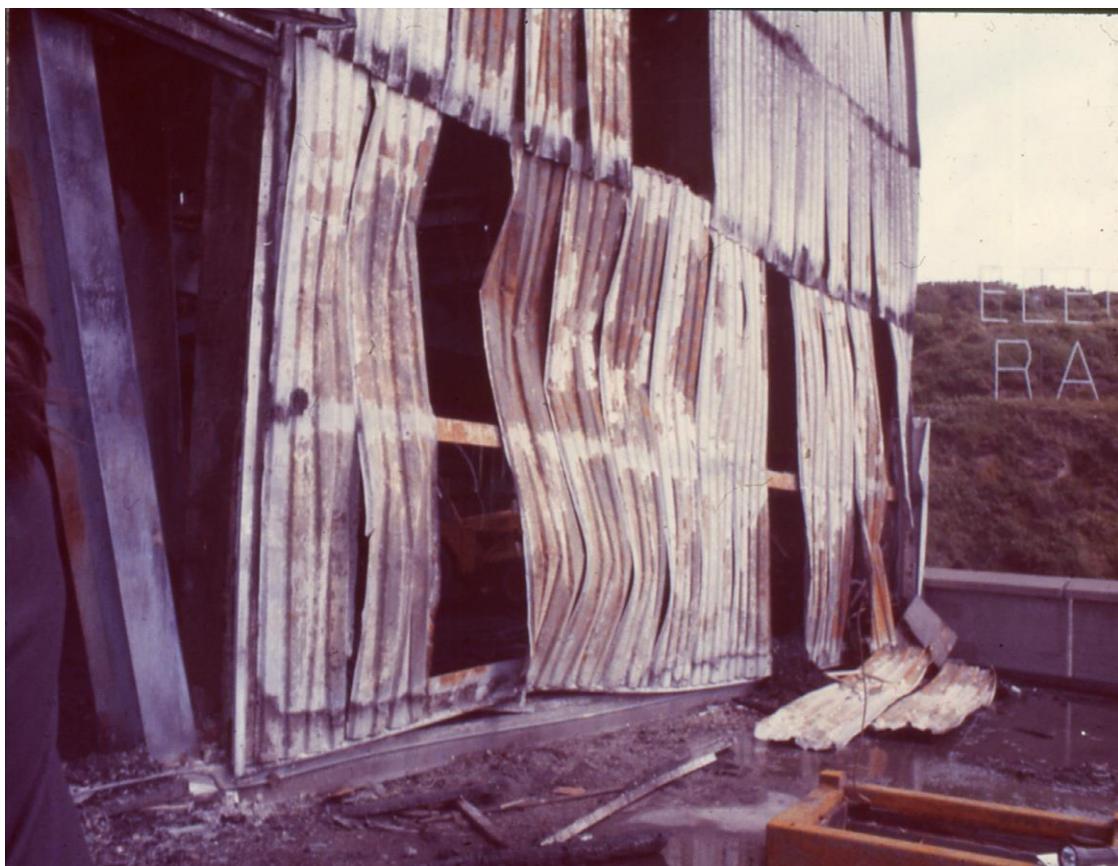
from the burning kiosk to the Galbestos wall was around 60 kWm^{-2} . This vastly exceeded the 10 kWm^{-2} threshold that the material had passed in a test. Since the core (steel and zinc) of the Colour Galbestos had a high thermal conductivity, fumes were soon given off on the **inner** side of the wall after two-and-a-quarter minutes. “Strong flames” were coming from the Galbestos one minute later. The fire behind the wall could have started in two ways: by the vapours reaching ignition temperature; or by a flame coming through a gap in the Galbestos from the kiosk fire as a result of differential thermal expansion of the metal.

Figure 6.3: The deformed Galbestos wall after the fire (Photograph: John Webb; Copyright Fire Research Station (FRS) and Building Research Establishment (BRE))
(This photograph appears with the written permission of BRE Global.)

FRS investigators noted that the site of the kiosk fire might have been close to one of the overlap joints between two sheets of the Galbestos. This might have allowed the fire to break through into the interior more easily. On ignition, flames spread more rapidly up the Galbestos sheeting than across it.

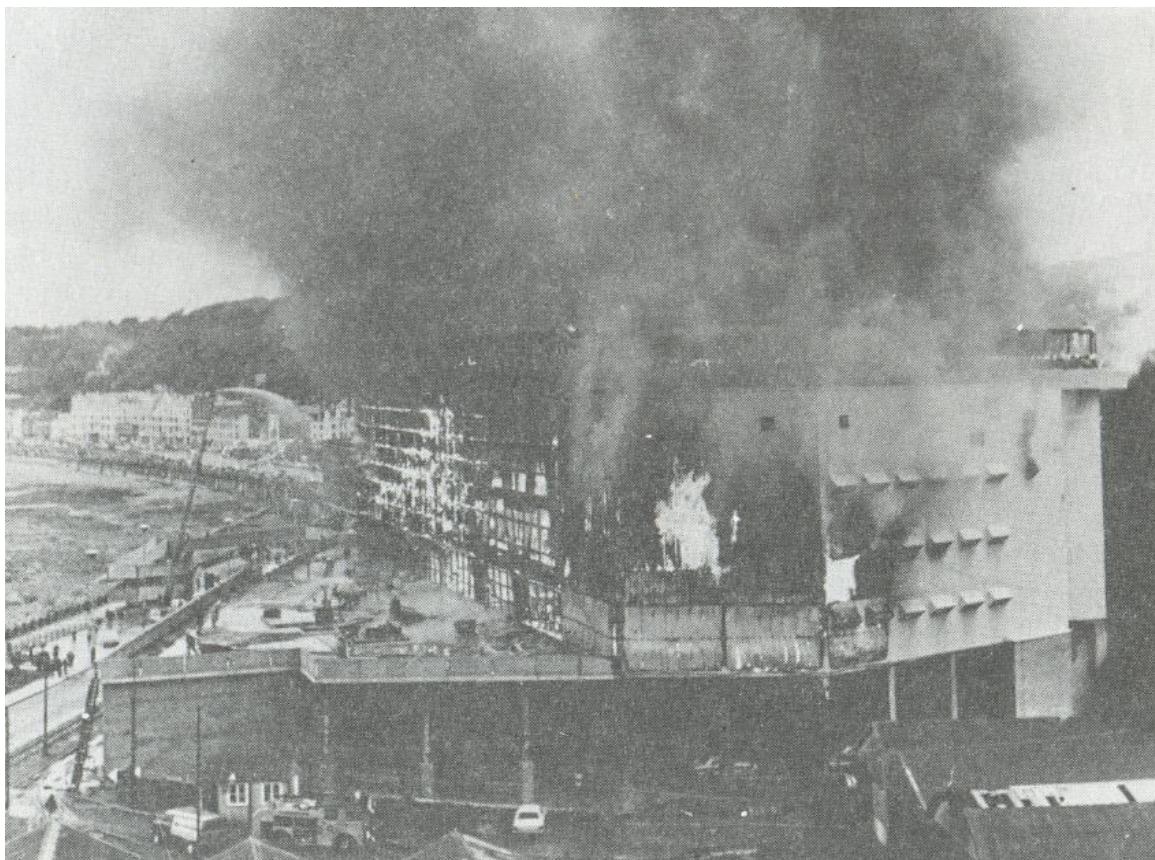
Figure 6.4: Burning Galbestos (the big flame in the foreground)

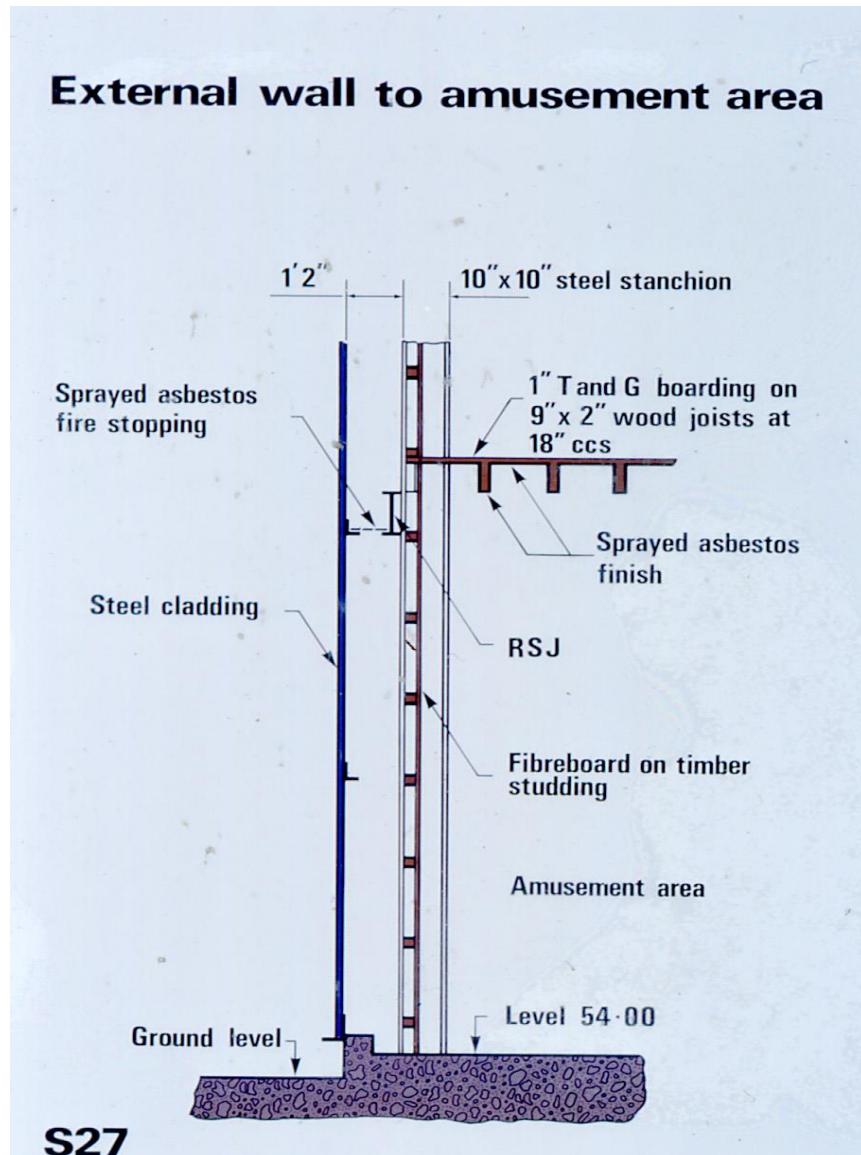
because it created a 12 inch wide (Rasbash, 1991) concealed gap or void with a combustible surface on both sides: Galbestos on the outside and Decalin on the inside. Furthermore, there were inadequate measures to stop the spread of fire inside the void. The only fire stop (sprayed asbestos on expanded metal lathing) visible to FRS investigators was in a horizontal plane at Marquee Showbar level (Summerland's fifth floor) (**figure 6.5**). This stop helped to prevent fire from spreading up the void for some time (Silcock and Hinkley, 1974), but “there is ample evidence that the fire stopping both horizontally and vertically as required by the Byelaws was certainly not complete in the months before the fire, though it may have been originally” (SFC Report, Paragraph 45, Page 15). It is thought the Decalin wall was fitted to fairly standard softwood studding.

Combustible voids are “a dangerous fire hazard and a serious breach of good building practice” (SFC Report, Paragraph 127, page 45) because a fuel rich fire of great intensity can develop in a void without anyone being aware of it. This is what happened at Summerland, when the kiosk fire breached the Galbestos wall and spread into the void behind it. It is estimated that the fire in the void started around 4-6 minutes after the external fire had become established in the remains of the crazy-golf course kiosk. This internal fire then gained intensity – but at all times being confined to the void – over the next ten minutes between about 7.45pm and 7.55pm (Time estimate by Professor Rasbash; see SFC Report Paragraph 106, Page 38). Professor Rasbash told the public inquiry: “The bonfire inside the cavity had about 15 minutes to build up without being detected.” It is not known what temperatures were reached in the void, but they may have reached 1000°C close to and after the Decalin wall gave way and more

Figure 6.5: Plan of the Galbestos and Decalin walls; 'steel cladding' is the Galbestos wall. The fire spread from left to right.

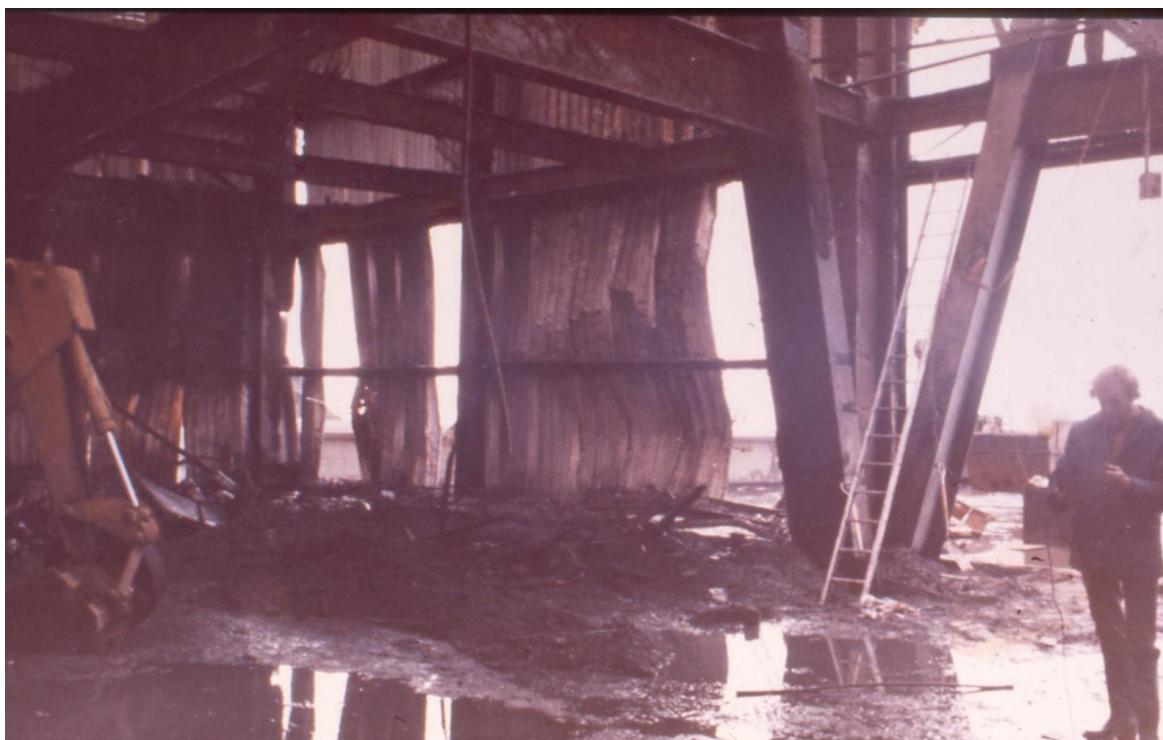
Figure 6.6: The remains of the inner face of the Galbestos wall. A wall of combustible Decalin fibreboard had been erected inside Summerland parallel to the Galbestos wall creating a 12 inch concealed void.

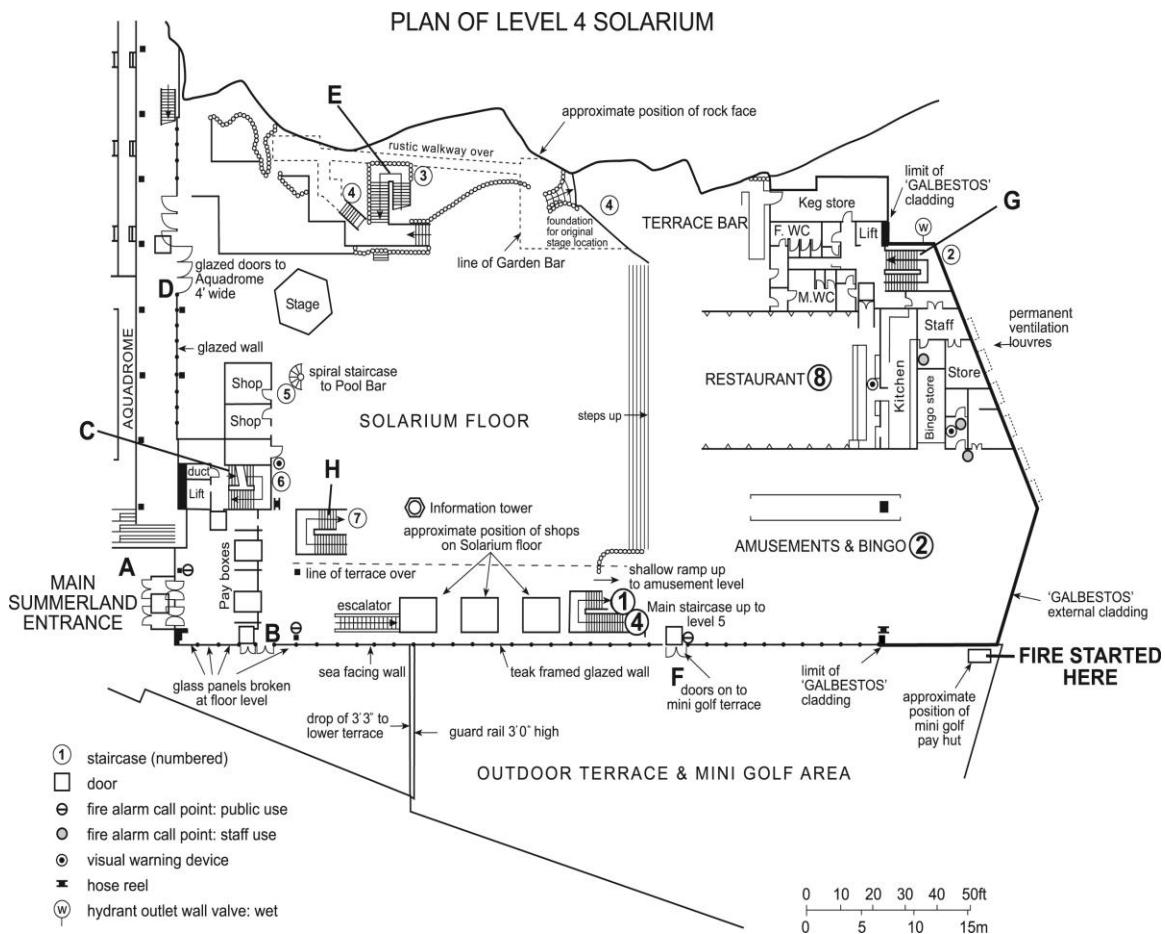
Summerland Fire Commission reported three deaths at the back of the Amusement Arcade, but a map in the Fire Research Station report (figure 1 of Silcock and Hinkley, 1974) shows two deaths in the Arcade (**figure 6.7**). Flames spread along the Arcade within tens of seconds. Even assuming that all the Arcade's combustible surfaces had become involved in the fire by this stage, fire investigators were puzzled by the amount of flame that poured out of the Arcade and on to the terraces above. Rasbash (1991) suggested the burning of gloss paint that may have been present on sprayed asbestos under the Arcade's ceiling might provide one possible explanation.

Figure 6.7 Location of the 14 bodies on the Solarium floor (bold circles)
It is not known whether the four bodies near the flying staircase were
on the Solarium level when the fire broke out or were descending from
the terraces. According to the SFC report, three people died in the
Amusement Arcade.

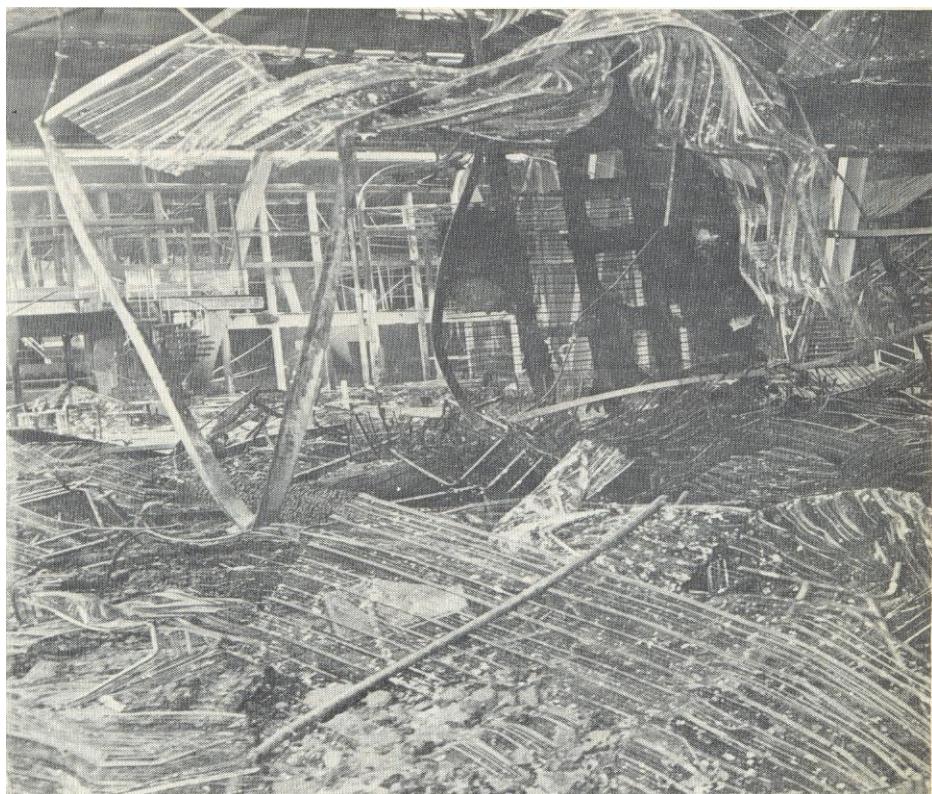
Figure 6.8: The effects of intense heat in the Solarium

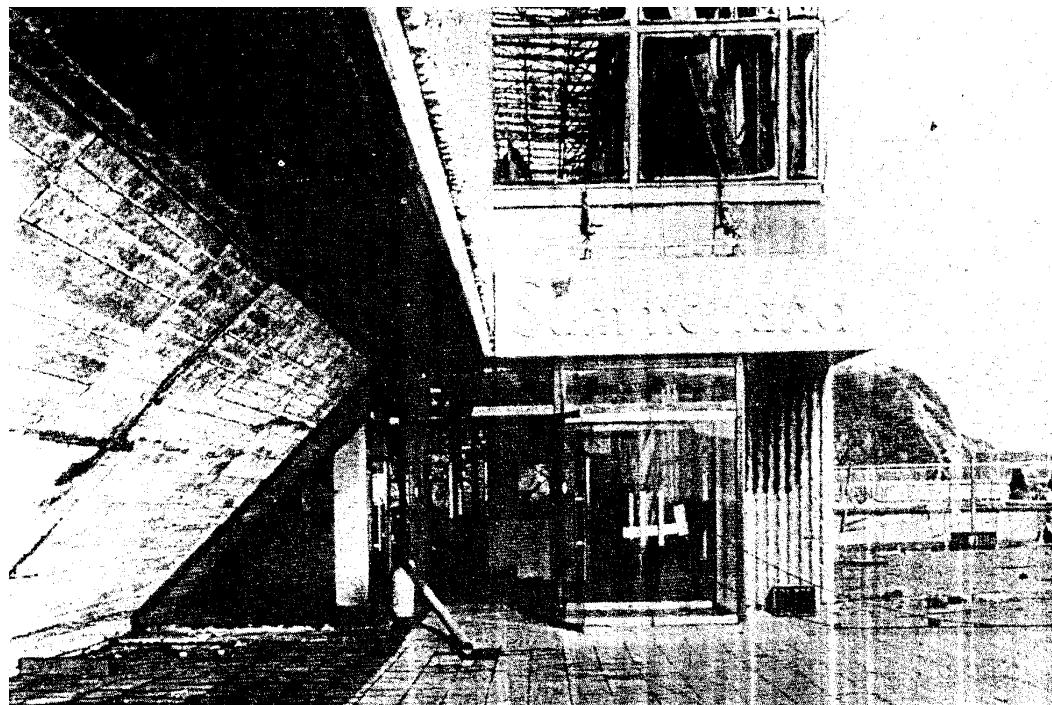
Survivors' accounts attest to scenes of pandemonium around Summerland's main entrance (section 4.2), which consisted of two pairs of double doors. Mr Shaffer, the House Manager, was responsible for this area, with the members of staff in the pay boxes reporting directly to him. However, when the fire broke out, two of the three doors for which Mr Shaffer had responsibility for were locked. These were one of the two pairs of main entrance doors (**figure 6.9**) and a fire exit at right angles to the main doors. Holidaymaker Mr Hugh Bryce said:

Figure 6.9: The main entrance doors after the fire

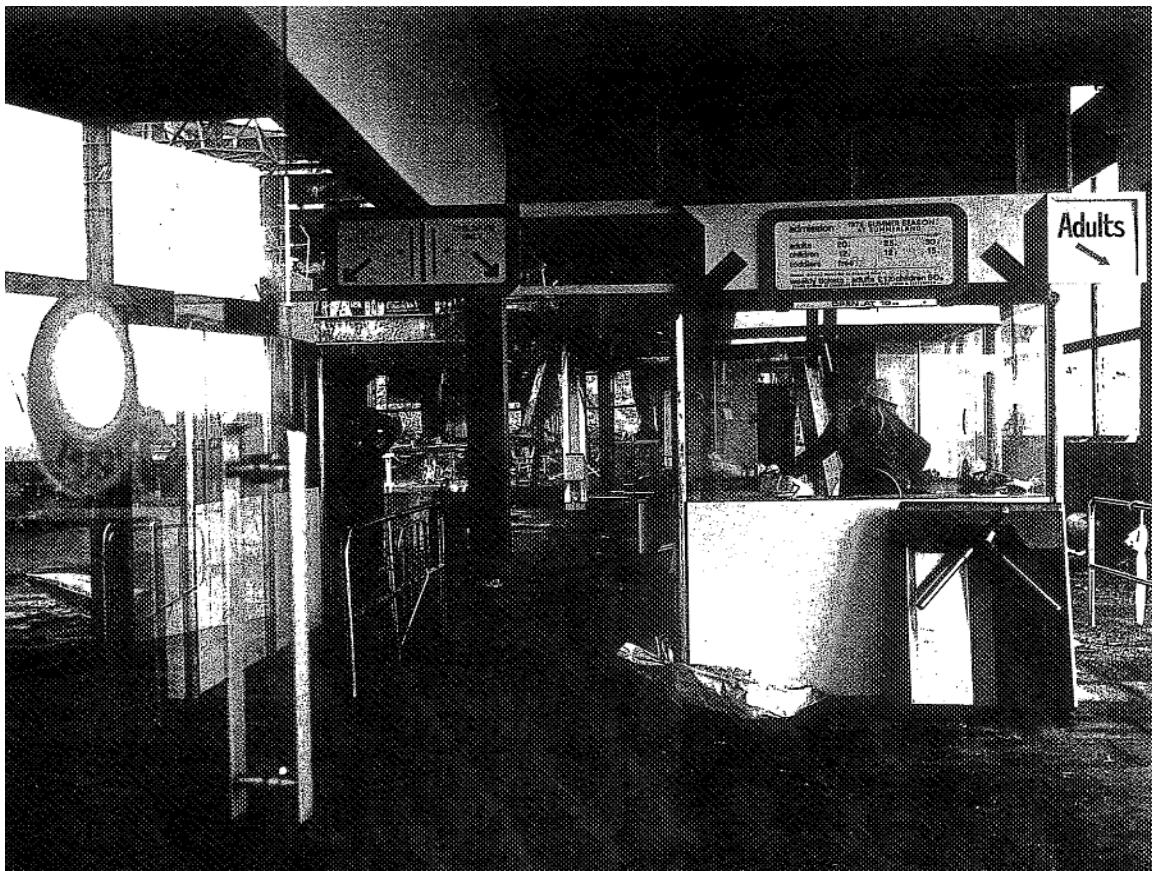
Mrs Mary Low said: “People trying to get out through the turnstiles at the front of the building got stuck. And more and more people were piling on to them in blind panic.” There were five turnstiles (**figure 6.10**) and a pair of swing gates, which allowed prams, pushchairs and wheelchairs to enter the building.

**Figure 6.10: The main entrance after the fire showing the pay boxes
One turnstile has been dismantled and placed in front of a pay box**
(Source: File of Police photographs, Isle of Man Public Record Office)

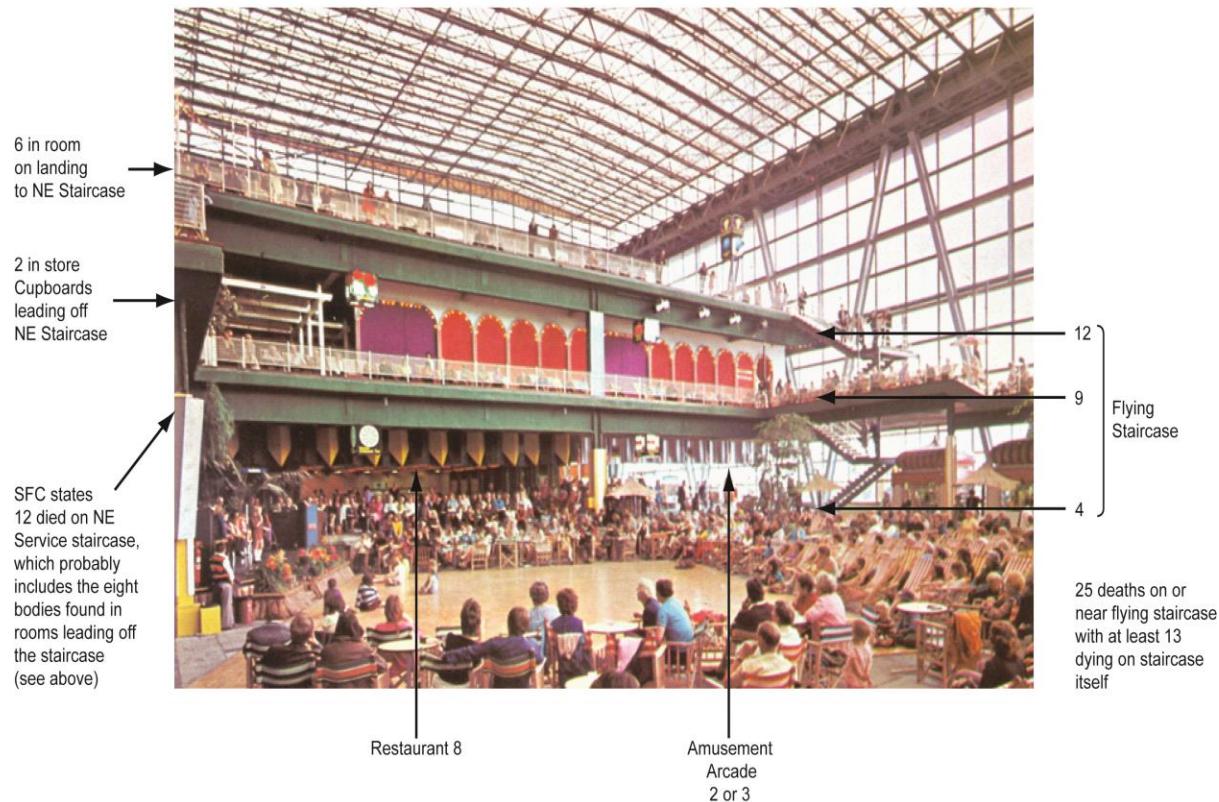
Figure 6.11: The distribution of bodies

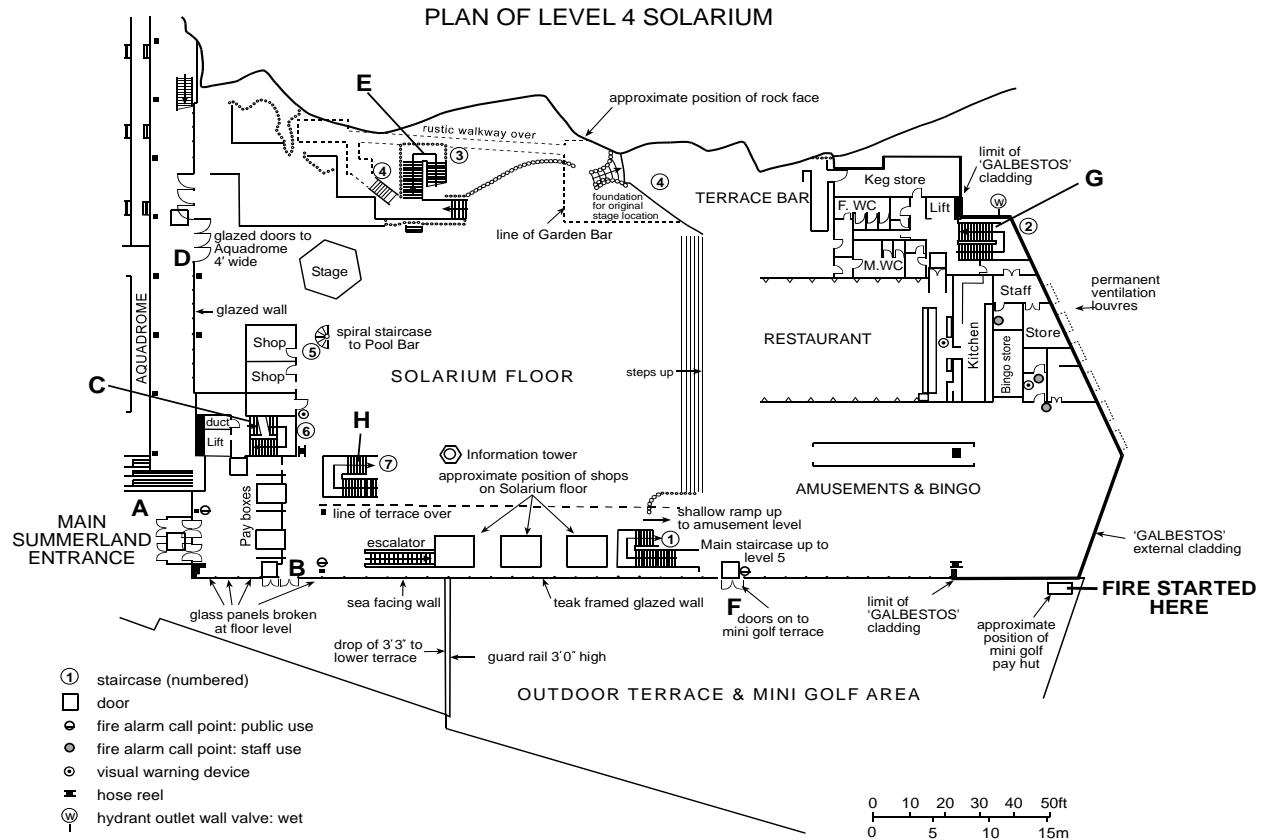
Figure 6.12: Escape routes (A, B, C, D, E, F, G and H) from the Solarium floor (Level 4). Note how six of the eight exits are at one end of the building. Re-drawn with annotations by Kevin Burkhil, University of Birmingham, from the original version in the SFC Report (1974).

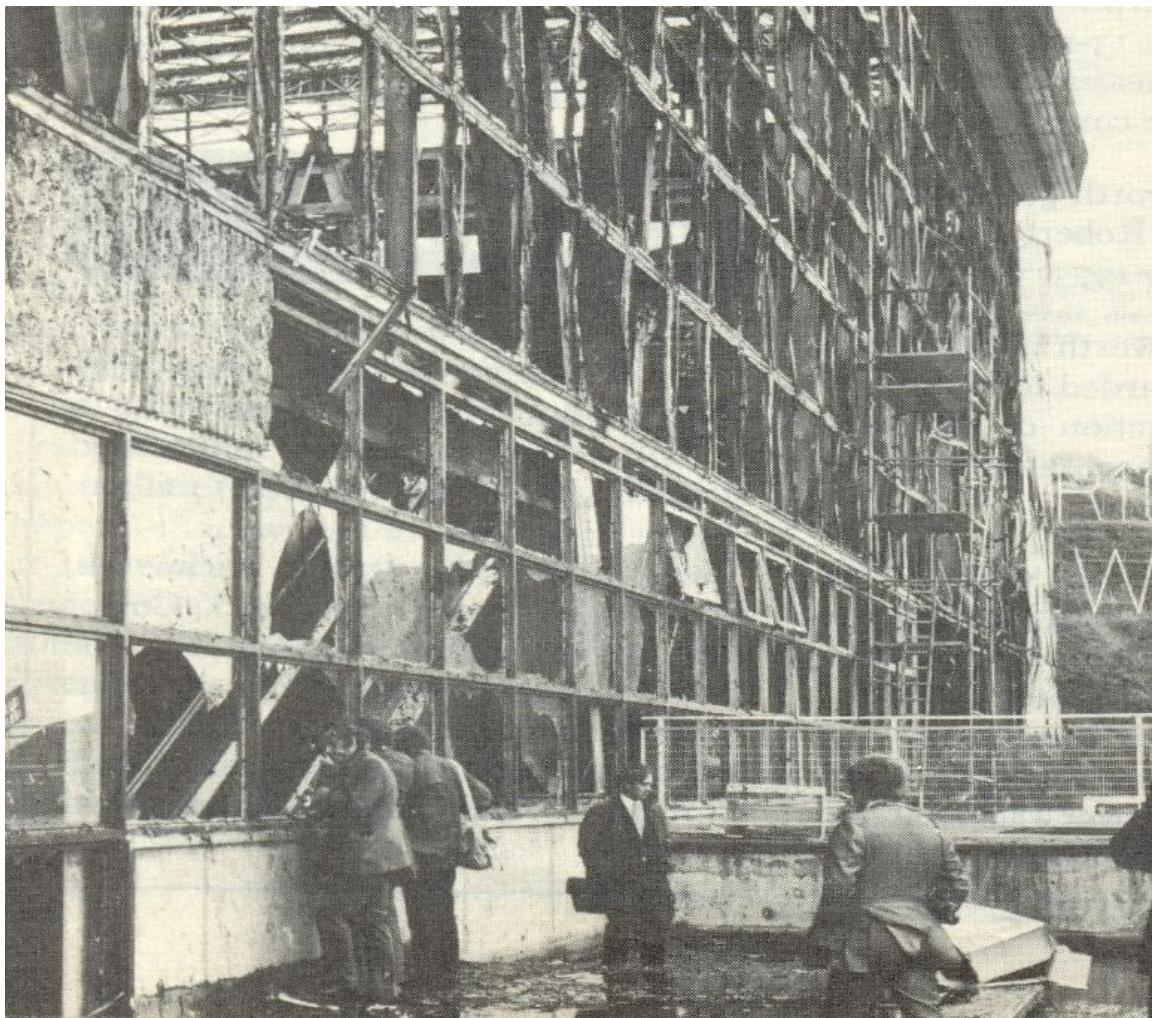
a concrete wall (3 feet 2 inches) (**figure 6.13**), the total drop from the top of the fence to the ground was 7 feet. The fence had been erected without the permission of the Manx fire chief to prevent people from sneaking along the terrace and entering Summerland without paying.

Figure 6.13: Some people escaping from the burning building had to climb over a fence that had been erected on the external terrace. Note the drop of 3 feet 2 inches between the mini-golf terrace and where the press photographers are standing. The smashed glass windows used to escape from the fire can also be seen.

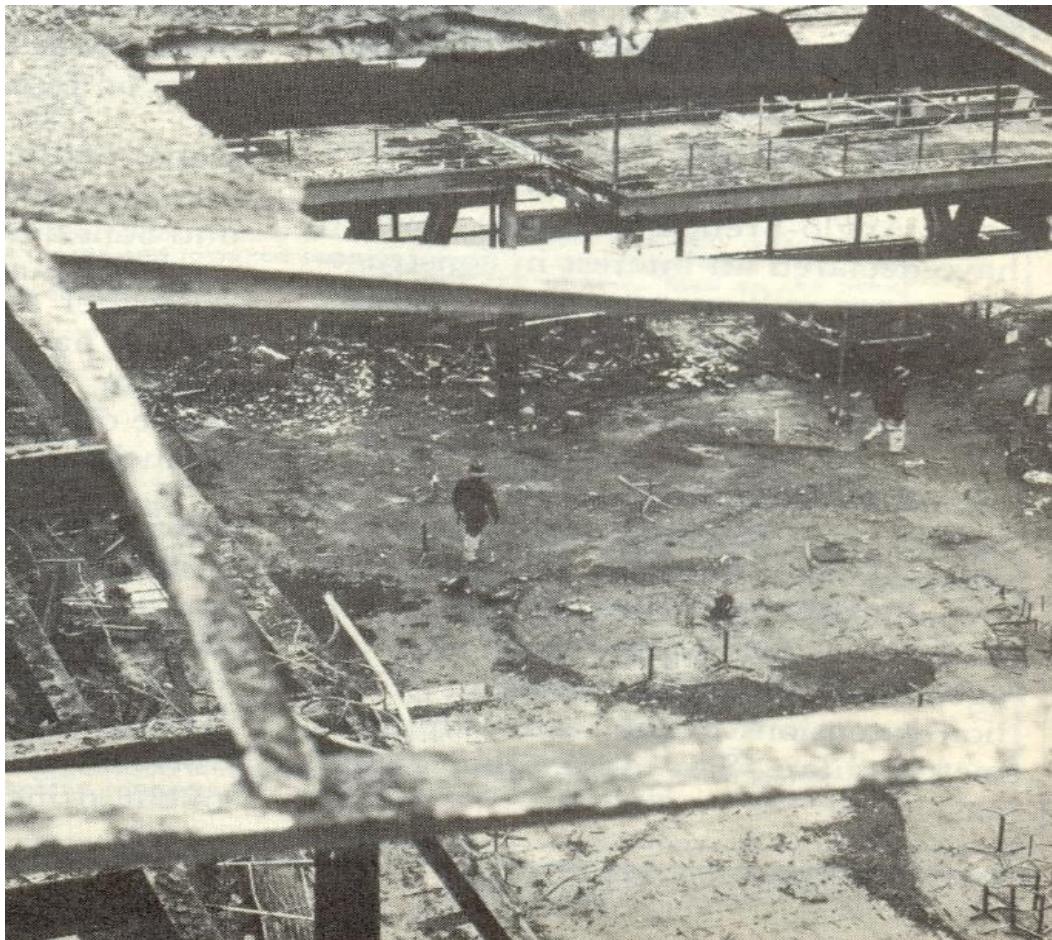
Figure 6.14: Scene of complete devastation: the Solarium viewed through the Oroglas roof after the fire. Note how the metal table legs survived the fire. The main entrance is near the top right-hand corner of the photograph.

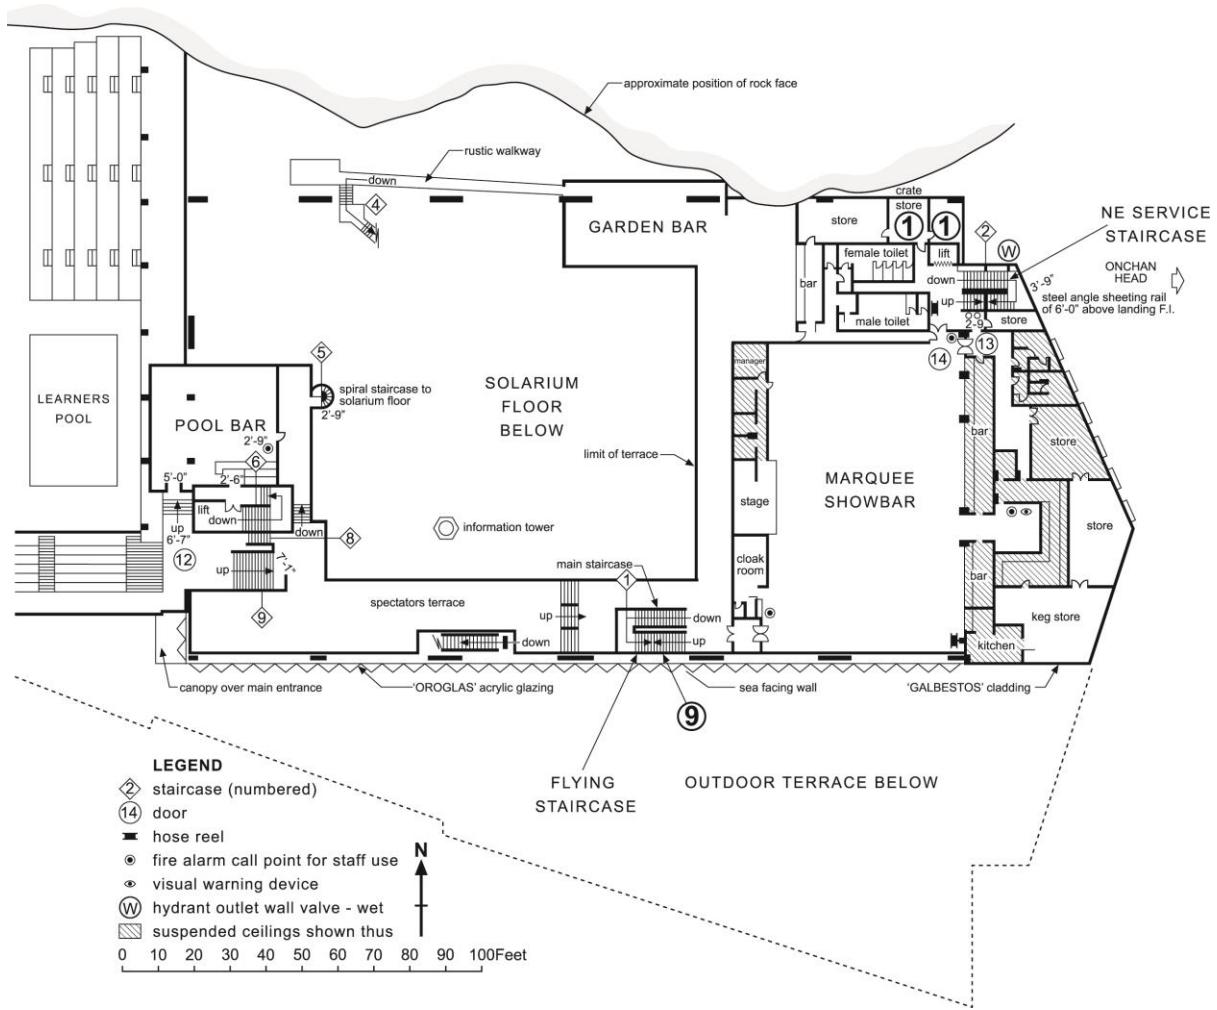
Figure 6.15: Location of bodies (bold circles) on the first terrace (Marquee Showbar). Figures obtained from Silcock and Hinkley, 1974); diagram redrawn by Kevin Burkhill, University of Birmingham, from the original version in the SFC Report (1974).

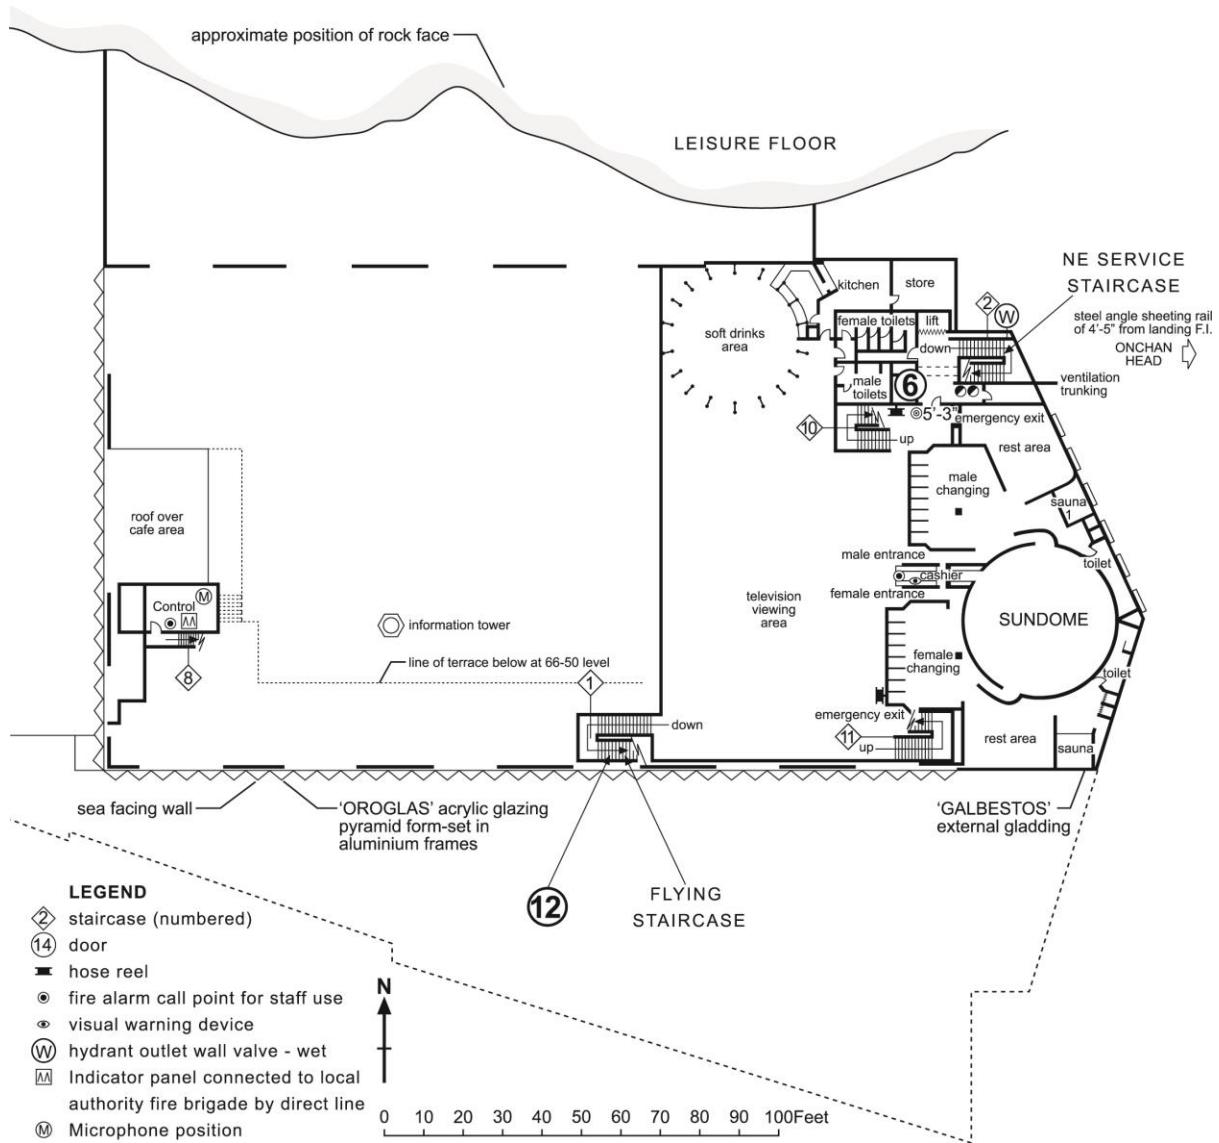
Figure 6.16: Location of bodies (bold circles) on the second terrace (Leisure Floor). Figures obtained from Silcock and Hinkley, 1974); diagram redrawn by Kevin Burkhill, University of Birmingham, from the original version in the SFC Report (1974).

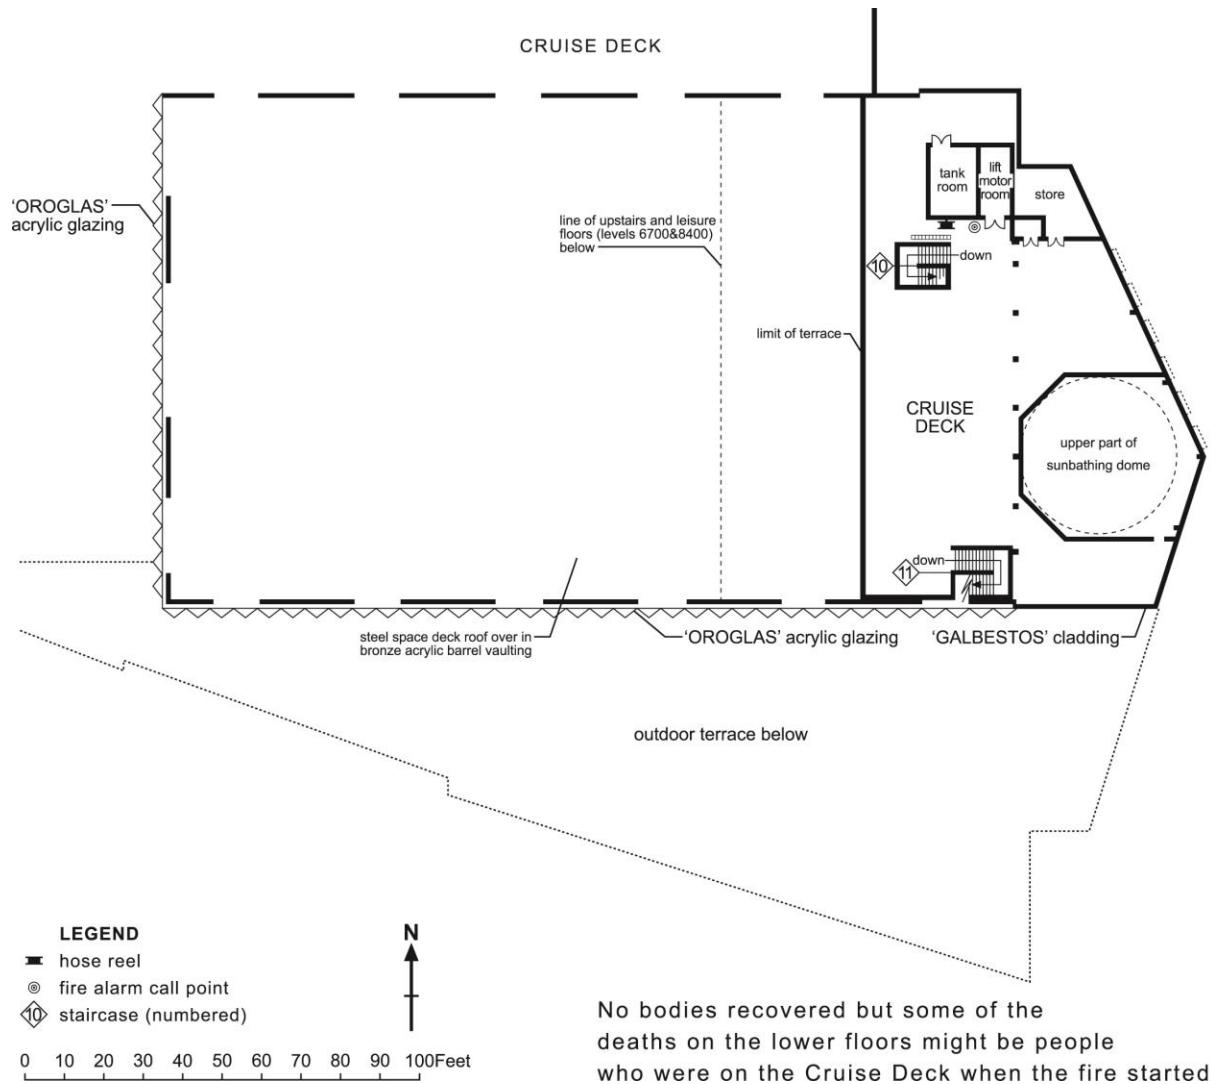
Figure 6.17: The Cruise Deck (Summerland's top floor). Diagram redrawn by Kevin Burkhill, University of Birmingham, from the original version in the SFC Report (1974).

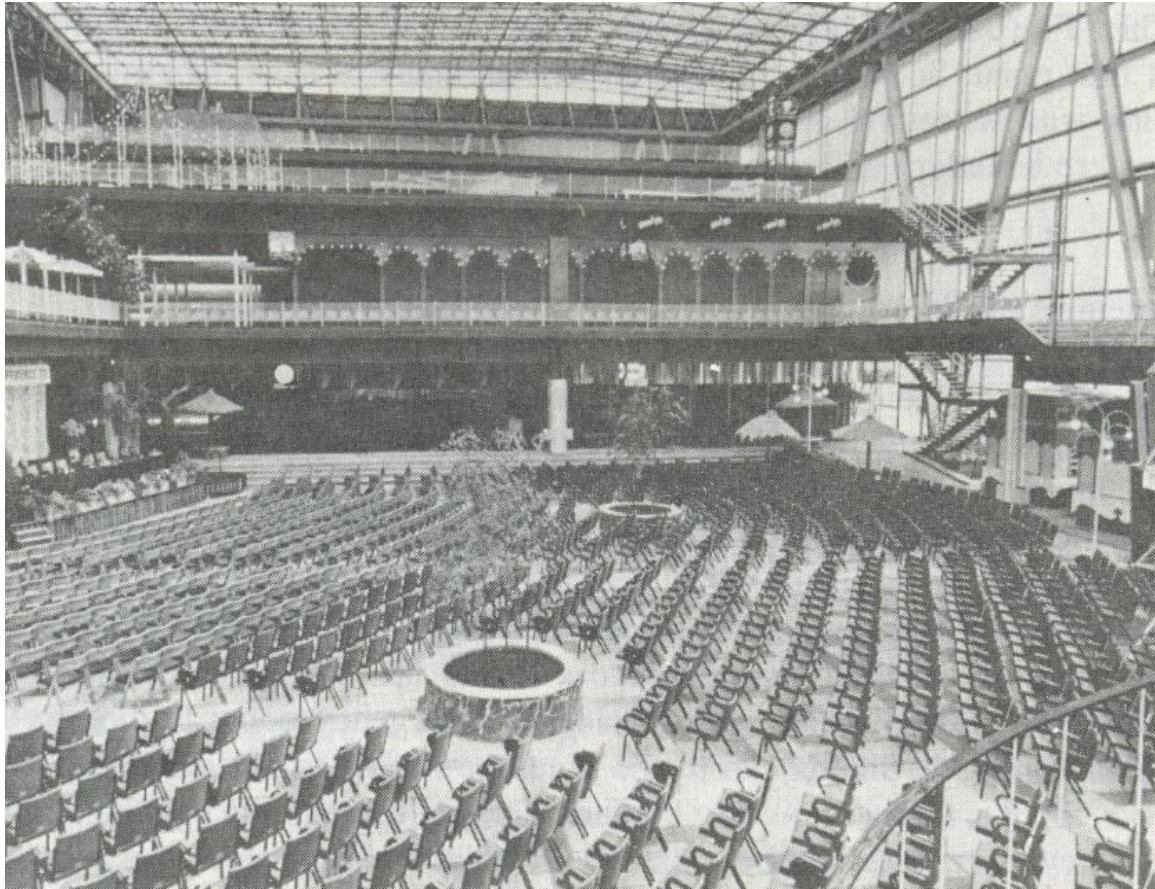
Figure 6.18: Looking east on the Solarium Floor towards the three terraces

The Flying Staircase can be seen on the right-hand side of the photograph. The NE Service Staircase (not visible) is in the top left-hand corner of the photograph. The Rustic Walkway descends from the Garden Bar on the first terrace, where the umbrellas can be seen on the left-hand side of the photograph. The point of discharge of the Rustic Walkway on the Solarium floor can be seen in figure 6.19. There was a gap between the edge of each terrace and the external Oroglass wall. This led to a chimney effect and funnelled the flames up to Summerland's roof; see section 6.5.3 for further details.

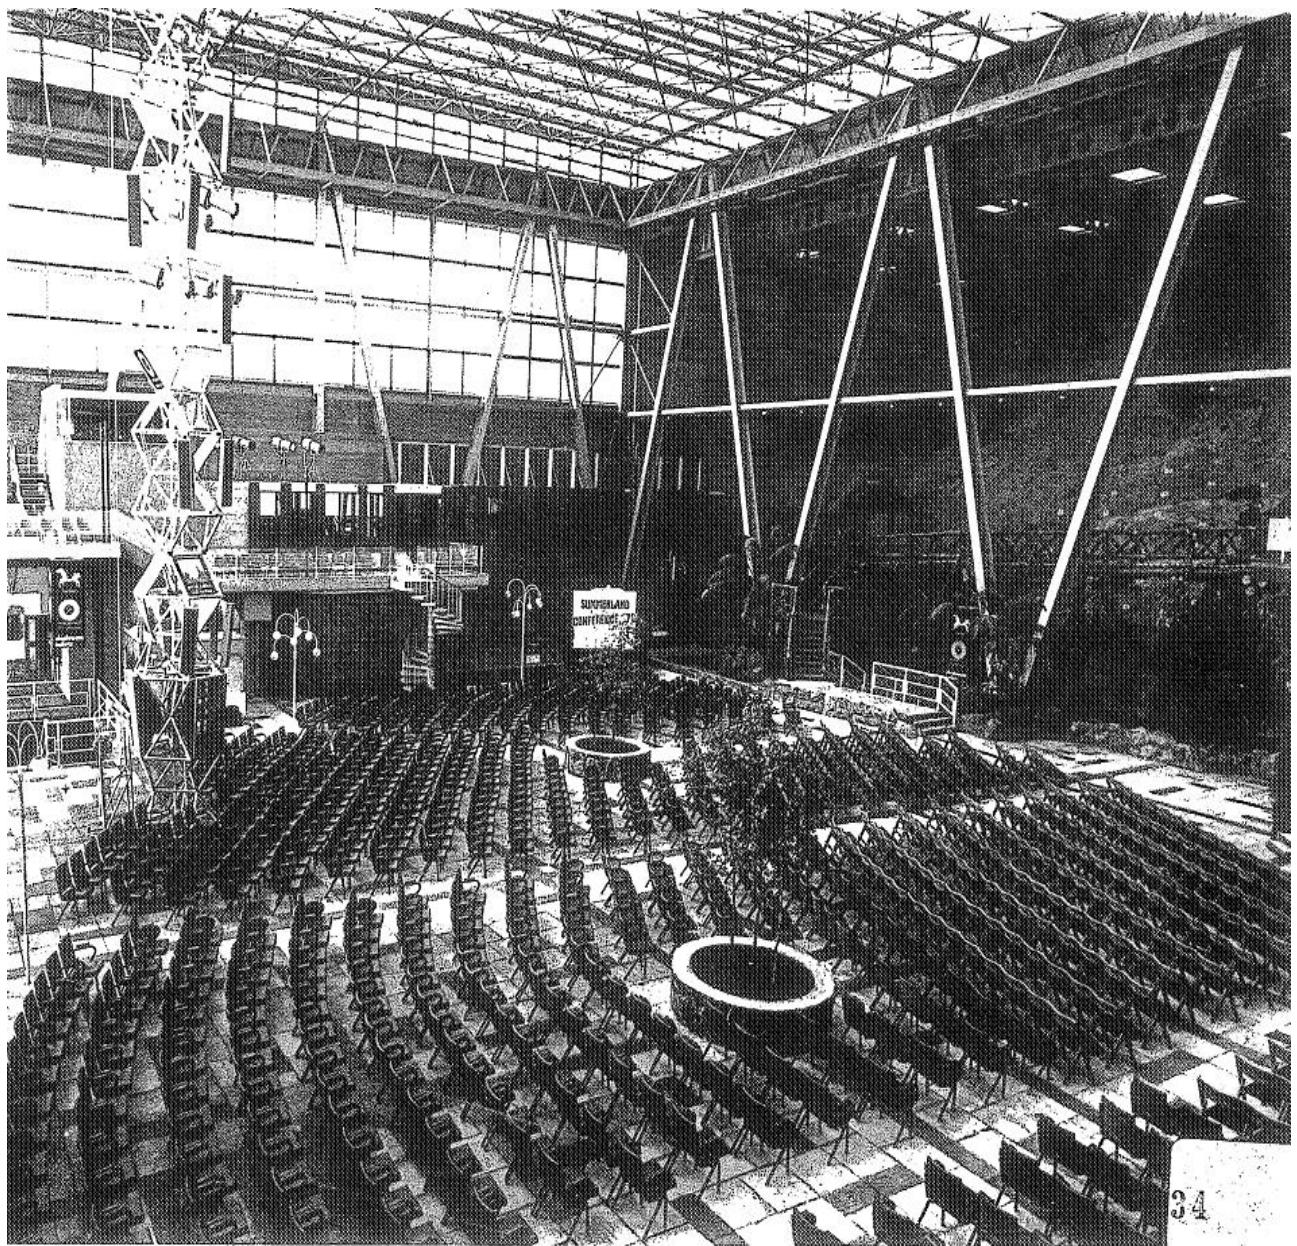
Figure 6.19: Looking west on the Solarium Floor towards the Aquadrome and main entrance
