CHAPTER 6

THERE ARE TO BE NO VILLAINS, JUST HUMAN ERROR

6.1 Introduction

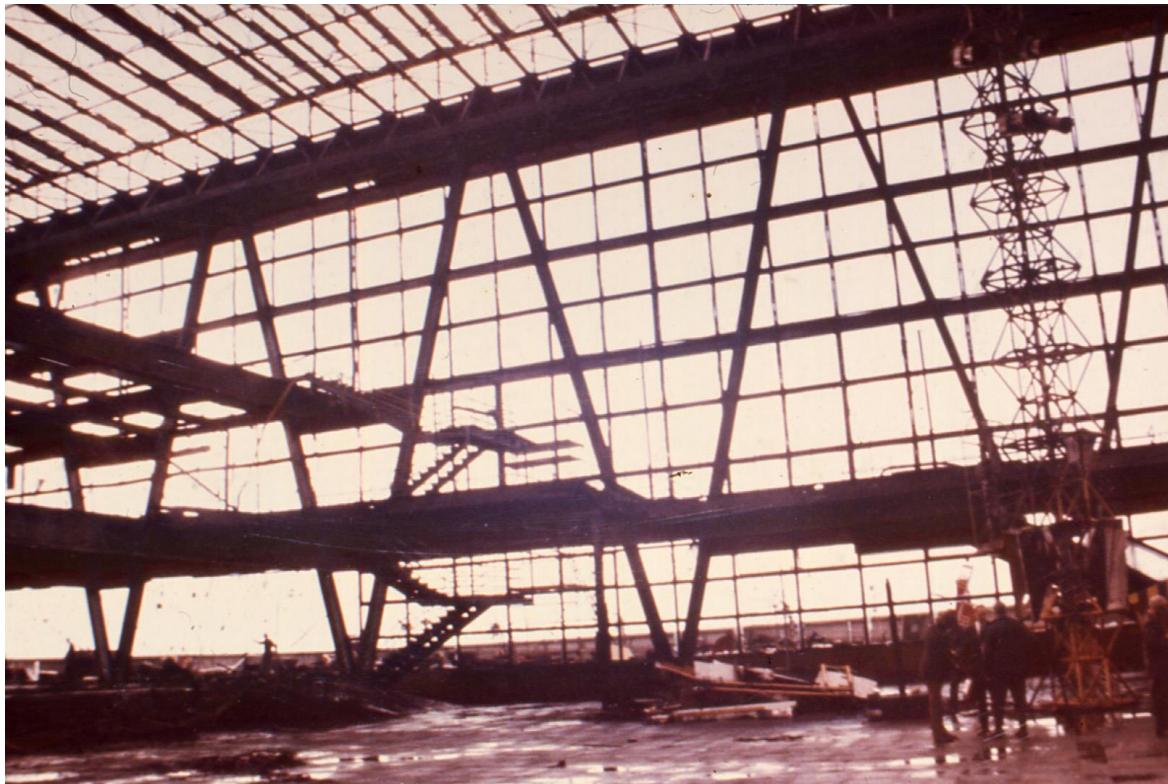
Figure 6.20: The Flying Staircase viewed from the cliff face after the fire. The main entrance is on the right-hand side and the terraces are on the left-hand side of the photograph (Photograph: John Webb; Copyright FRS/BRE)

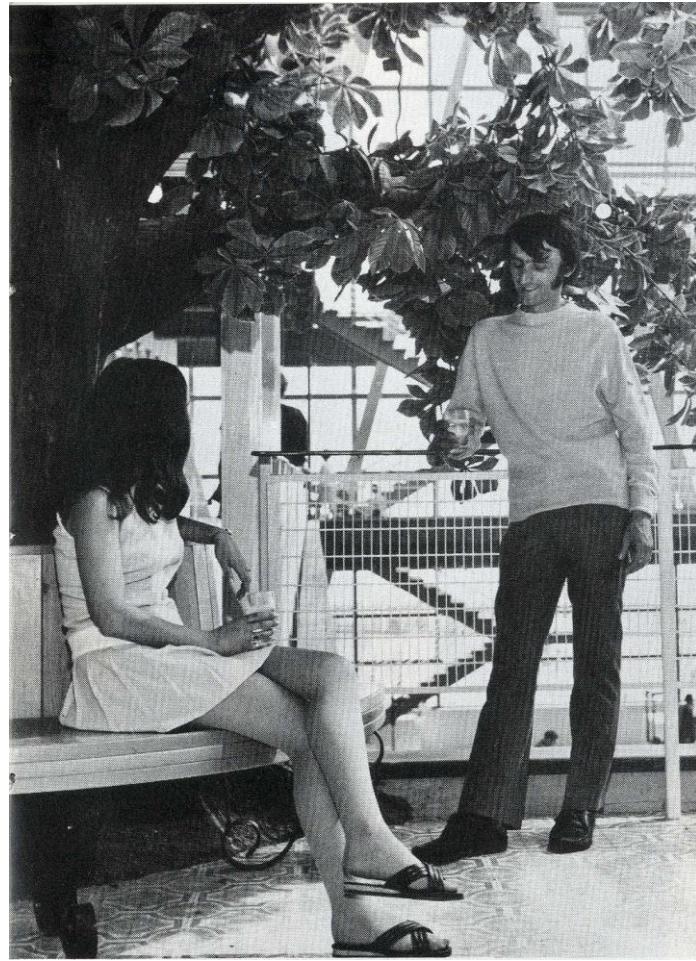
Primarily, the Flying Staircase was an unsatisfactory means of escape because its *open plan* design offered no protection from the fire – hence, the staircase was “wrong in type”. The staircase was in the wrong position because it was situated adjacent to the combustible Oroglass promenade wall (**figure 6.21**).

Figure 6.21: The Flying Staircase viewed from the Garden Bar. This photograph shows the staircase's proximity to the combustible Oroglas wall (Source: *The Summerland Story*, 1972, page 17)

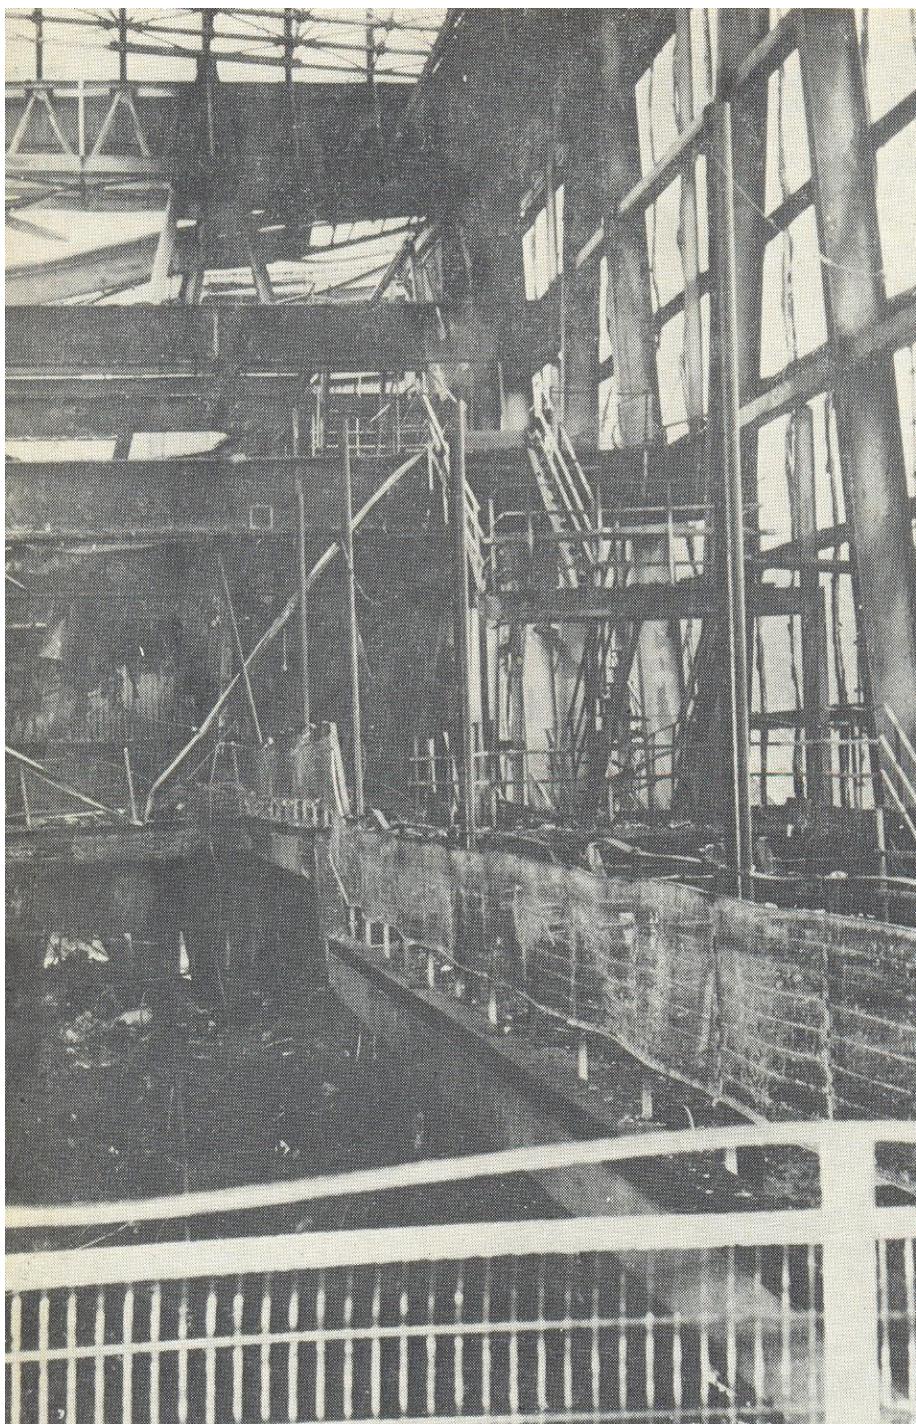
The SFC report also refers to 'travel distance'. By this, the Commission is referring to the *excessive* distance that a person would have to walk if he used the Flying Staircase to escape from the building. For example, consider a woman in the soft drinks area on the second terrace (the Leisure floor, see **figure 6.16**). She would firstly have to run up to 110 feet to reach the Flying Staircase. She would then use the staircase to descend 31 feet to the Solarium floor before running another 145 feet to reach the main entrance, a total distance of around 286 feet.

Figure 6.22: The Flying Staircase viewed after the fire from the Marquee Showbar level. Note how the treads have been completely burned away (Source: *Royal Institute of British Architects Journal*, July 1974, page 19)

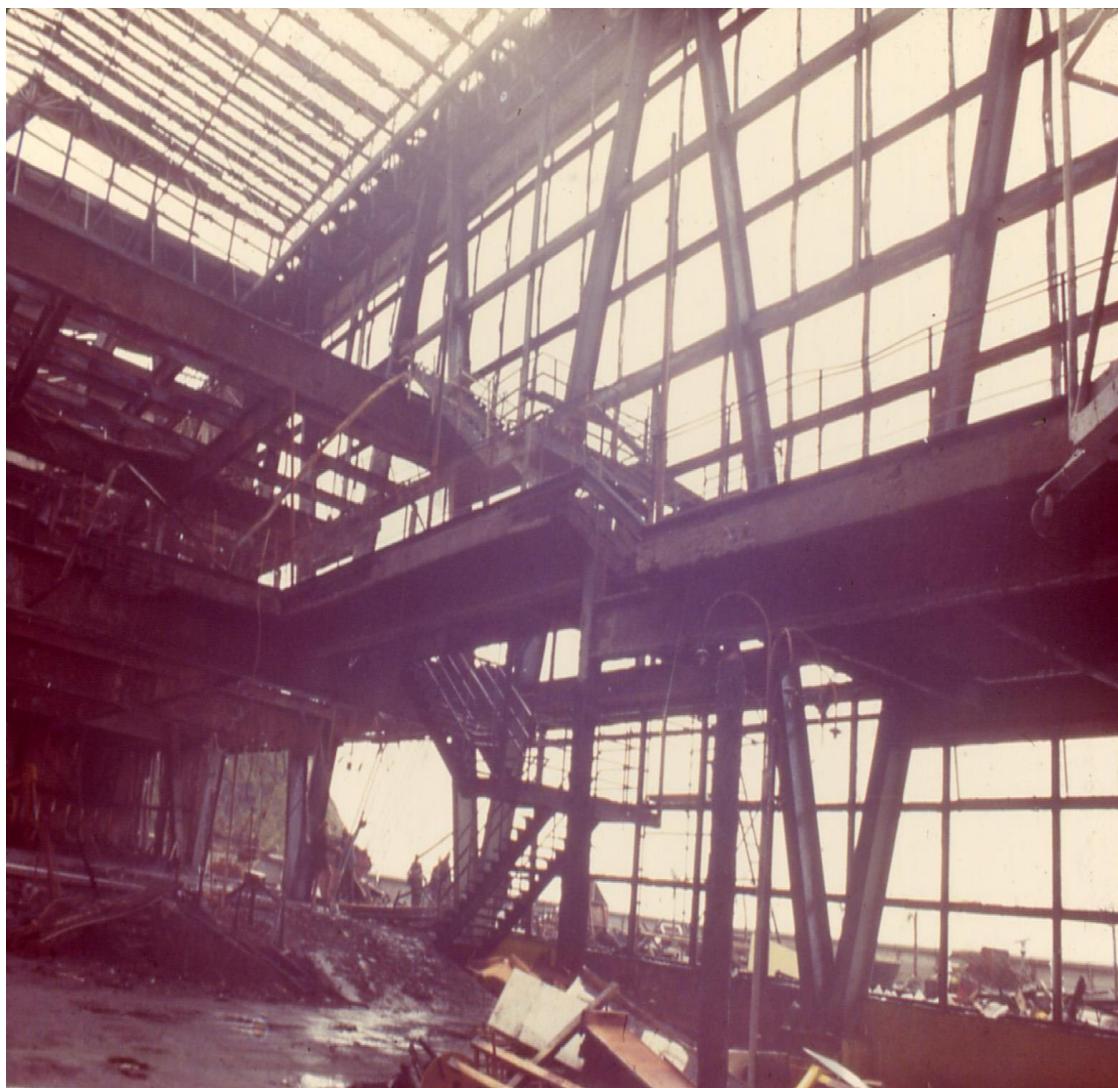
Figure 6.23: The Flying Staircase “created a wholly unnecessary hazard” (Photograph: John Webb; Copyright FRS/BRE). This photograph appears with the written permission of BRE Global.

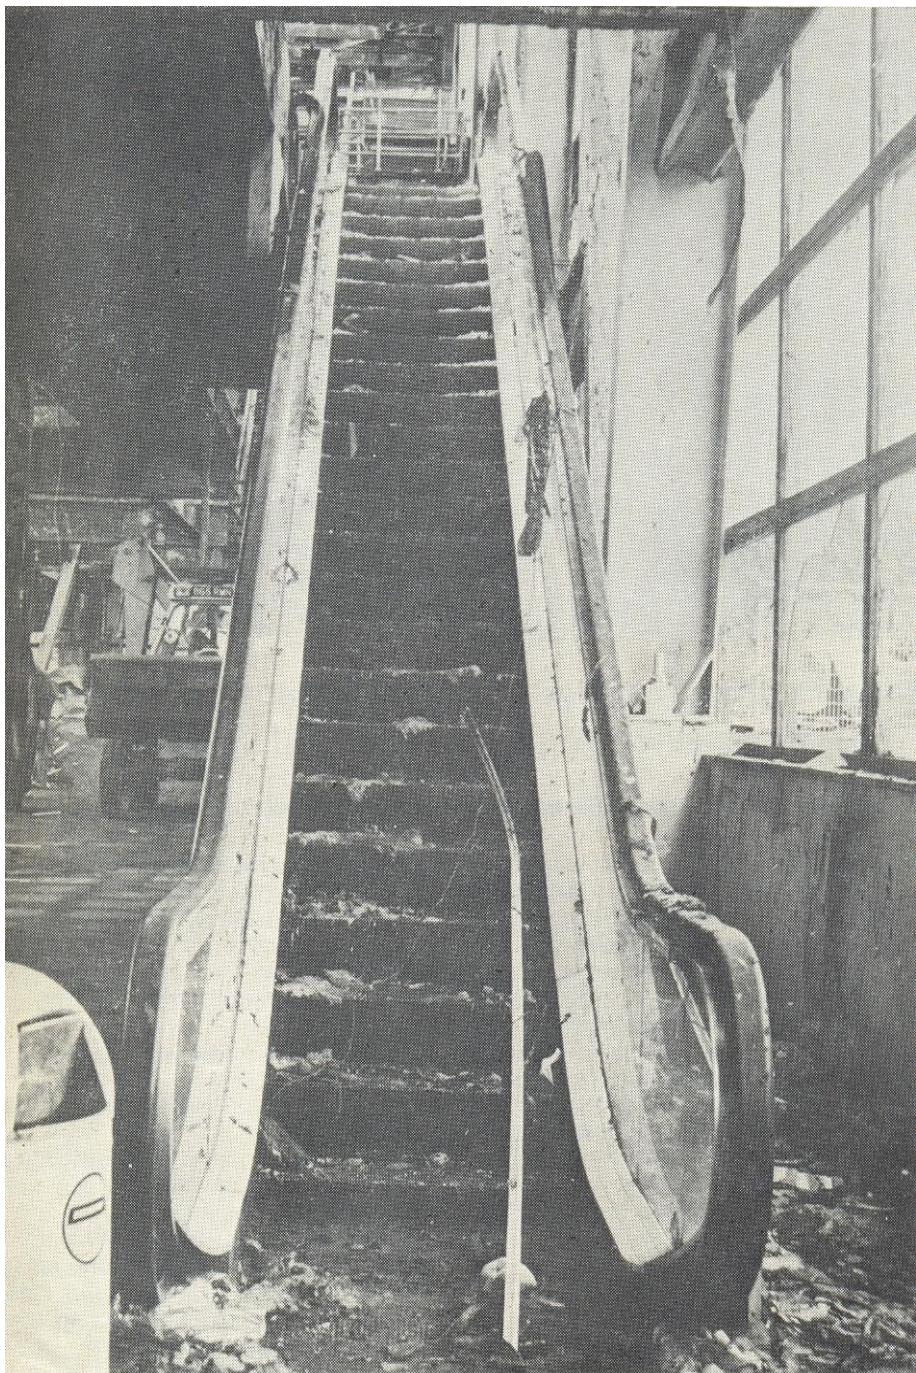
As the Flying Staircase rapidly became engulfed in flames, Mr Harding (Technical Services Manager) directed people 50 feet along the seaward-facing terrace to the escalator. Mr Harding ran down the escalator (which was travelling upwards) and stopped it (**figure 6.24**), before assisting people to escape from Summerland. Those people who did not run down the escalator might have run further along the terrace and down the spiral Pool Bar stairs (width = 2 feet 9 inches) to reach the Solarium floor (**figure 6.8** and **figure 6.19**). At the western end of the building, some people in the Pool Bar would have also used this narrow spiral staircase.

Figure 6.24: People unable to use the Flying Staircase to descend to Solarium floor level ran along the terrace and instead went down the upward moving escalator

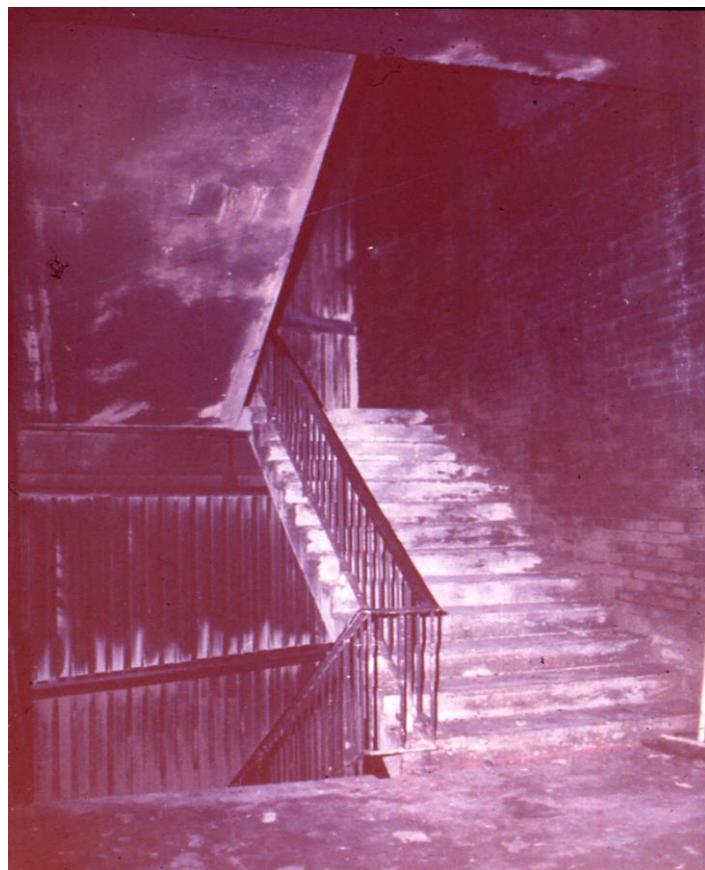
1. The walls of two sides of the stairwell were constructed out of combustible Colour Galbestos steel sheeting (section 6.4.2). This violated Manx Theatre Regulation Number 8 (**figure 6.25**).

Figure 6.25: The NE Service Staircase at Marquee Showbar level. Note the use of combustible Galbestos steeling for the half-landings

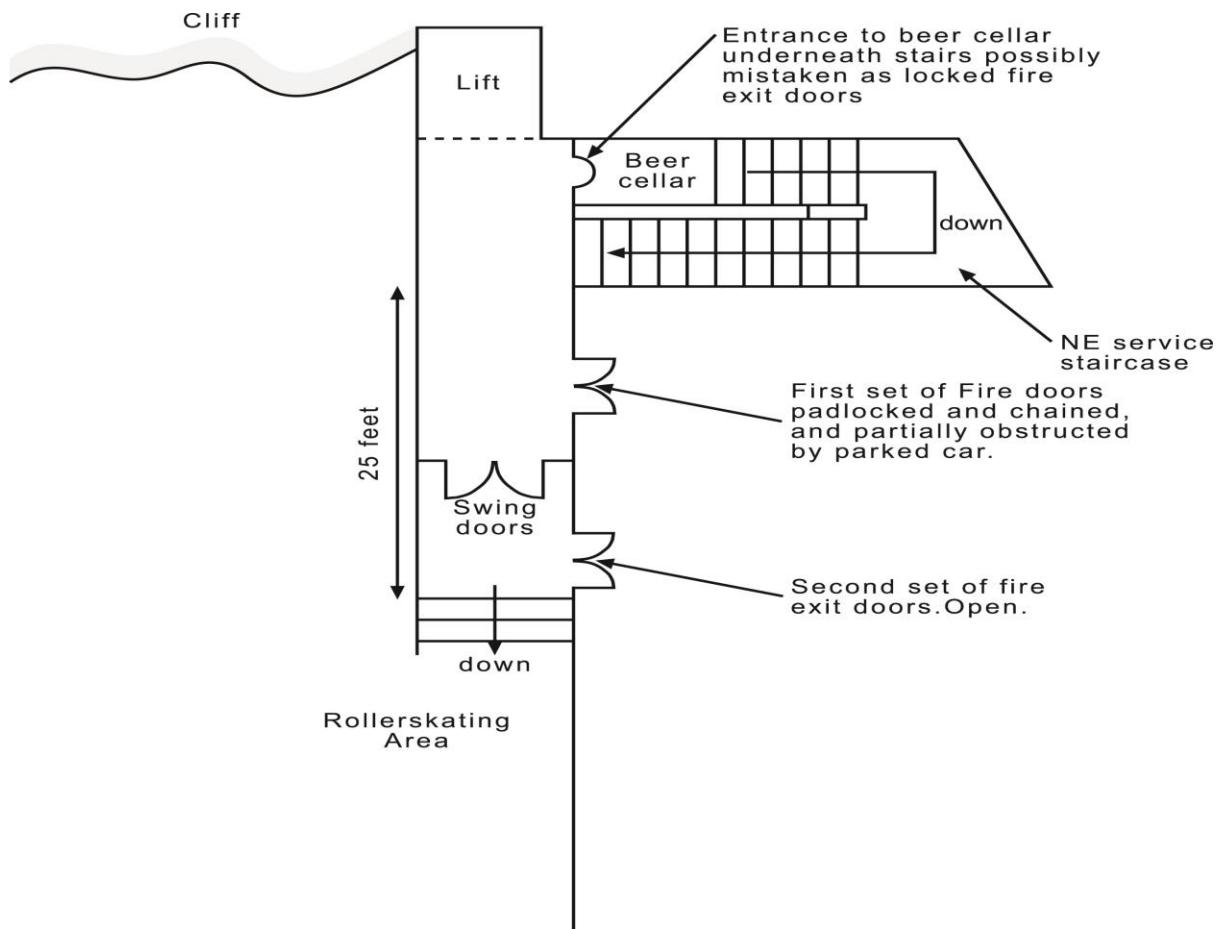
People that reached the bottom of the NE Service Staircase faced further difficulties. The geography at the bottom of this staircase was peculiar (**figure 6.26**). Coming down the staircase one was always turning to the right to go down the next flight. However, at the bottom of the stairs, you had to turn *left* to reach the fire exit doors (**figure 6.27**). If you had turned right at the foot of the stairs, you would have encountered a pair of doors that were locked by a chain and padlock through the handles that were the entrance to a beer cellar underneath the staircase. In the light of the doors' positioning and the darkness and confusion that existed, Summerland fire investigator John Webb strongly believes several people mistook the locked beer cellar doors as the fire escape doors. The *Summerland Fire Commission* did not comment on this possibility.

Figure 6.26: The geography of the bottom of the NE Service Staircase (Enlarged from the original plan in the SFC Report; drawn by Kevin Burkhill, University of Birmingham)

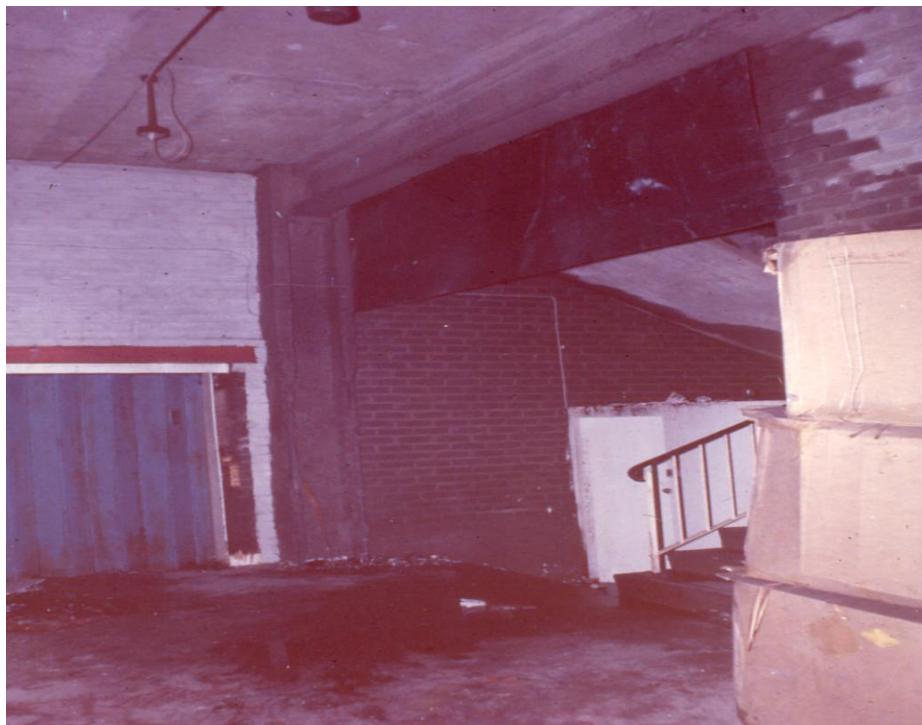
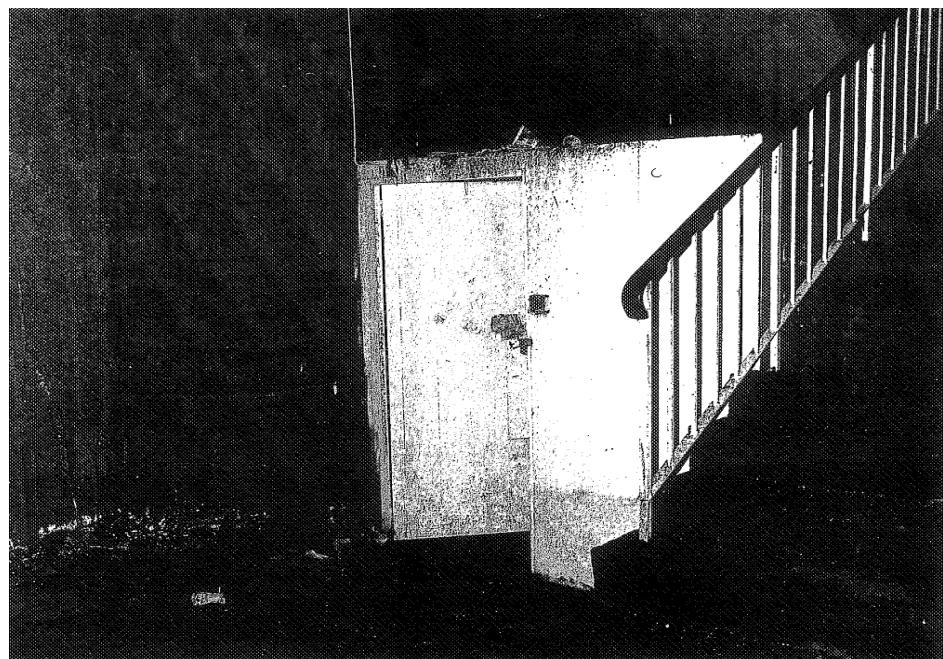
It has already been established (chapters 4 and 5) that the set of doors nearest to the bottom of the NE Staircase was chained and padlocked when the fire broke out. This set of doors was also obstructed by a parked car. The padlock was eventually taken off and the car moved, but “not before people escaping down the stairs had found themselves unable to open these doors (*Summerland Fire Commission*, Paragraph 183, Page 62). It is extremely fortunate that a pair of swing doors (**figure 6.26**) near the locked

Figure 6.27: The bottom of the NE Service Staircase (top). To reach the exit door, a person had to turn left at the bottom of the stairs. Turning right led to the locked beer cellar under the stairs (see bottom photograph for a closer view).

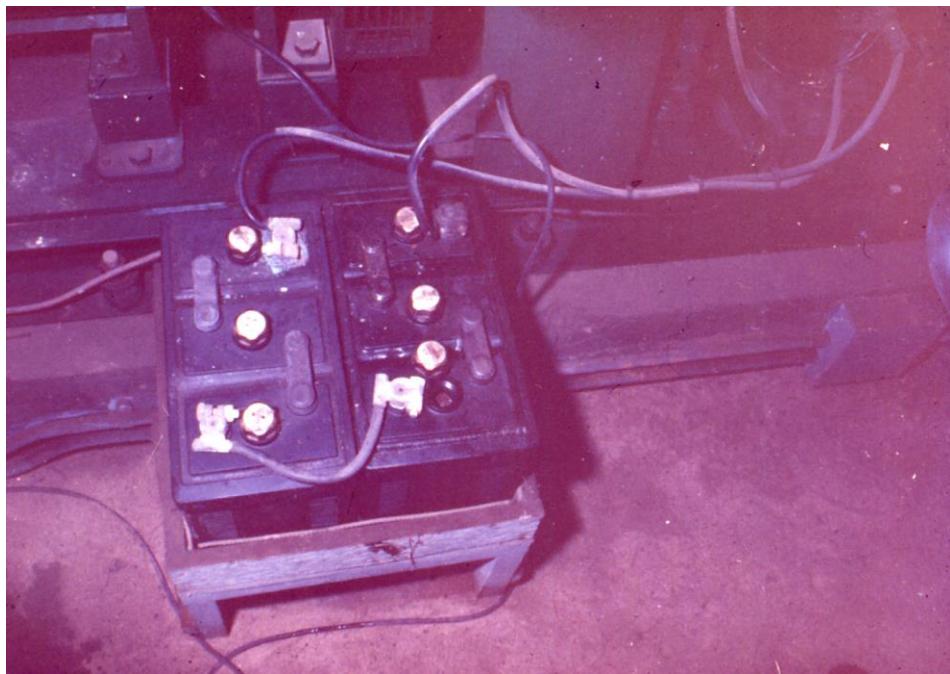
second theory: that is, the switch for isolating the generator had been left in the OFF position. It is possible that the SFC favoured theory two over theory one because important observations about the state of the starter batteries (**figure 6.28**) were omitted from the Fire Research Station's report (Silcock and Hinkley, 1974) and thus were not conveyed to the SFC (John Webb, Personal Communication).

Figure 6.28: The starter batteries for the emergency generator
(Photograph: John Webb, Copyright FRS/BRE)

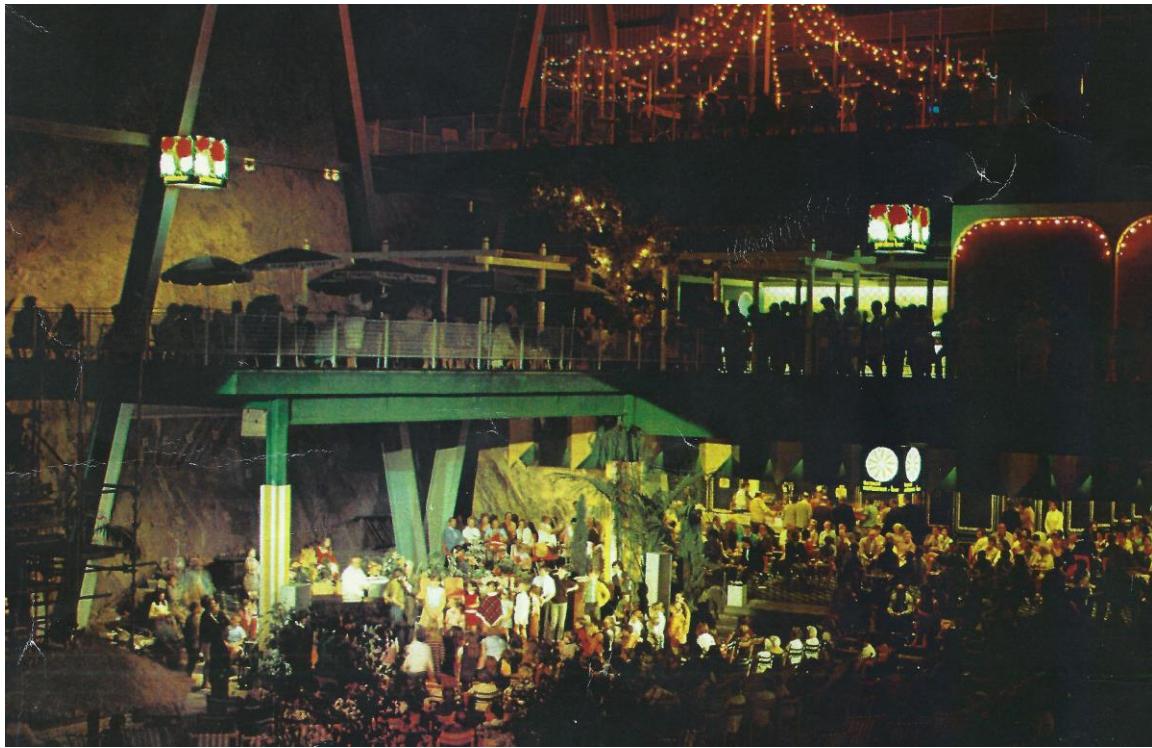
The *Summerland Fire Commission* identified several reasons why the fire spread rapidly once it had broken out of the void. Firstly, Summerland's open plan design allowed the fire to roam freely because there were no effective measures to stop it spreading either horizontally and vertically. In particular, the three terraces were open on one side (**figure 6.11**), which meant they were exposed to fire on the Solarium floor below. The contribution of the building's open plan design to the disaster had already been highlighted by the Island's Chief Fire Officer and a UK fire expert in August 1973 (section 5.2.2). Open plan buildings are said to lack 'compartmentation'. The objective of compartmentation is to contain the fire to one part of the building whilst allowing people in the other parts of the building to escape. In other words, compartmentation separates people from the fire risk. Promotional literature for the building (*The Summerland Story*, page 26) claimed the risks of fire spread had been 'overcome': clearly, they had not been and the building's design was conducive to rapid fire spread. As Summerland had almost no compartmentation, the people inside the building and the fire risk were mixed up together on the Solarium floor and the three terraces (**figure 6.29**). In the light of the defects in the design of the NE Service Staircase (section 6.5.2), the Solarium and the terraces can essentially be regarded as one compartment. At Summerland, faults in the building's management (i.e. delayed evacuation; see section 6.5.1) and design (i.e. excessive travel distances on open escape routes; see section 6.5.2) resulted in hundreds of people occupying the same compartment as the fire. It is now easy to account for the high death toll in the Summerland fire.

Figure 6.29: Summerland's open plan design provided a free ticket for the fire to roam freely

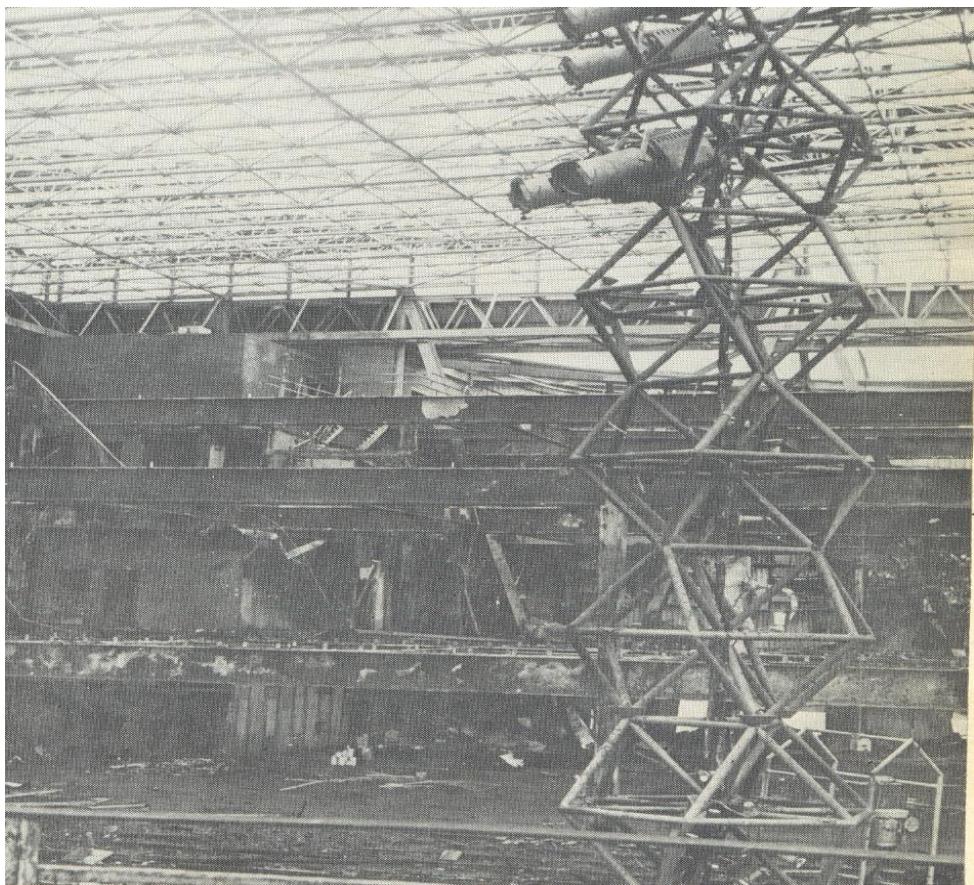
Figure 6.30: The fire completely stripped away the terraces’ softwood floors. The remains of an open plan staircase connecting the Cruise Deck (Level 7) to the Leisure Floor (Level 6) can be seen in the top left-hand corner of the photograph

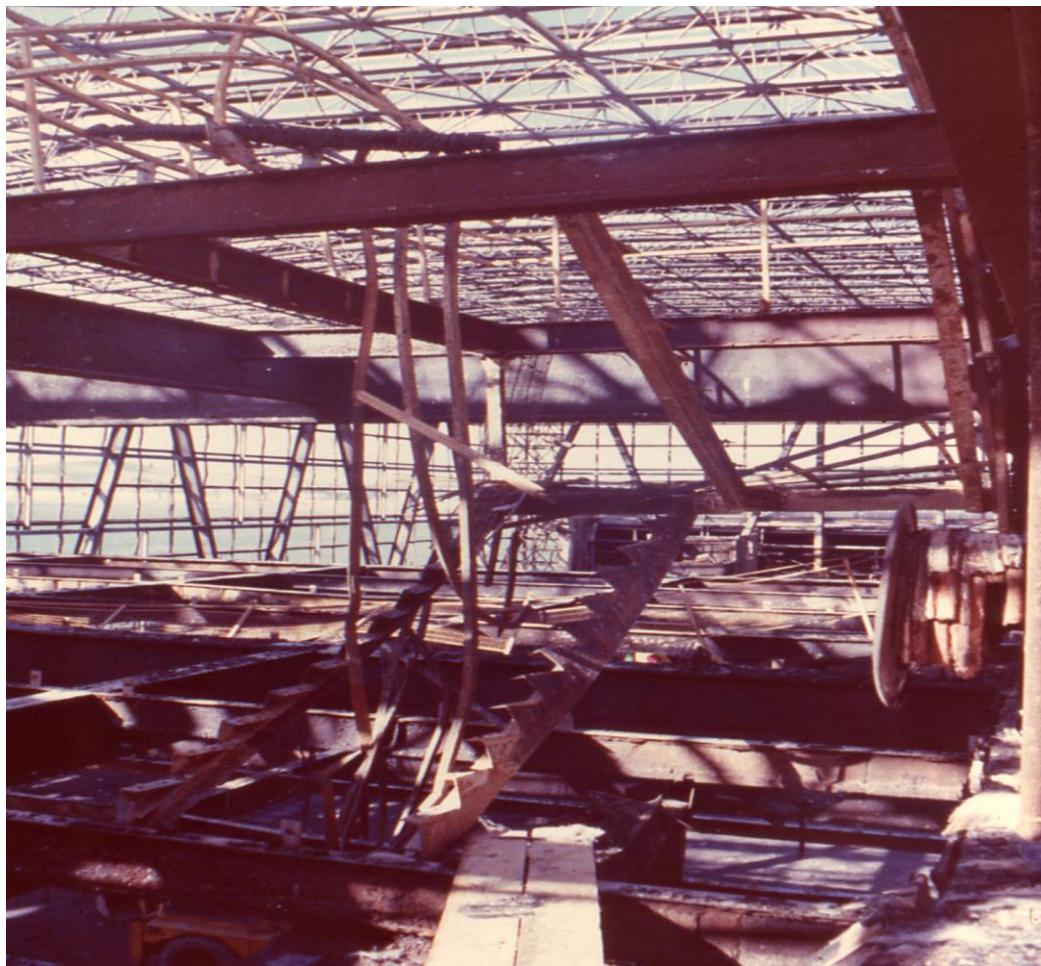
Figure 6.31: Another view of the terraces taken from the NE Service Staircase at the 84 ft level

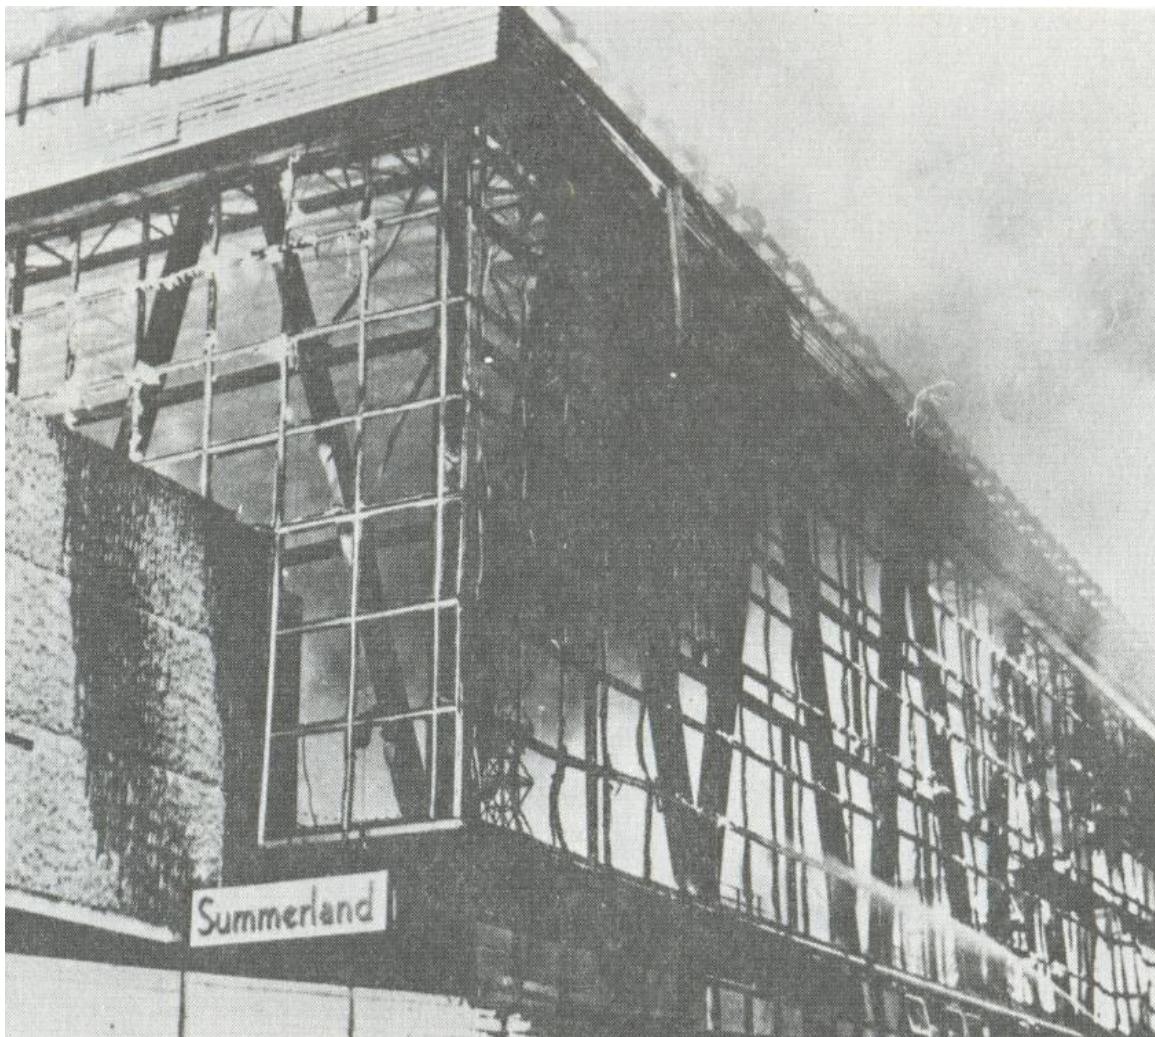
Figure 6.32: Venting of the fire caused by the destruction of the Oroglas promenade wall (Source: Pym, 1977, page 88)
