Winter 2013-14: "The Remote Control Flood"

And other tales of the advancement of hydrological science through technology.....

BHS Symposium, University of Birmingham September 2nd 2014

Nick Everard – Technical Adviser, Hydro-Acoustics Environment Agency, United Kingdom nick.everard@environment-agency.gov.uk

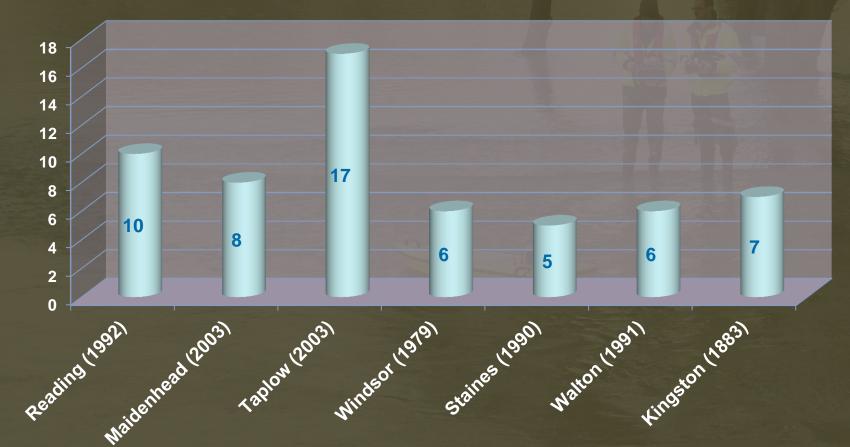
January/February 2014: **59** high flow gaugings on Lower Thames. All used RC boat and ADCP.

Lower Thames ARC-Boat gaugings in 2014 floods - total 59

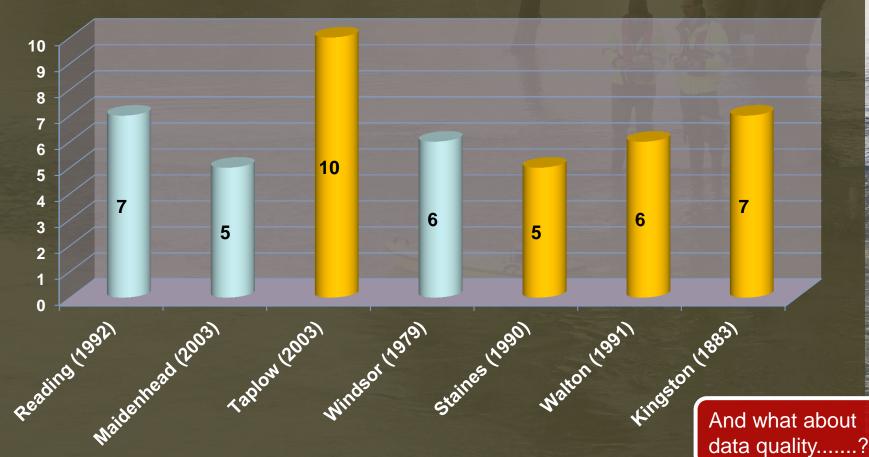
At all sites on Lower Thames at least 5/10 highest ever gaugings this year, with RC boat. Highest ever gaugings at 4 sites

Highest gaugings in 2014 floods (out of top 10 highest)

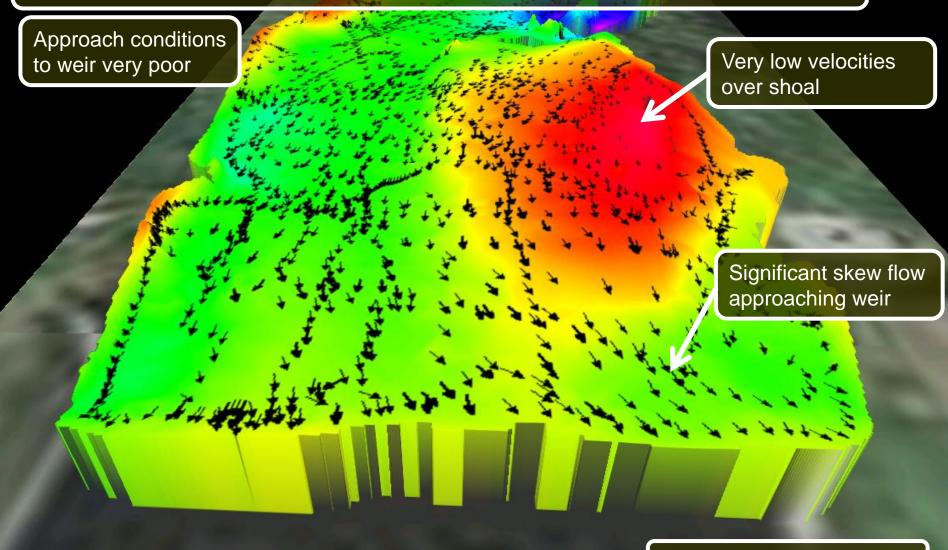
River Kennet at Theale

After the flood – hydrometric impacts

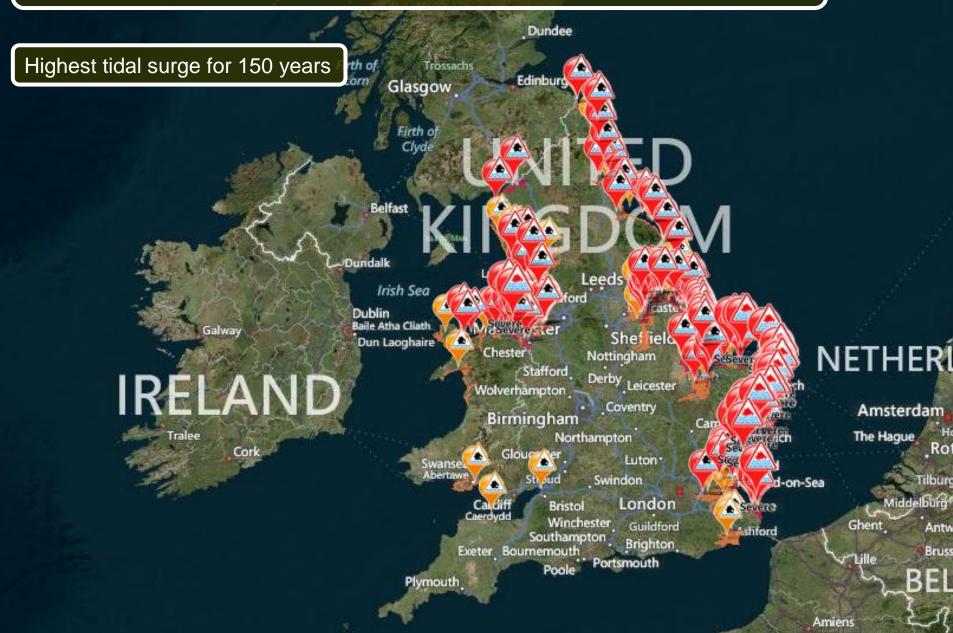
East coast tidal surge December 2013

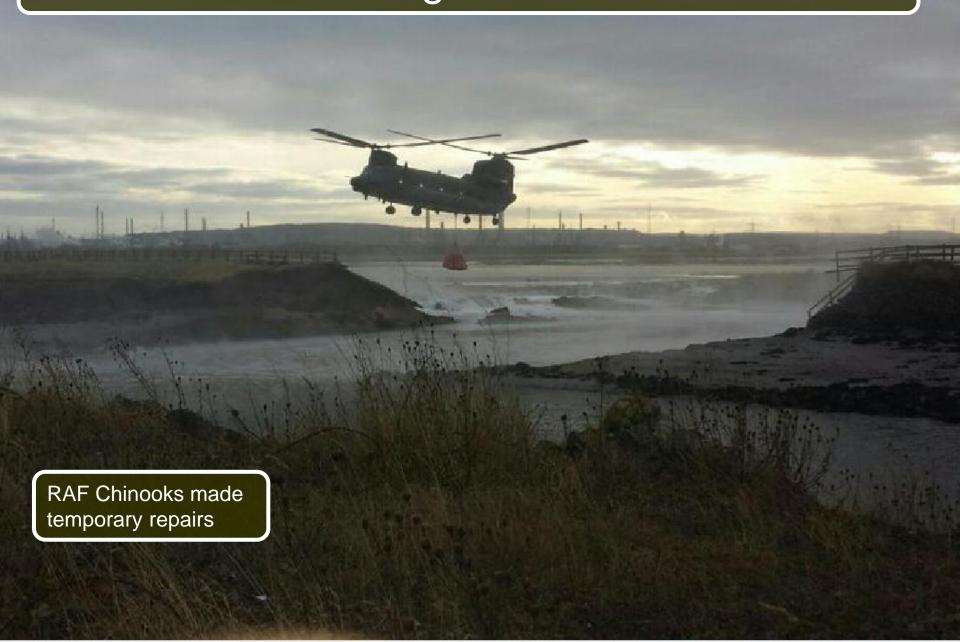
East coast tidal surge – Seal Sands breach

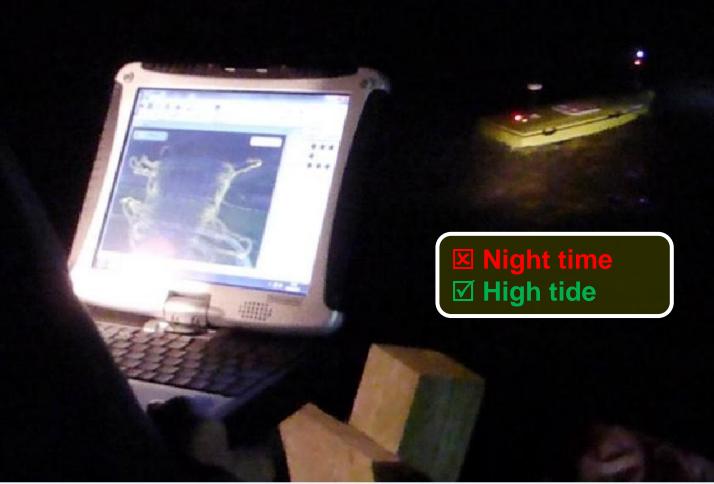
East coast tidal surge – Seal Sands breach

ARC-Boat/ADCP survey attempt no.2
