CHAPTER 7

LEARNING THE LESSONS OF THE SUMMERLAND FIRE

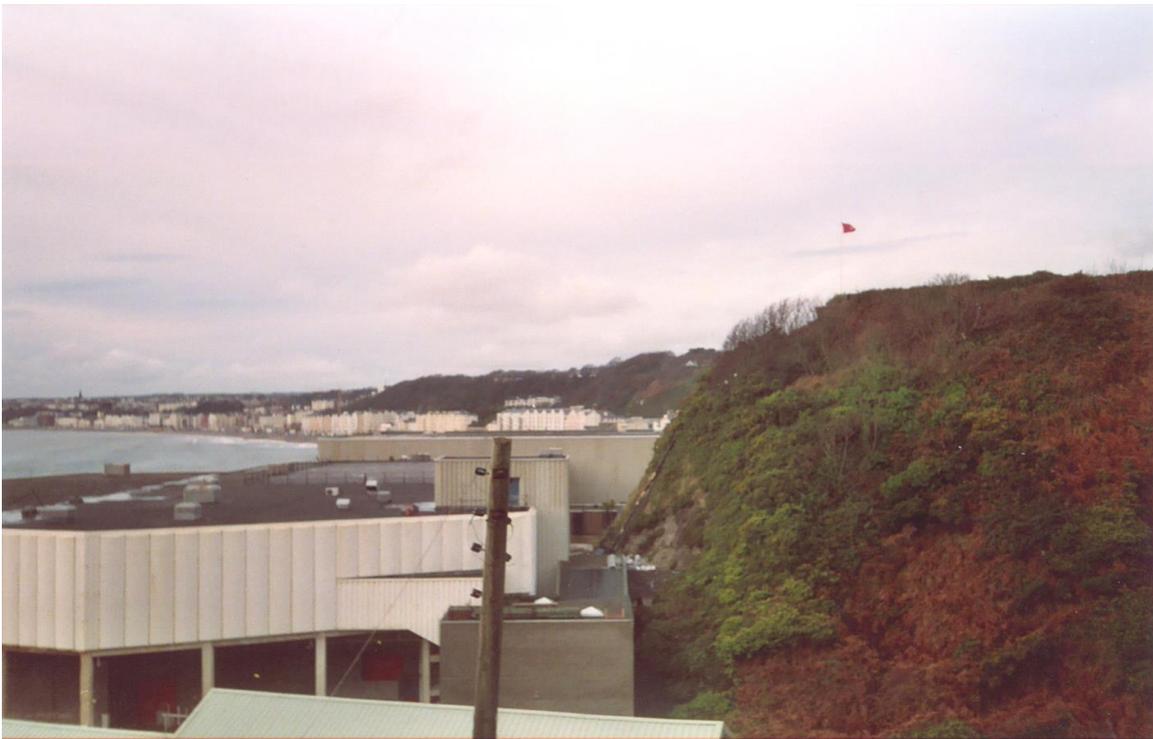
Figure 7.2:

The upper floor of the rebuilt structure was erected clear of the cliff face

means of escape would remain unsatisfactory because of excessive travel distances on some open routes. In his *Isle of Man Weekly Times* article, Fry (1973) sees the absorption of the natural cliff face into Summerland as one of the great strengths of the original complex whose aesthetic appeal could be improved in the new Summerland. On the contrary, the cliff hindered the means of escape in the original Summerland; from a fire safety perspective, grafting the building, particularly the upper floors, into the cliff was not an acceptable solution for the new Summerland (**figure 7.2**).

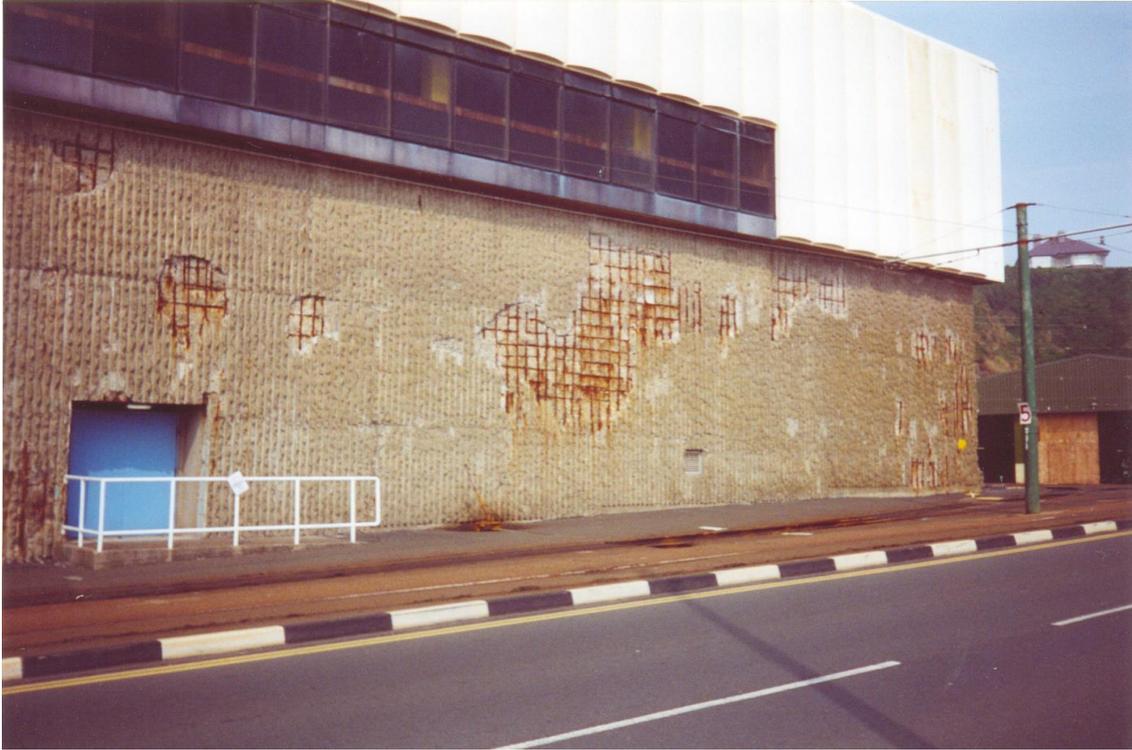
Figure 7.3: Summerland from King Edward Road in 2003

This photograph shows the enclosed nature of the rebuilt upper floor and the rotting concrete wall of the original building. The fire exit is from the underground disco (CAVE 3) and was added after the fire.

During the re-design, the authorities considered moving the two tracks of the Manx Electric Railway that run directly in front of Summerland (**figure 7.3**). They decided against this solution, but instead the building's alarm system was wired to traffic lights on the Promenade that would change to red when activated to allow unobstructed access to the building (Hayward, 1978). The railway would not cause a problem for two of the four escape routes from Summerland's basement nighttime discotheque because the railway would have stopped running by that time. The track bed of the railway was hardened after the fire to provide easier access for emergency vehicles (Crawford, 1978). Summerland's fire detection equipment was so sensitive that it was often activated when dust was disturbed during dancing displays (Michael Joyce, Personal Communication).

Summerland I. A long but narrow row of windows in the building's south wall admits even less light into Summerland II at this level (**figure 7.3**).

The Cave’s third fire exit is by a new emergency escape staircase (CAVE 3) that is entered midway along the club’s main floor just before the entrance to the back room. This staircase leads directly out on to King Edward Road (figure 7.3).

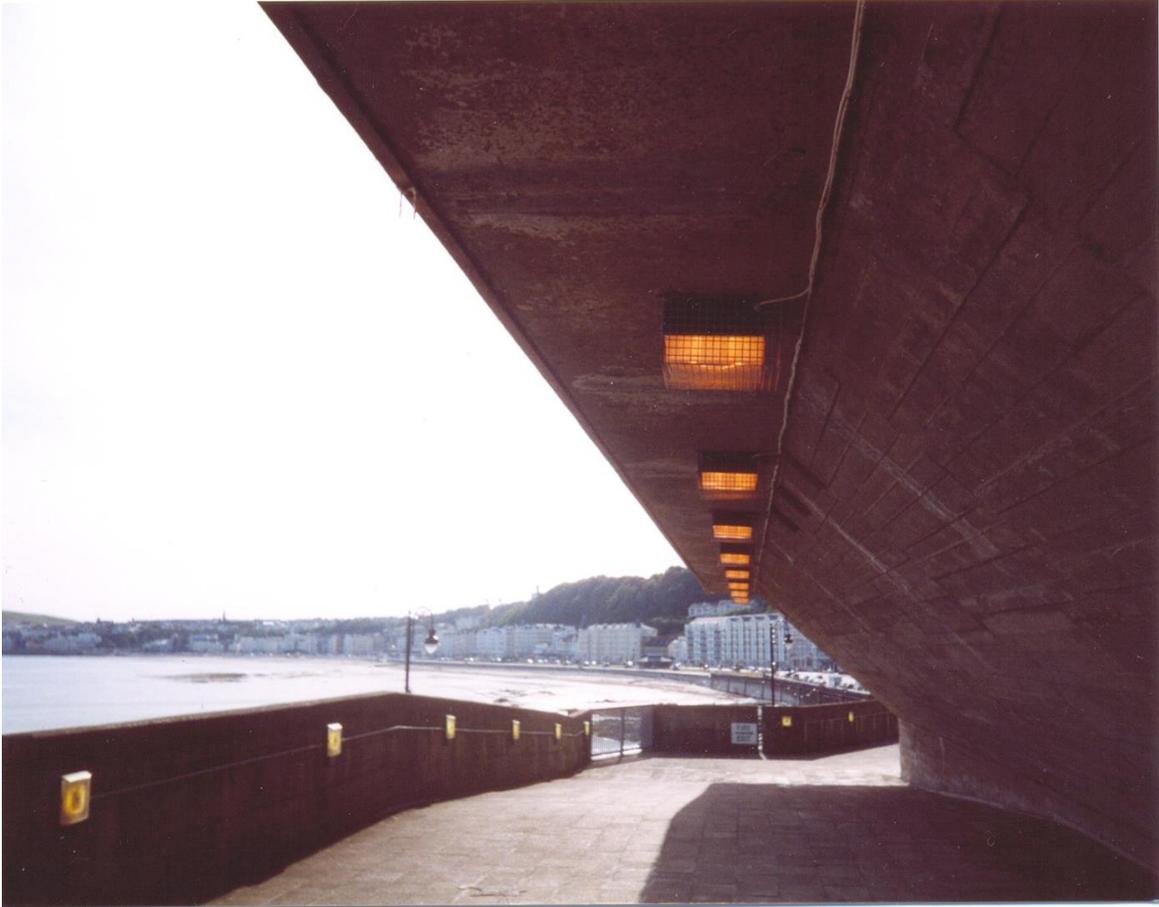
Figure 7.4: The walkway leading from the upper entrance in the rebuilt complex. (Photograph: Ian Phillips)

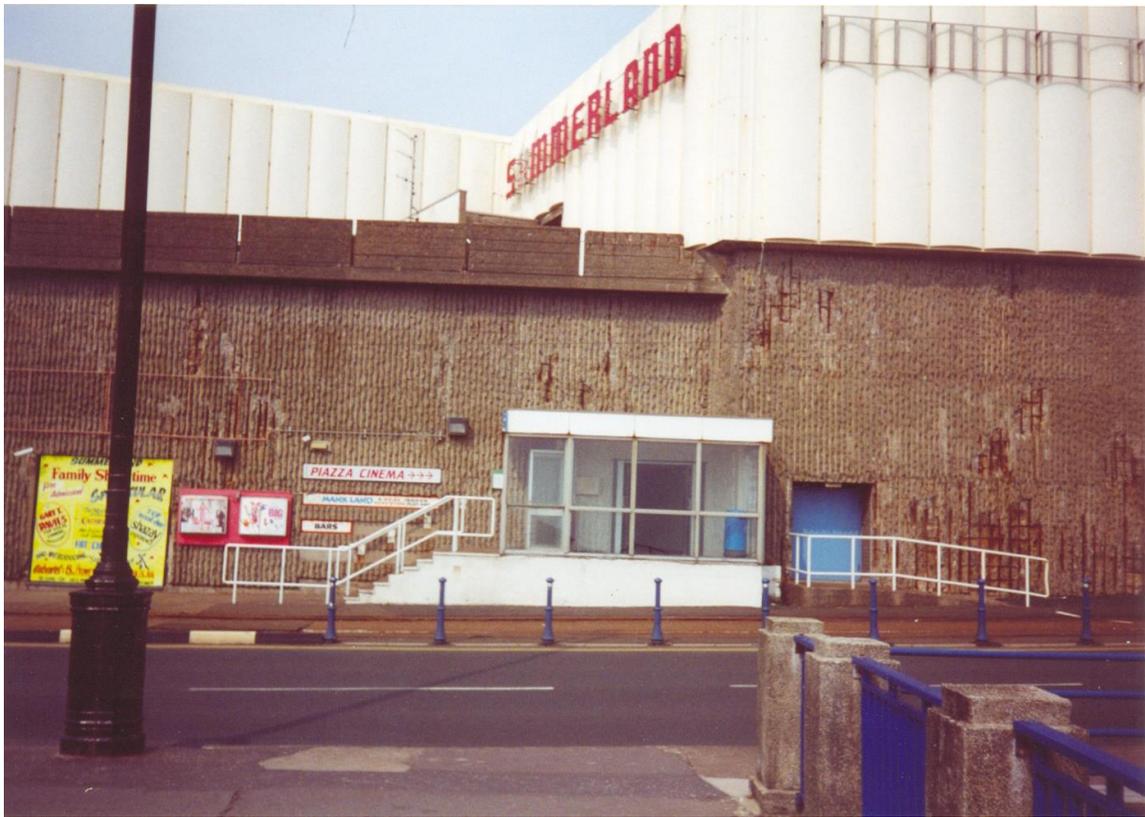
Figure 7.5: A new entrance at street level was added when Summerland was rebuilt

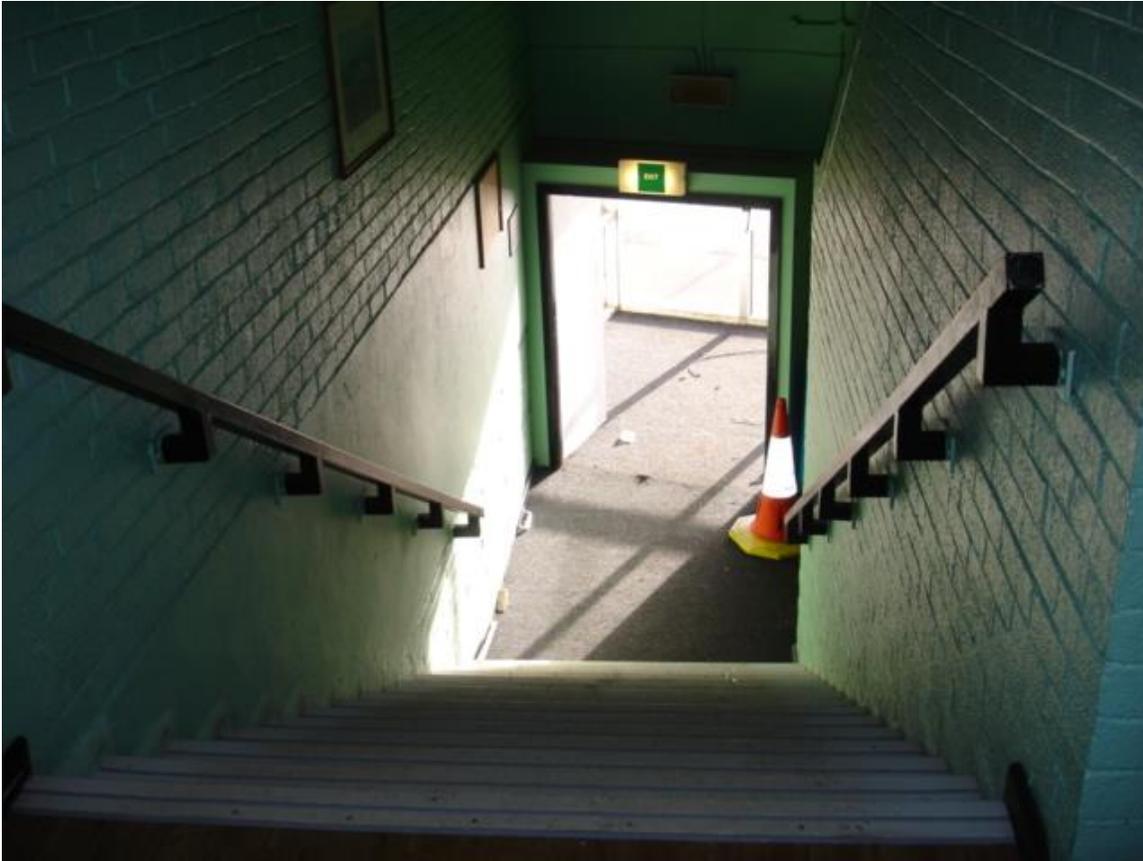
Figure 7.6: The staircase leading down to the main entrance. The doorway leading to the open air was only added after the fire. A person using this staircase in the original Summerland would have had to descend a further flight of stairs to the right of the traffic cone into the Disco Foyer area. This illustrates how escape routes in the original Summerland were not direct enough.

This new doorway provides access to a staircase that was preserved from the original Summerland. On climbing one flight of stairs, the visitor reaches the building's reception level (**figure 7.6**).

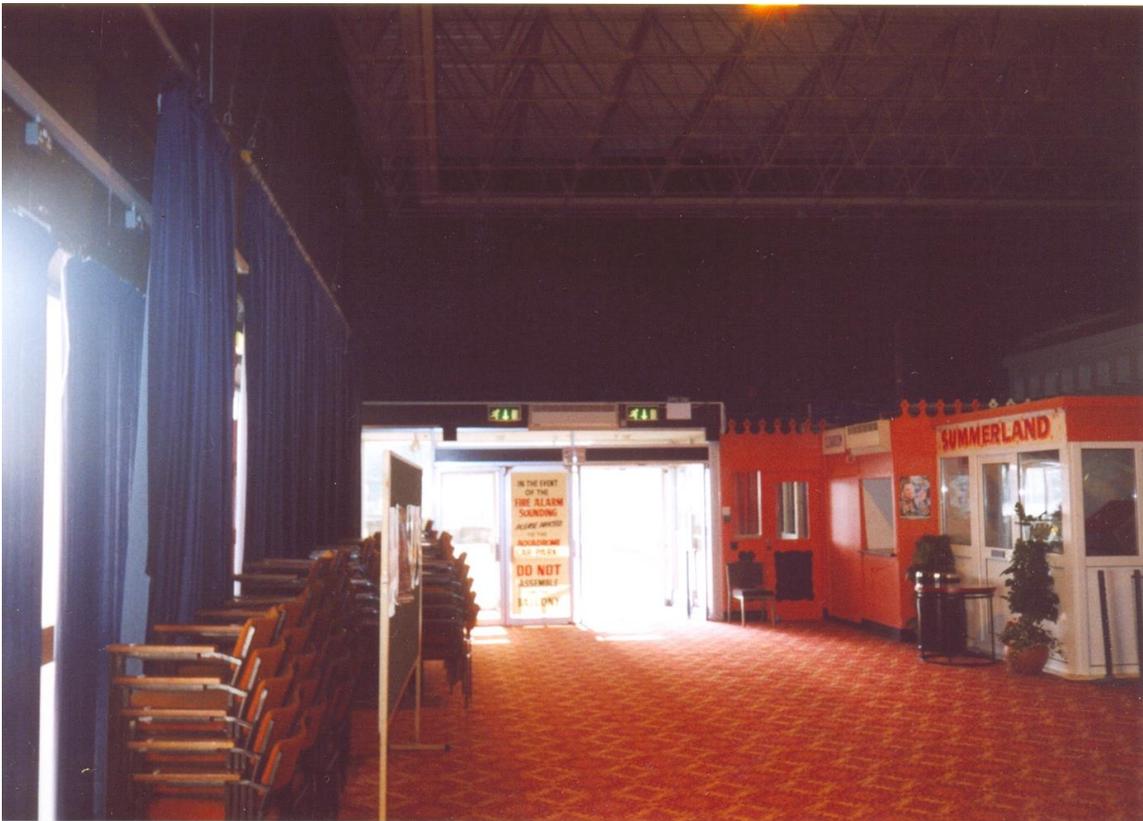
Figure 7.7: Summerland’s upper entrance (E3 on figure 7.21). This was the main entrance into the original Summerland. The architects considered moving these doors to the south wall, where the chairs are currently stacked. The cloakroom and kiosk on the right-hand side of the photograph were added later.

To resolve the problem of the pay boxes hindering people's escape from the building, a new set of doors with a total escape width of 14 feet was added to the north of the pay boxes (**figure 7.8**). When a general admittance charge to Summerland was dropped (along with the pay boxes), these doors were removed and part of the space used for a kiosk and cloakroom (**figure 7.7**).

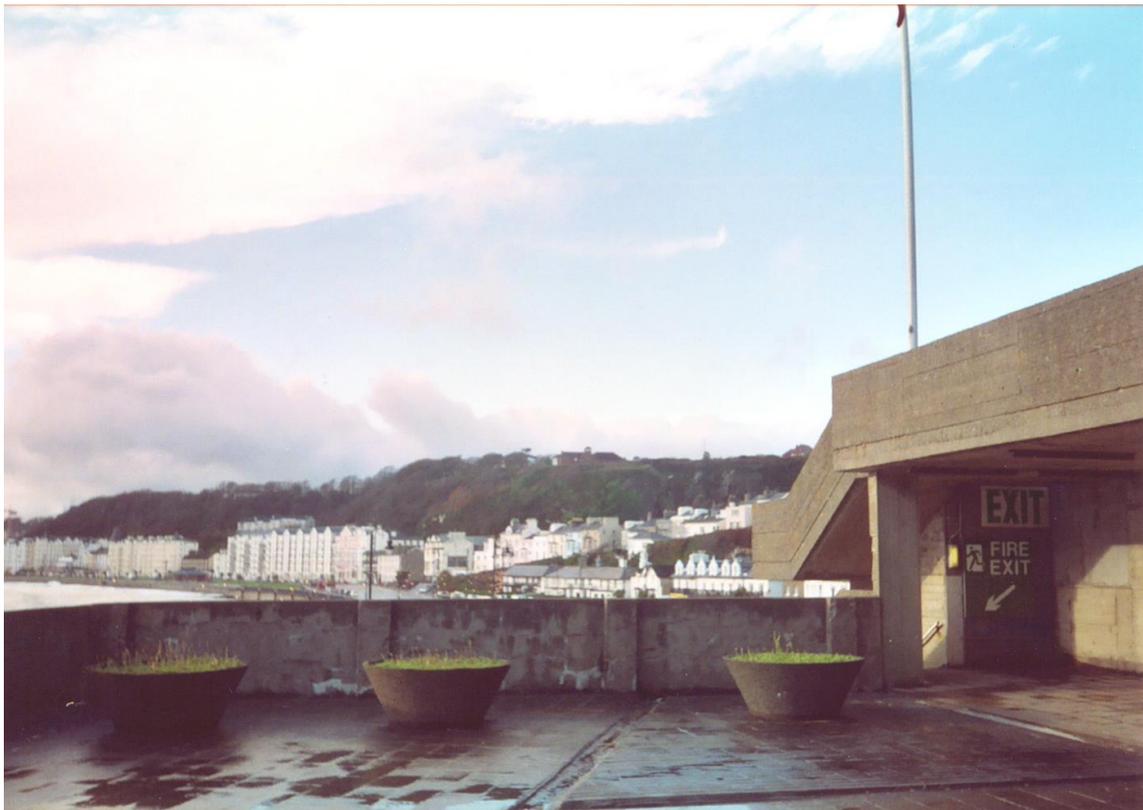
**Figure 7.9: The stairs leading down to street level from the upper entrance into Summerland
(Photograph: Ian Phillips)**

Green fire exit signs and directional signs have been added to the terrace; the external stairs leading down to the Aquadrome car park are even marked by a large fire exit sign (**figure 7.9**). The purpose of these signs is to discourage people from lingering on the terrace in the event of an emergency. In terms of evacuation procedures, the external terrace is being treated as if it is an integral part of the building; it is not a place of safety, but an *escape route* to the assembly point.

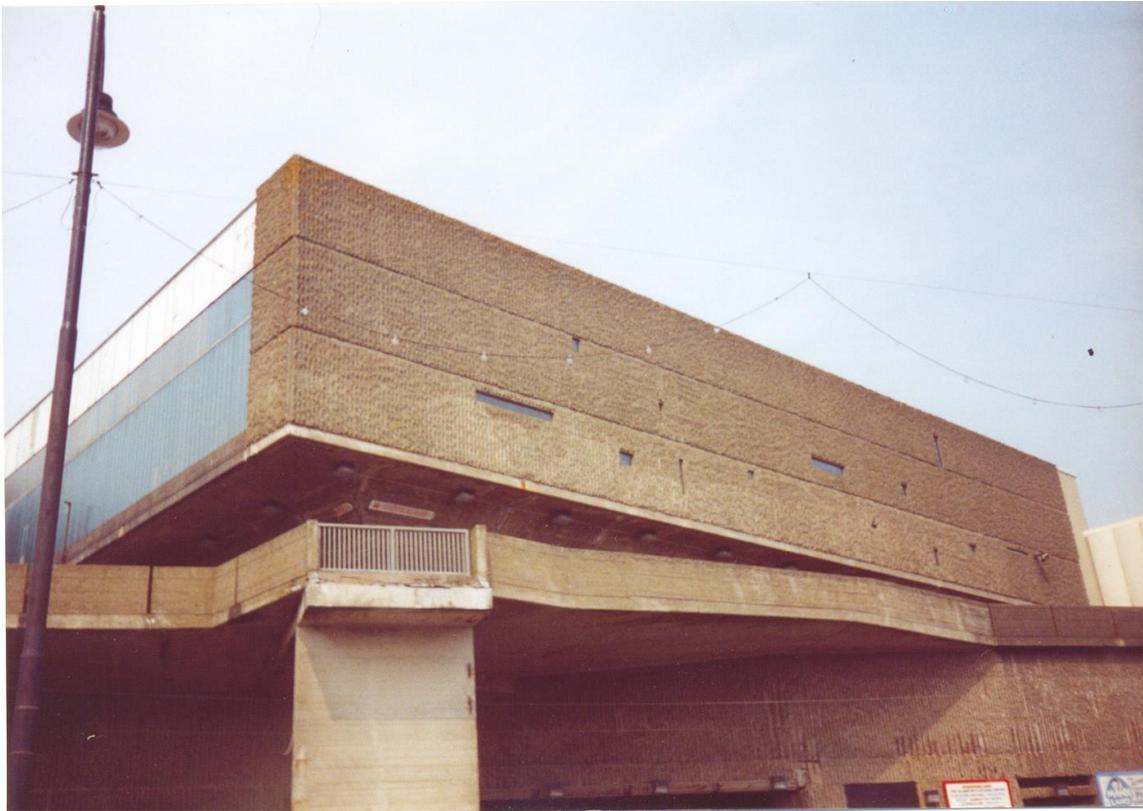
**Figure 7.10: The Aquadrome - the railings and the uneven concrete surface show the location of the former bridge
(Photograph: Ian Phillips)**

When Summerland re-opened in 1978, a visitor could have reached street level by using the pedestrian bridge over the Manx Electric Railway and King Edward Road. The bridge was subsequently demolished (**figure 7.10**), which meant that the only public means of access to the terrace was by ascending the steps from the Aquadrome car park (**figure 7.9**). Summerland's management is also conscious of the need to keep the main entrance free from obstructions: a notice warning people against chaining bicycles is prominently displayed by the main entrance.

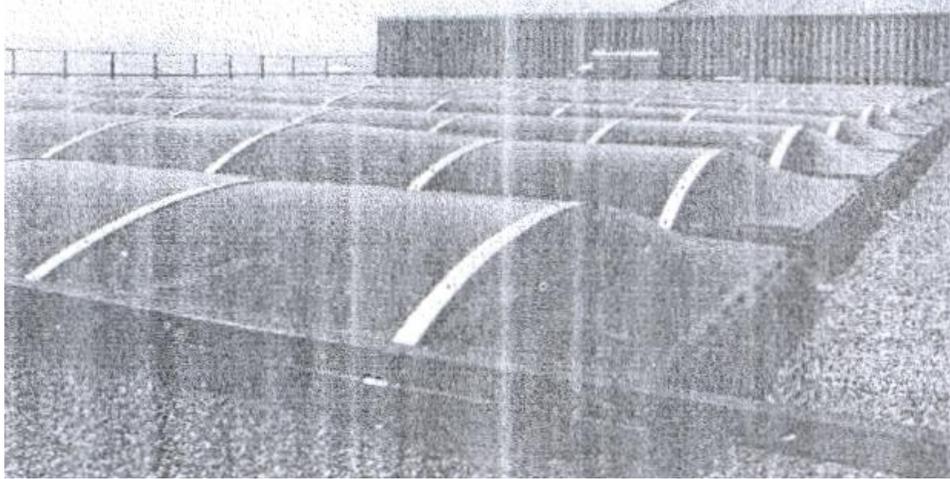
**Figure 7.12: The suntrap of barrel sectioned “Plastilux” sheeting
(Source: Crawford, 1978, page 37)**

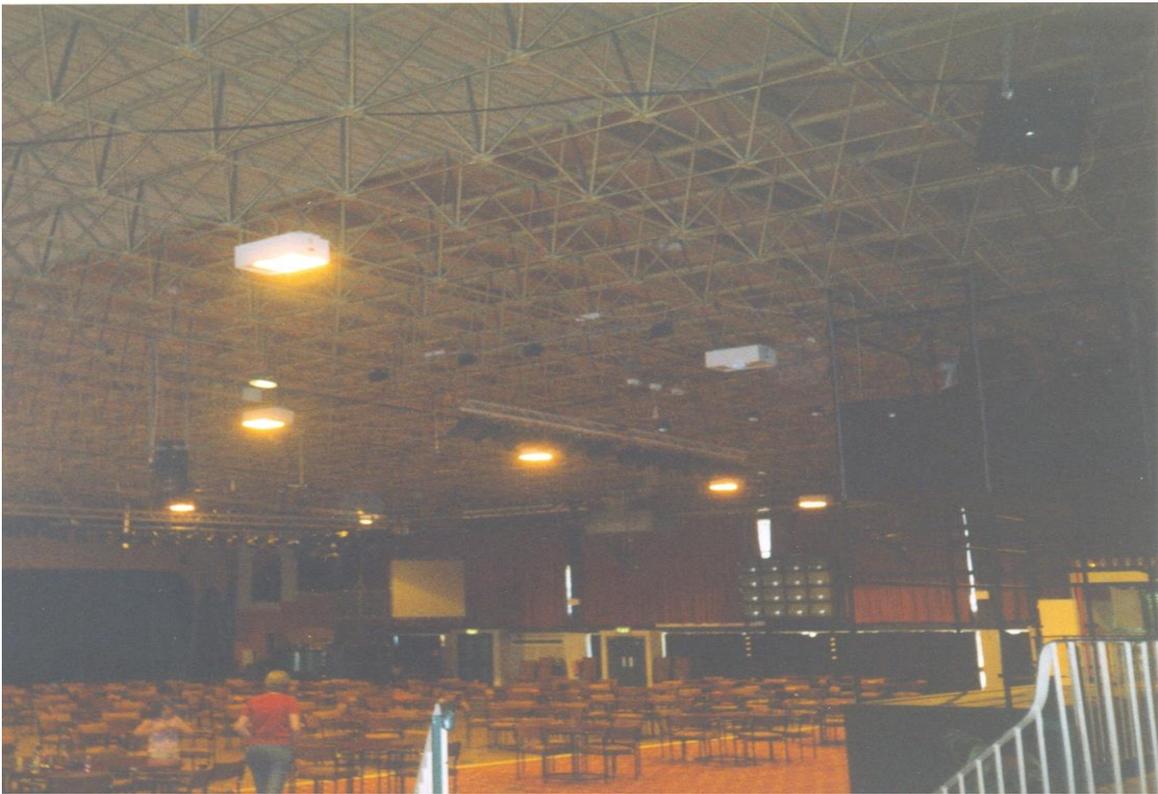
Figure 7.14: The Piazza floor in 2003 – the height of the roof is less than one-half of the height of the Oroglas roof in the original Summerland.

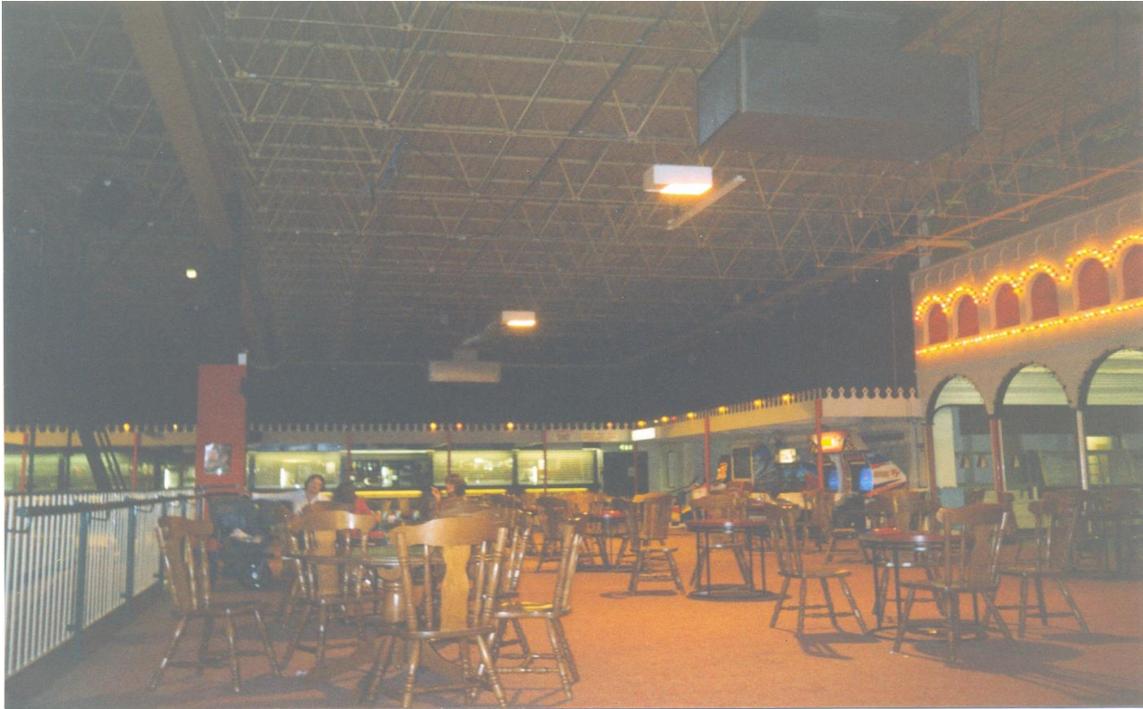
Figure 7.16: The 53.66ft level of the Piazza floor. The Piazza Cafeteria is on the right-hand side of the photograph. The white railings on the left-hand side can be seen on the right-hand side of figure 7.15.

Another similarity is the Piazza Cafeteria (**figure 7.16** and **figure 7.17**), which occupies a similar position to the Restaurant in the original complex. However, the differences between the two Summerlands are more noticeable than the similarities. The most notable difference is that the three open fronted terraces have not been rebuilt. As Mr Radcliffe, the Chairman of the Local Government Board, explained to Tynwald members in October 1975:

Summerland. In 2003, these two TV rooms were no longer open to the public, with the Manx Model Railway Club utilising space in this area. These television rooms occupy roughly the same position as the crazy-golf kiosk where the Liverpool schoolboys started the fire. The Cinema occupies a similar position to the amusements and bingo area in the original building. Summerland in 2003 did not have an amusement arcade as such, but machines line the wall between the Cafeteria and the flight of stairs providing access to the lavatories above the Piazza floor (**figure 7.16**).

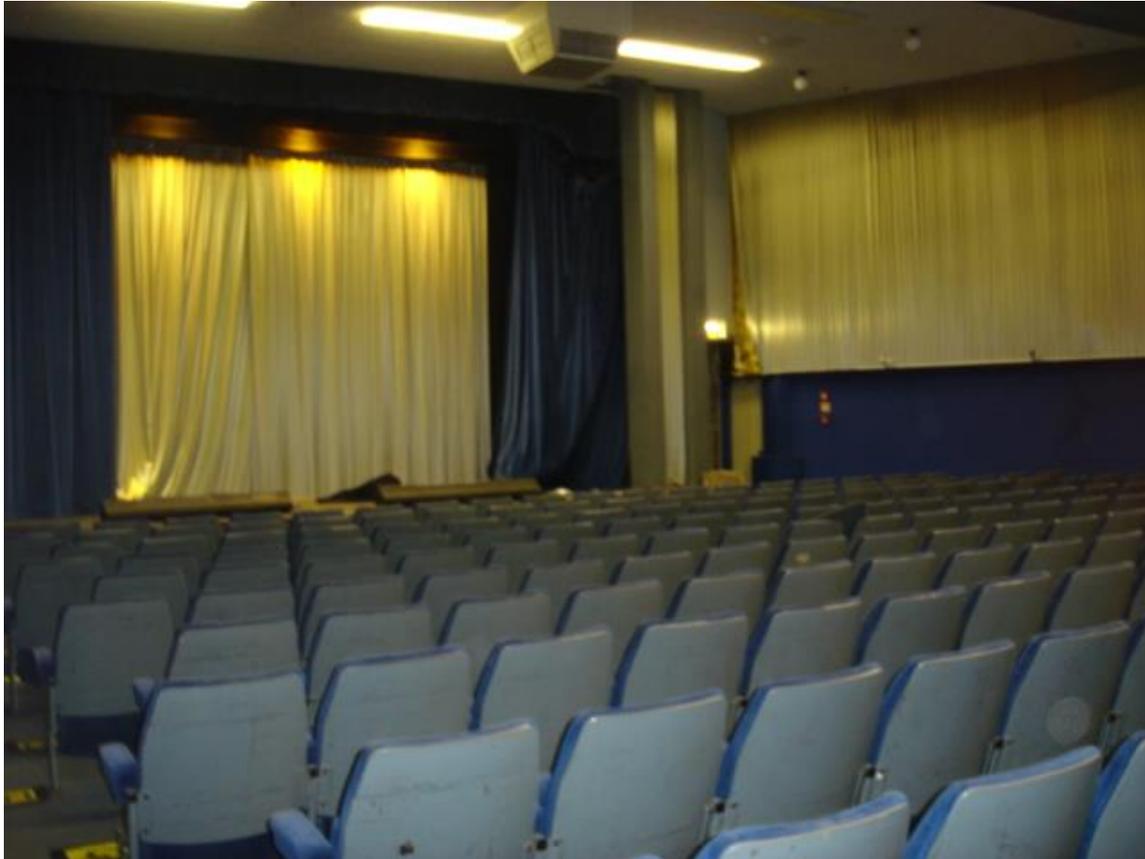
Figure 7.18: The Cinema. The doorway to the right of the screen leads to staircase C1 on the plan (figure 7.21)

In addition to the Cafeteria (which is often used for children’s birthday parties), the eastern end of the Piazza Level contains a 200 seat Dolby Sound Cinema showing the latest films (**figure 7.18**).

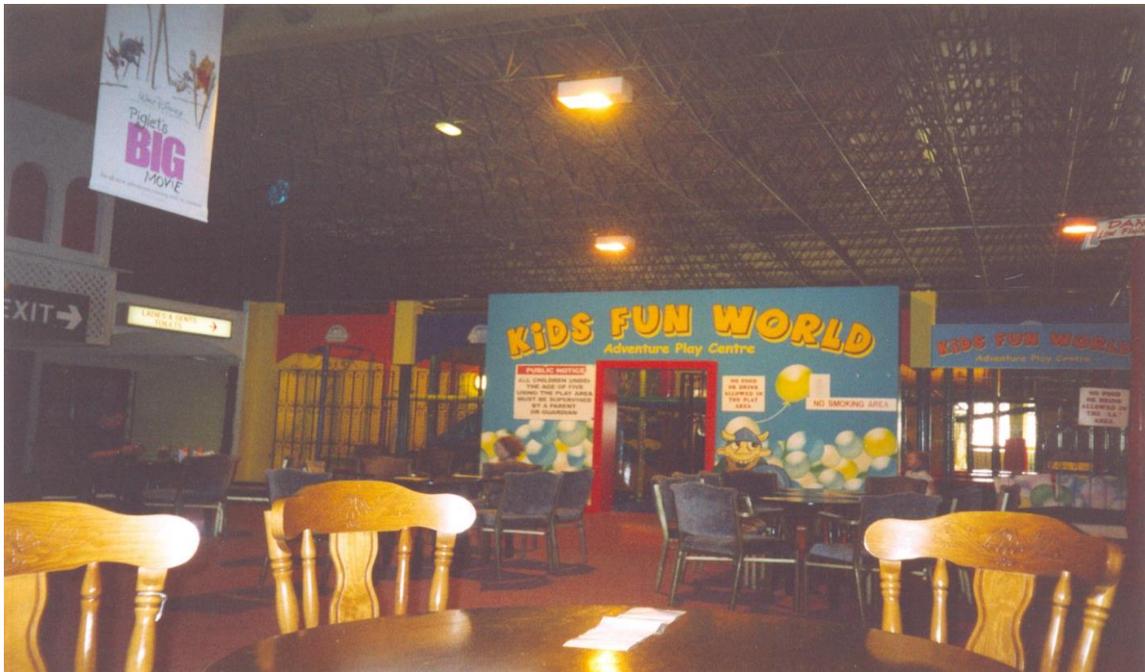
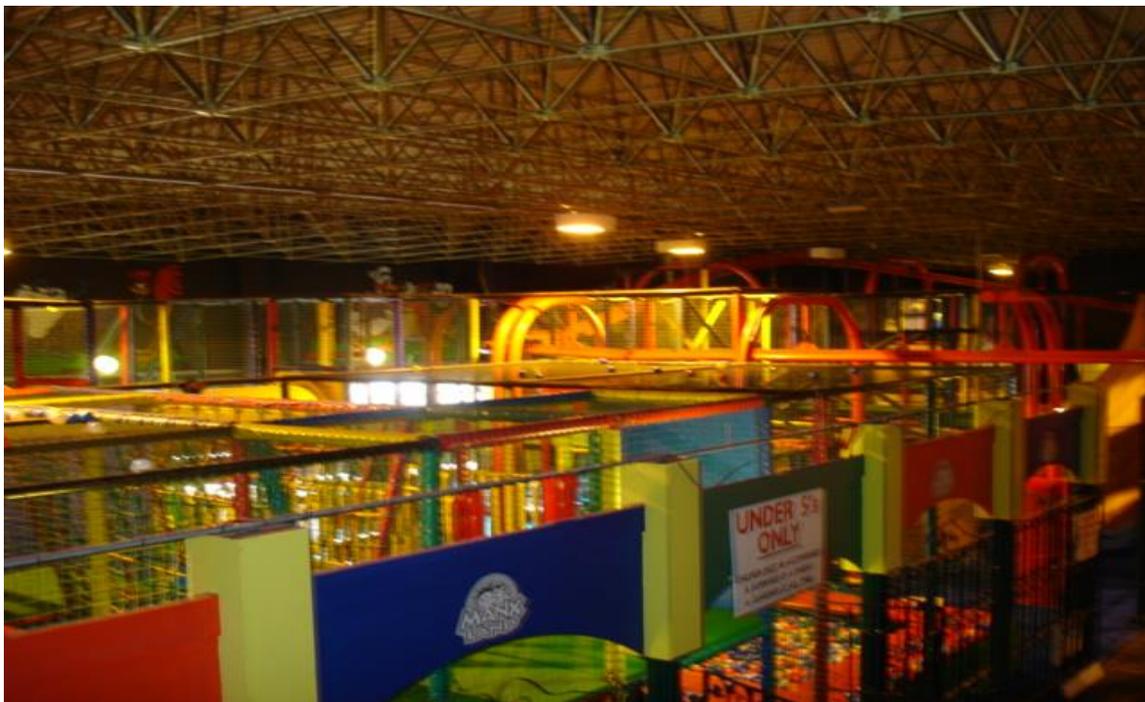
Figures 7.19 and 7.20: The Manxland children's play area
Note the prominent green exit sign on the left of the top photograph.
(Figure 7.19: Ian Phillips; Figure 7.20: Ricky Rooney and James Turpin)

The area formerly occupied by the crazy-golf course was largely occupied in 2003 by the Manxland Children's Play Area (**figures 7.19** and **7.20**). Manxland is a soft play area that according to a promotional leaflet has "lots of exciting features including ballpools, climbing frames and an aerial glide". Manxland replaced the amusements and bingo area that occupied this area when the complex reopened in 1978. There was no bingo area in Summerland in 2003.

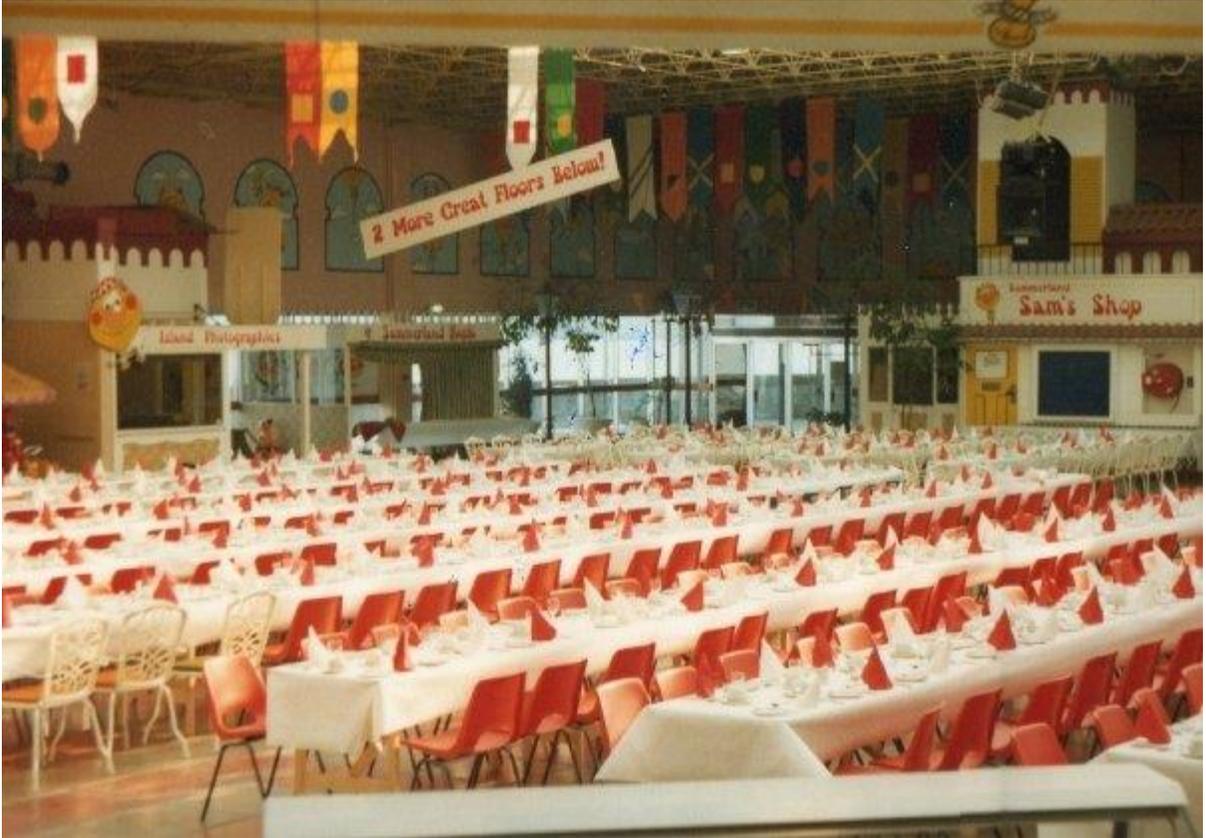
Figure 7.24: The double set of glass doors forming the terrace entrance (E3) can be seen in the background of this photograph taken in 1983 (Photograph: Added to the *Summerland Appreciation Society Group* on Facebook by Chris)

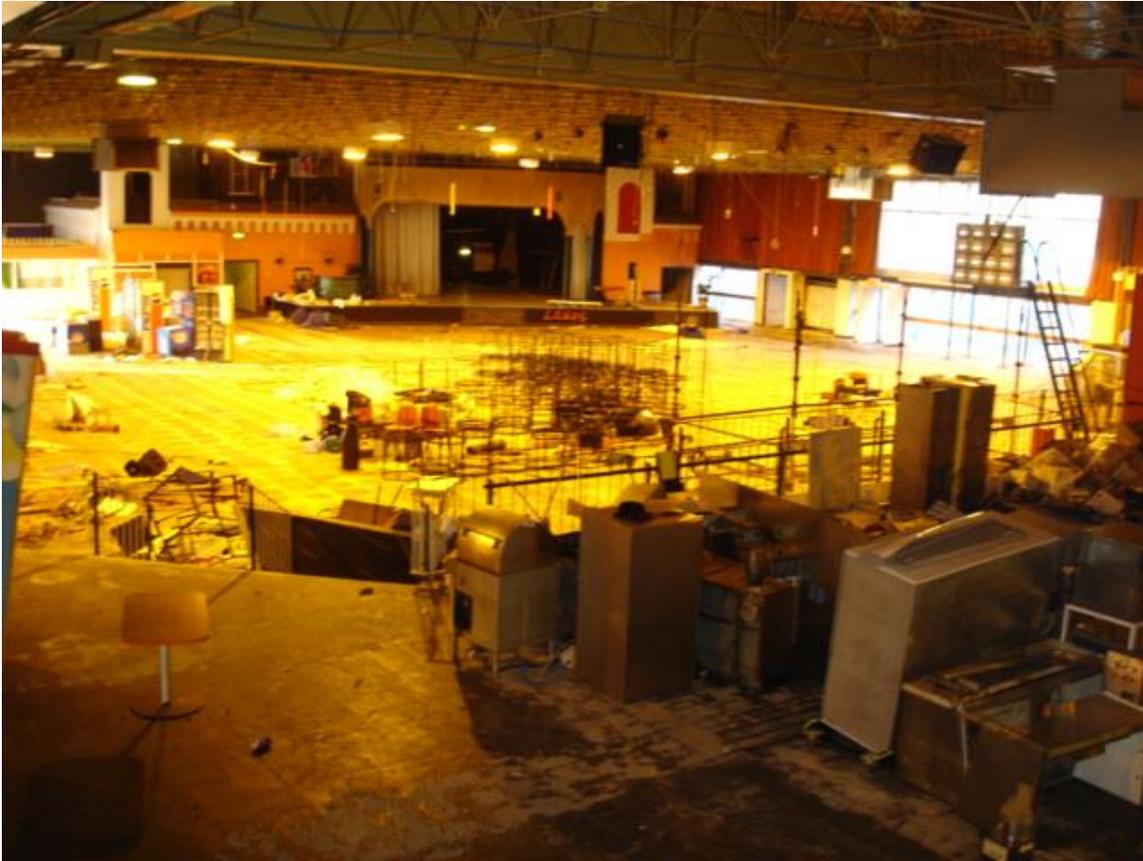
Figure 7.25: The adjusted administration staircase (AAS) is reached through the doorway to the immediate left of the stage. This photograph was taken after Summerland closed to the public in 2004.

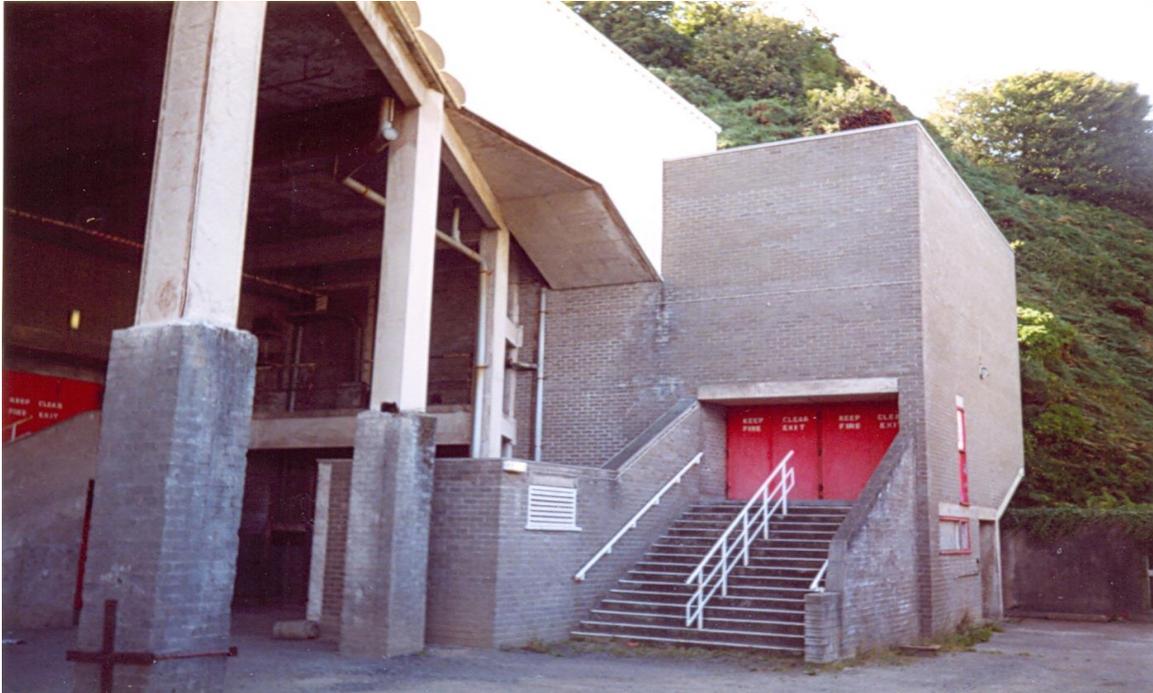
**Figure 7.29: The fire escape reached from doors B1, B2 and B3 on the Piazza floor and the raised path by the cliff face
(Photograph: Ian Phillips)**

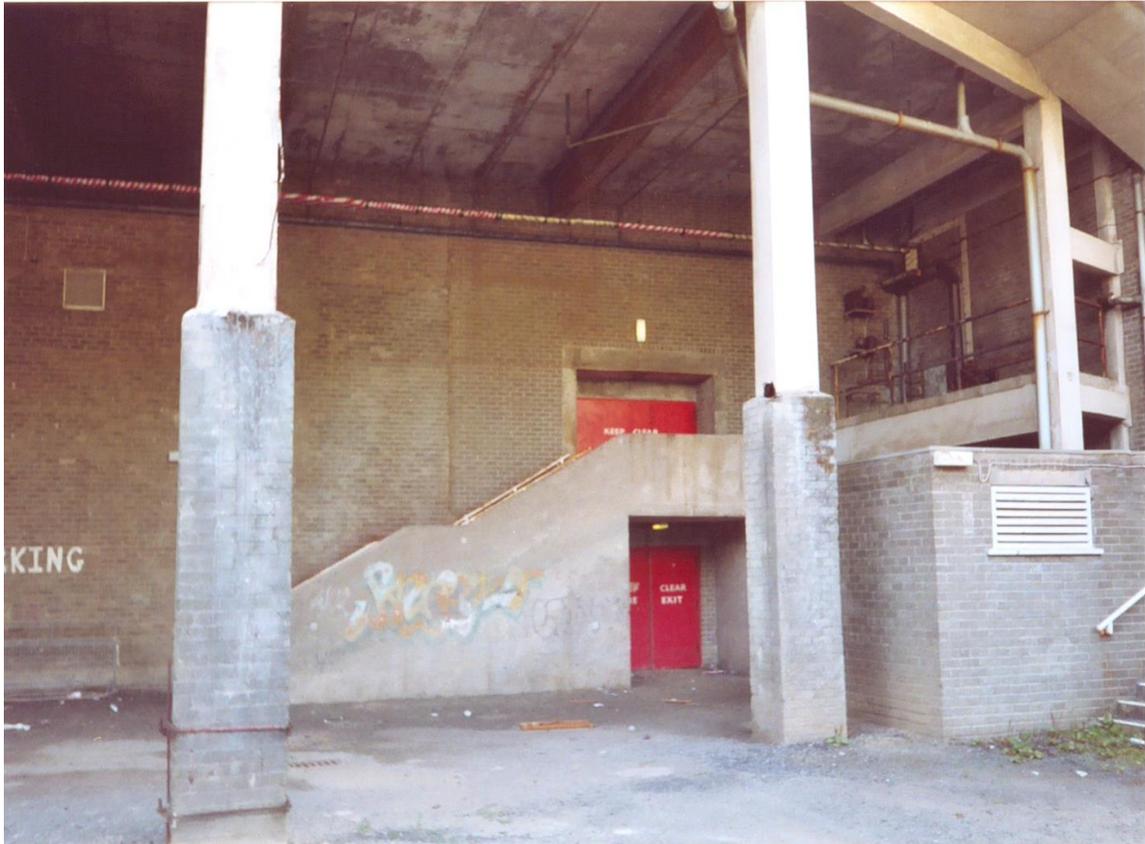
Figure 7.30: The point of discharge of the staircase (C1) serving the NE corner of the Piazza floor and the upper-level toilets is the lower of the two doors. This door can also be reached from the protected escape corridor to the north of the squash courts at Lower Downstairs Level (Photograph: Ian Phillips)

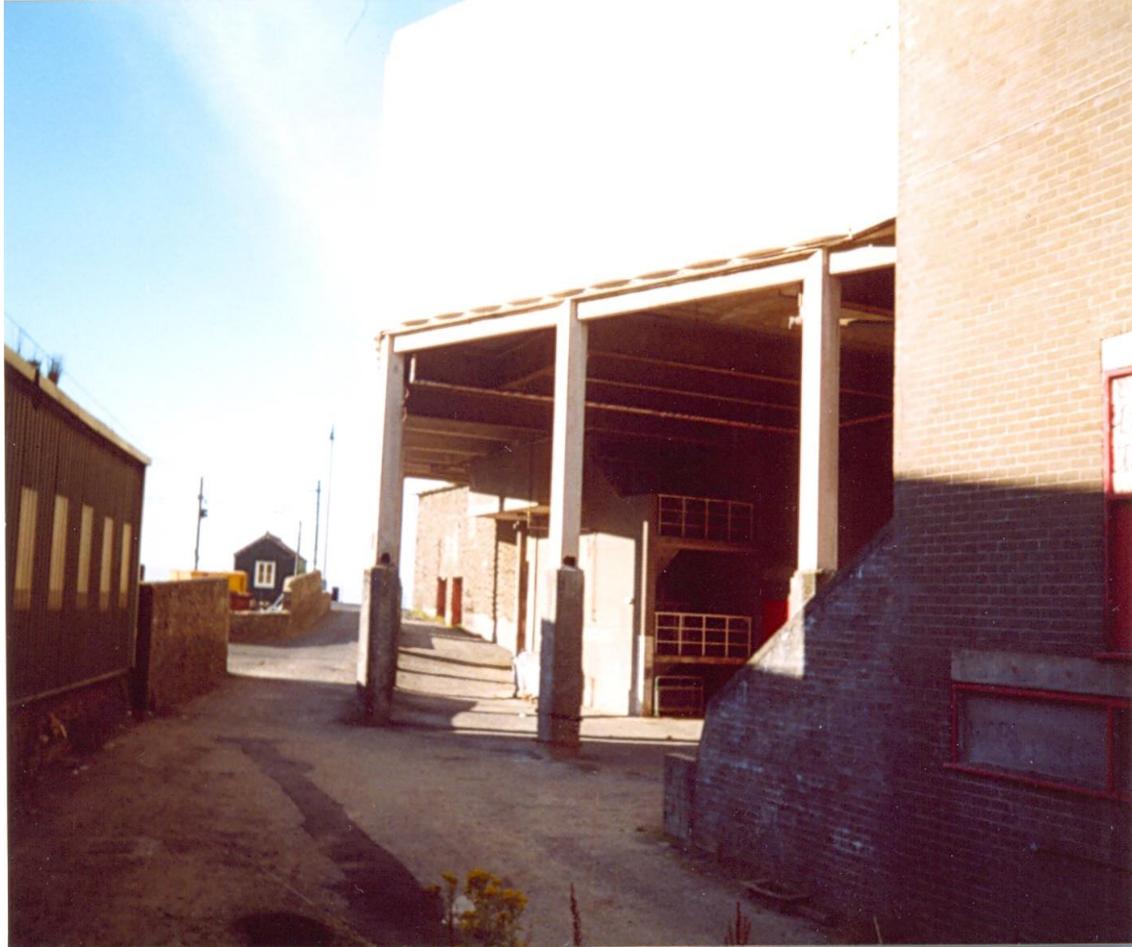
**Figure 7.34: The external fire escape with the yellow railings (C3)
reached from the Piazza floor
(Photograph: Ian Phillips)**

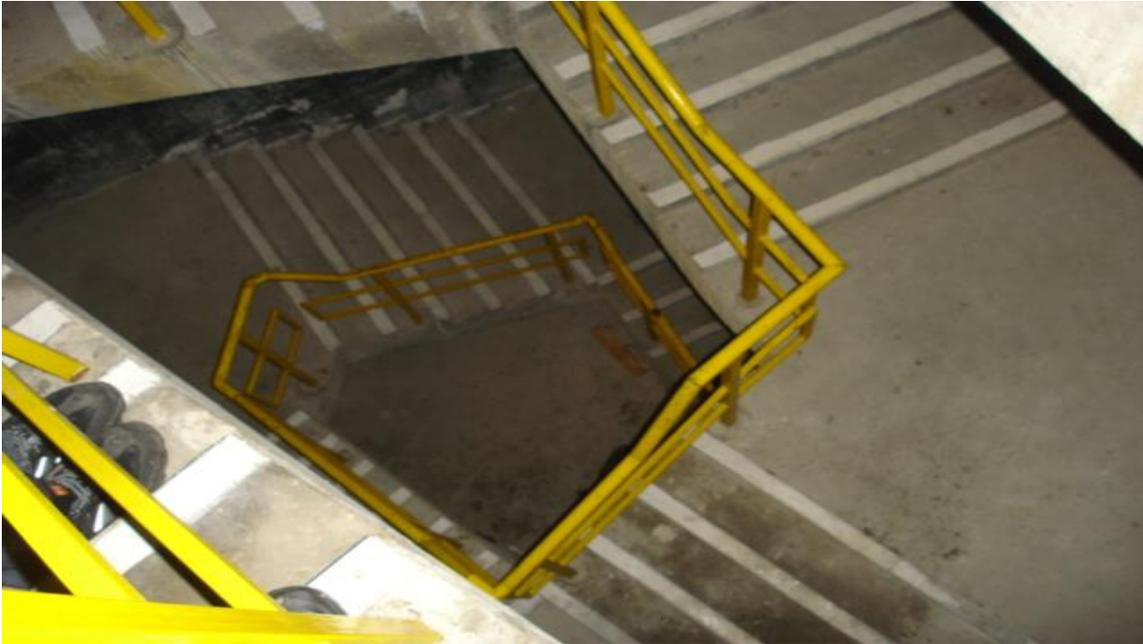
Figure 7.35: The SE Staircase. This staircase descends directly into the open air and can only be entered at Piazza floor level. Unlike the poorly designed NE Service Staircase in the original Summerland, the SE Staircase is a properly designed and sterile emergency escape staircase (Photograph: Ricky Rooney and James Turpin).

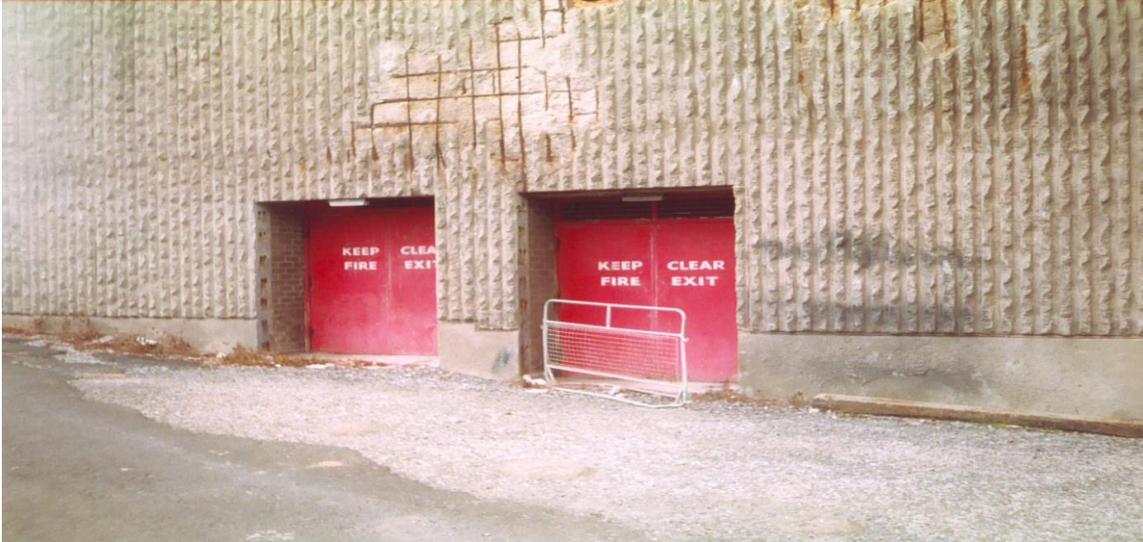
Figure 7.36: The SE enclosed staircase discharges directly into the eastern service yard (left-hand door). The fire exit on the right is from the sports halls. (Photograph: Ian Phillips)

The SE enclosed staircase was added to the building partly to address the criticisms voiced by the *Summerland Fire Commission* about the defective means of escape at the building’s eastern end:

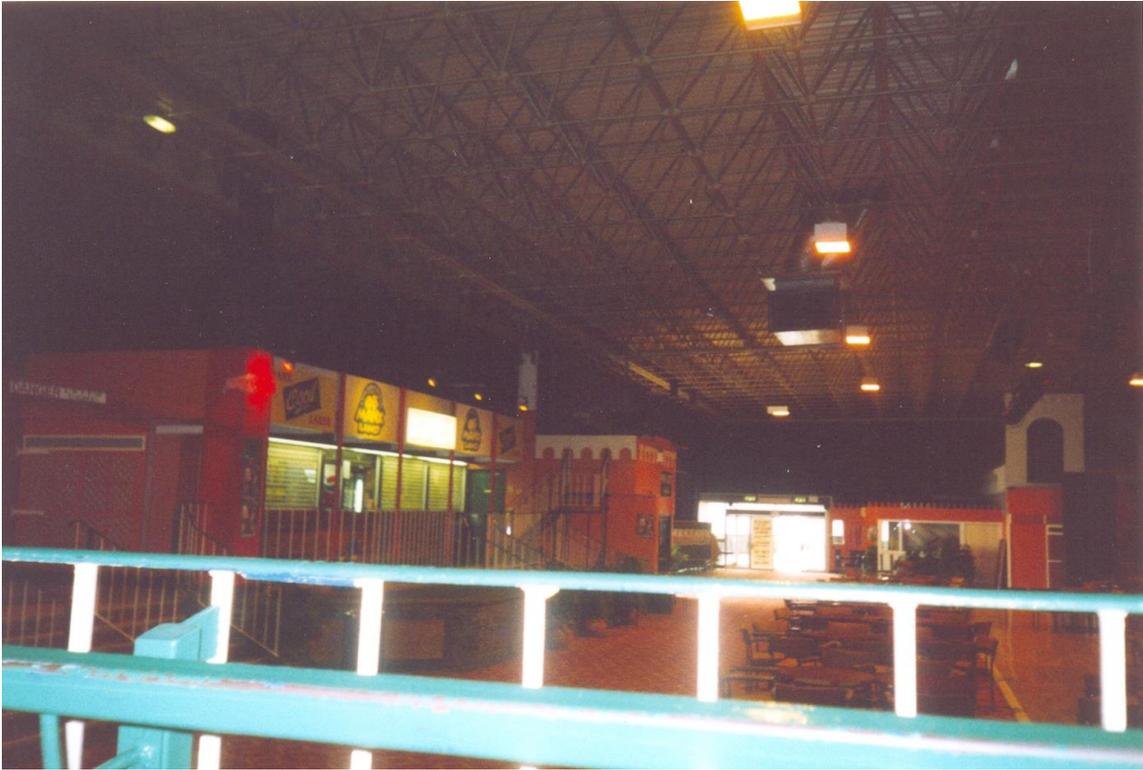
Figure 7.37: A view of the upper entrance (E3: the double set of glass doors) from the 53ft level. The staircase that descends to the reception level (E1) can be seen on the left-hand side of the photograph between the cinema snack bar and the notice board. Note the large green fire exit sign above the door.

There are two escape routes from the southern side of the Piazza floor between exits C3 and E2. The first of these fire exits (D1) is located to the immediate west of the Manxland children’s play area by the snack bar and leads directly into the open air just along from the terrace entrance. This emergency exit reduces escape distances for people on the southern side of the Piazza floor around the Manxland children’s play area. The second escape route is by an enclosed staircase (E1) that descends to the building’s upper downstairs or reception level (section 7.6.1) (**figure 7.37**).
