CHAPTER 7

LEARNING THE LESSONS OF THE SUMMERLAND FIRE

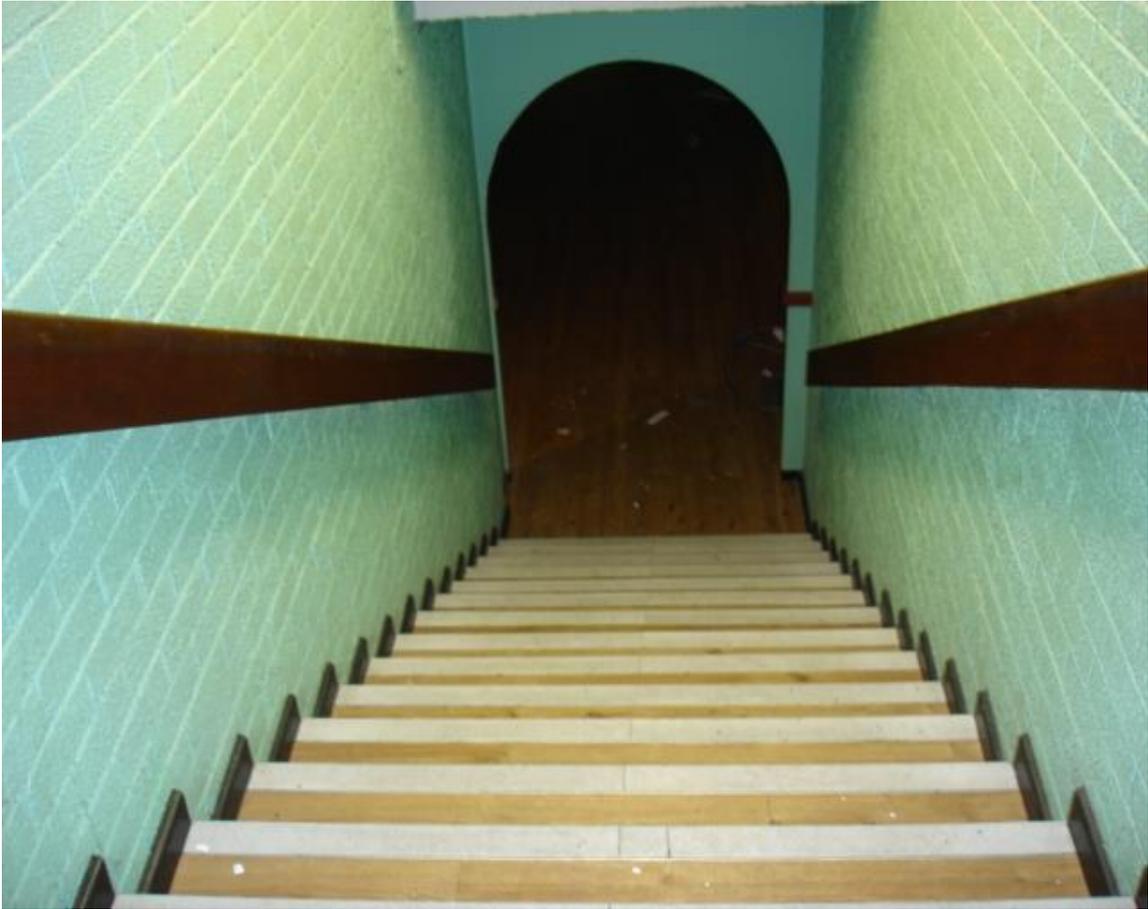
Figure 7.38: Staircase E1

This staircase replaced the Cinema staircase in the original Summerland (Photograph: Ricky Rooney and James Turpin)

U1: up to the Piazza level using the new concrete staircase (E1) (**figure 7.38**) that replaced the Cinema Staircase.

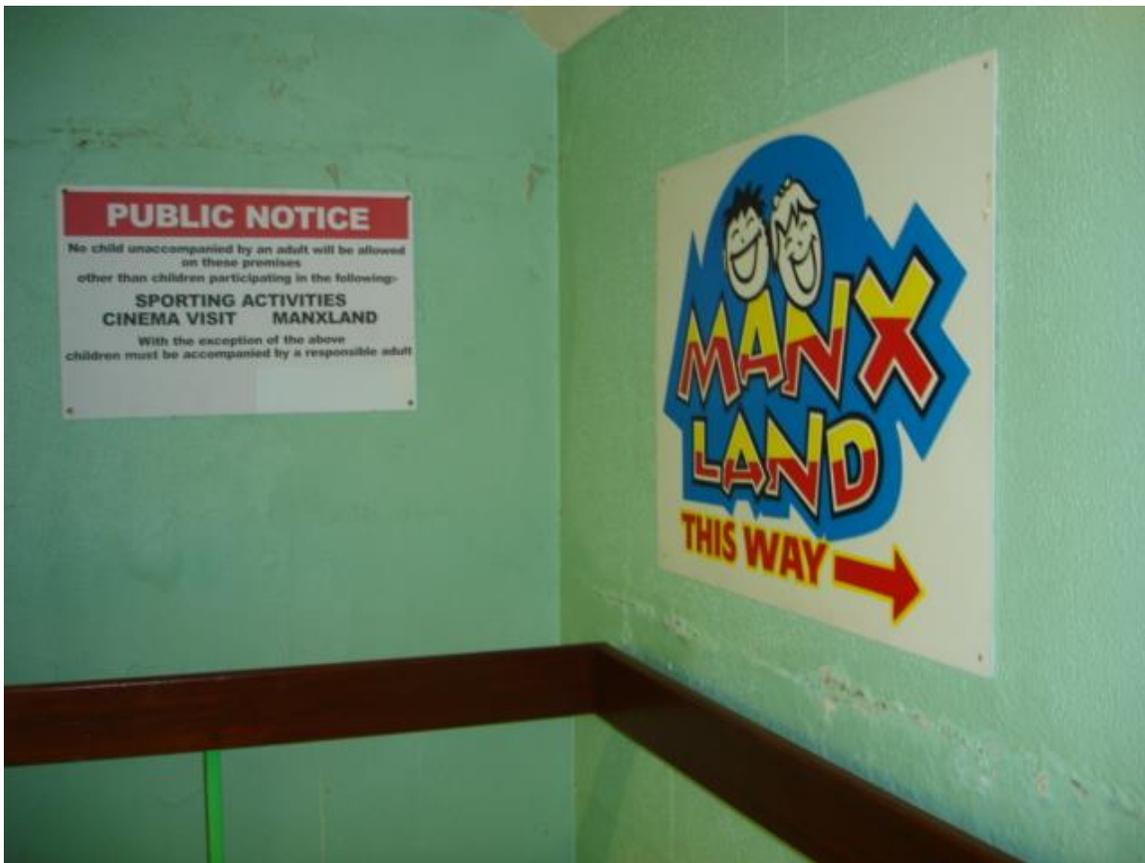
Figure 7.39: Children are more likely to be accompanied by their parents in the re-built Summerland. This photograph was taken on stairwell E1: the replacement of the cinema staircase (Photograph: Ricky Rooney and James Turpin)

main entrance that children must be accompanied by an adult at all times unless they are participating in certain activities (**figure 7.39**). This is different to the original Summerland complex where “young boys were admitted unaccompanied” (SFC Report, Paragraph 241, Page 76). The General Manager at the time of the fire admitted that unaccompanied 10-year-old children were allowed into Summerland.

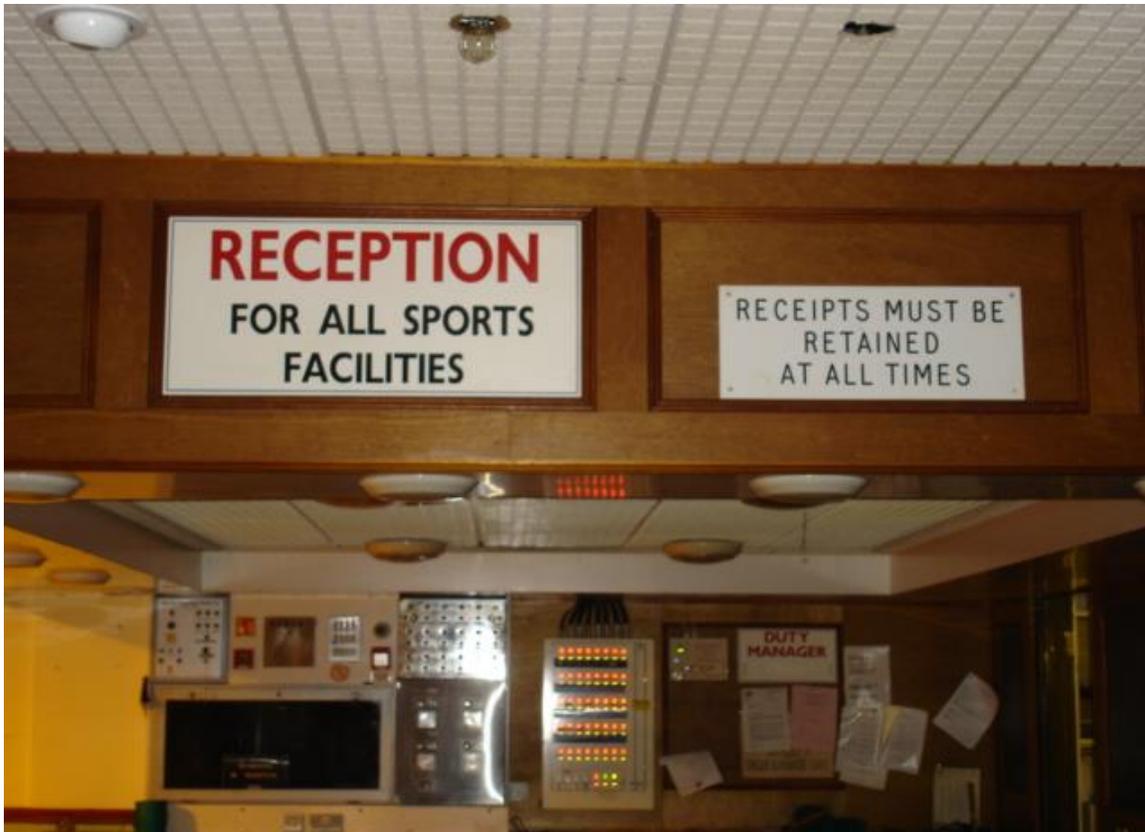
Figure 7.41: Reception desk containing Summerland’s central fire alarm panel. Note the ‘Duty Manager’ sign. (Photograph: Ricky Rooney and James Turpin)

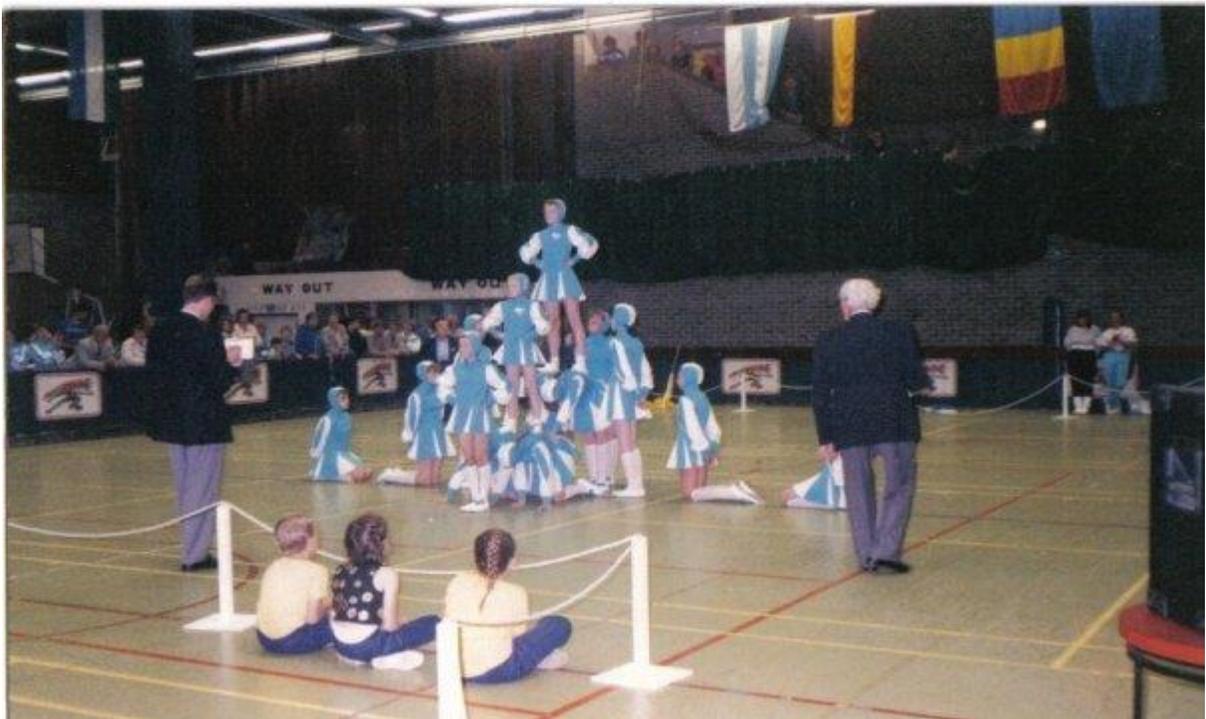
Figure 7.43: The sports halls in 1989. Concrete staircase DOWN 2 leading down from the Upper Downstairs Level (see figure 7.40) can be seen on the photograph (Source: Added to the *Summerland Appreciation Society Group* on Facebook by Amanda)

DOWN2: a new concrete staircase that descends to the sports hall (**figure 7.43**), with escape routes out into the eastern service yard.

In the original Summerland, this floor consisted of one large undivided space between the main road and the cliff face, which housed a funfair and the rollerskating and astroglide areas. In Summerland II, this floor has been subdivided. Whilst a large sports hall (**figure 7.43** and **figure 7.44**) occupies the majority of the space on this floor, four squash courts (plus a spectators' gallery) and a sauna have been added on the floor's north side and a weights and fitness training room on the floor's south side. The area occupied by the sports hall in 2003 was used for rollerskating, badminton, a gymnasium and children's rides when Summerland reopened in 1978.

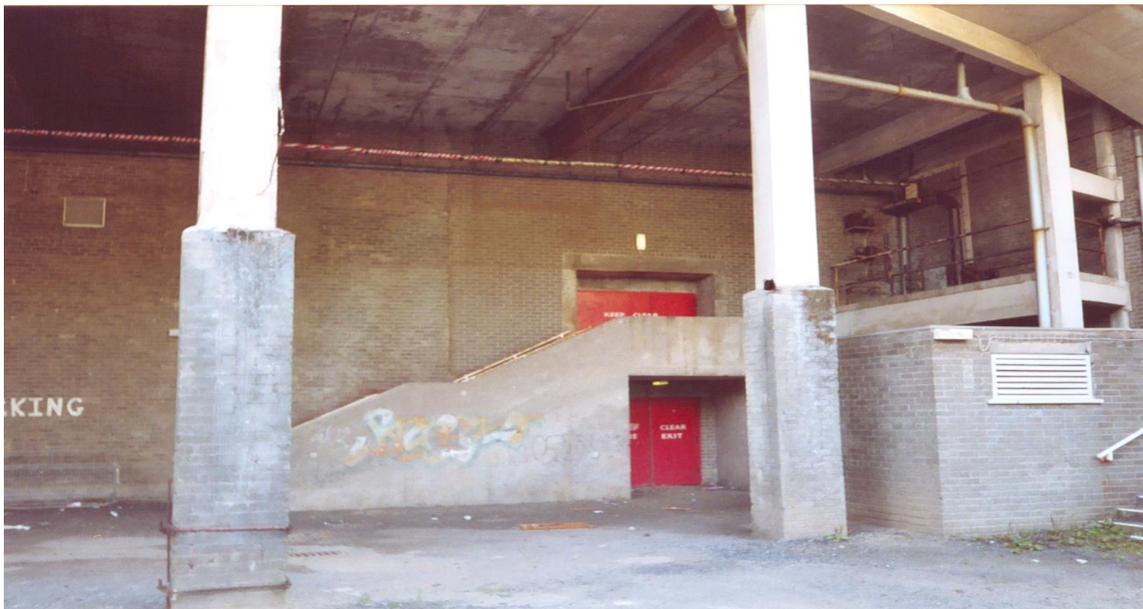
Figure 7.47: Two of the three fire exits (SQ1, SQ3) from the squash courts and their spectators' gallery. The third exit (SQ2) is out of view to the right of the ground floor fire exit visible in the photograph. Doors SQ1 and SQ2 can also be reached from staircase C1 that descends from the Piazza floor. (Photograph: Ian Phillips)

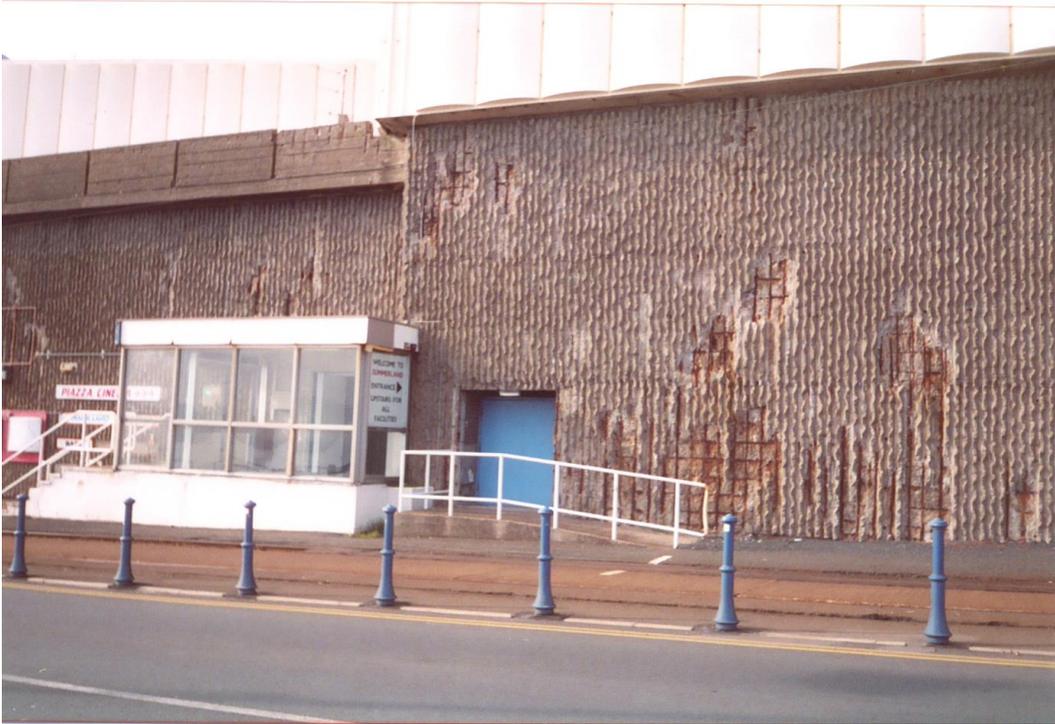
Figure 7.48: The new fire escape from the Sports Hall directly to the right of the main entrance (SP3)

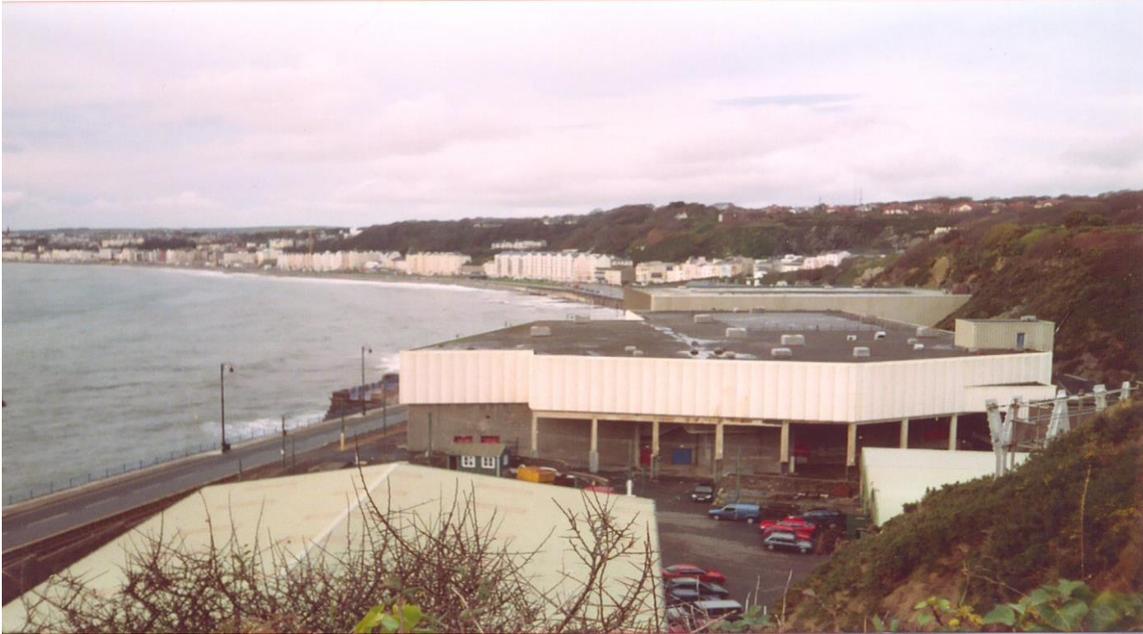
Figure 7.49: The authorities have gone to extremes in providing generous means of escape at Summerland’s eastern end. Note that the roof height of the rebuilt Summerland is lower than the Aquadrome.

The substantially improved means of escape from Summerland II is most apparent when viewing the building from the Eastern Service Yard (**figure 7.49**). There are nine exits on to this yard compared to only three in the original Summerland (**table 7.2**).

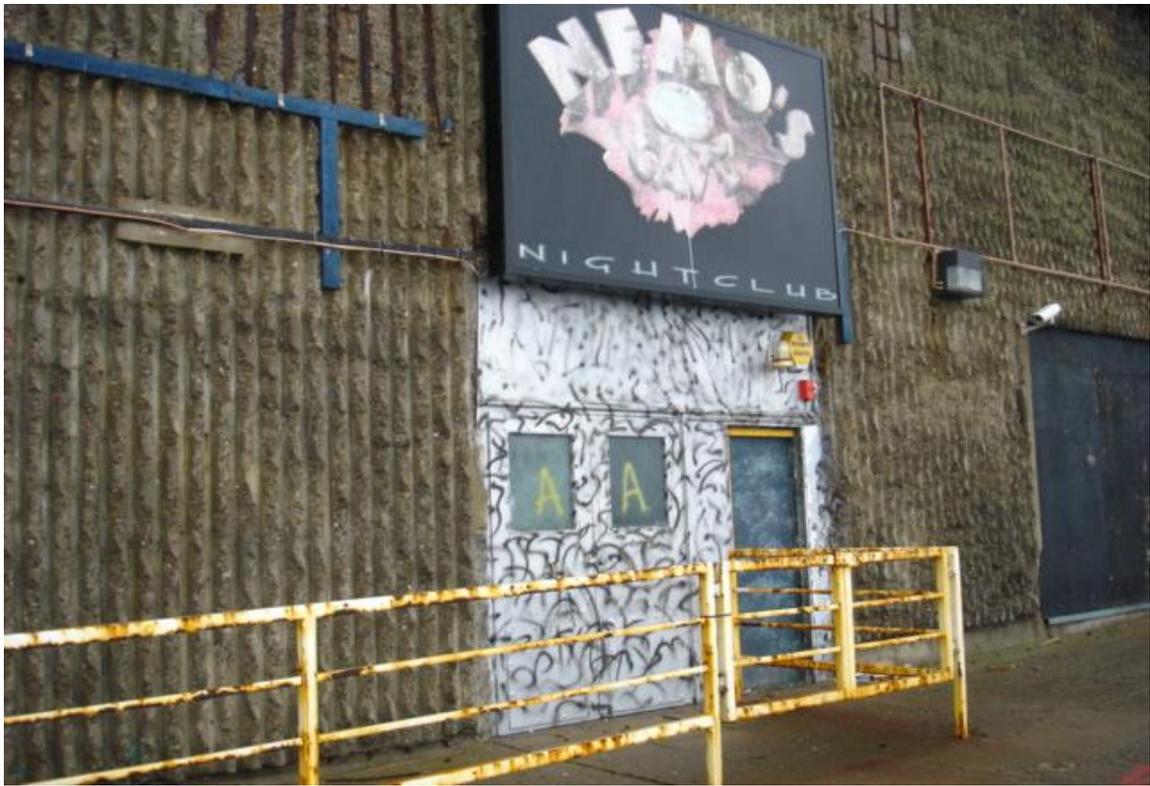
Figure 7.54: The main entrance and exit into Nemo's Cave nightclub. These new entrance doors were built after the fire; the original entrance (now bricked up) can be seen on the right-hand side of the photograph.

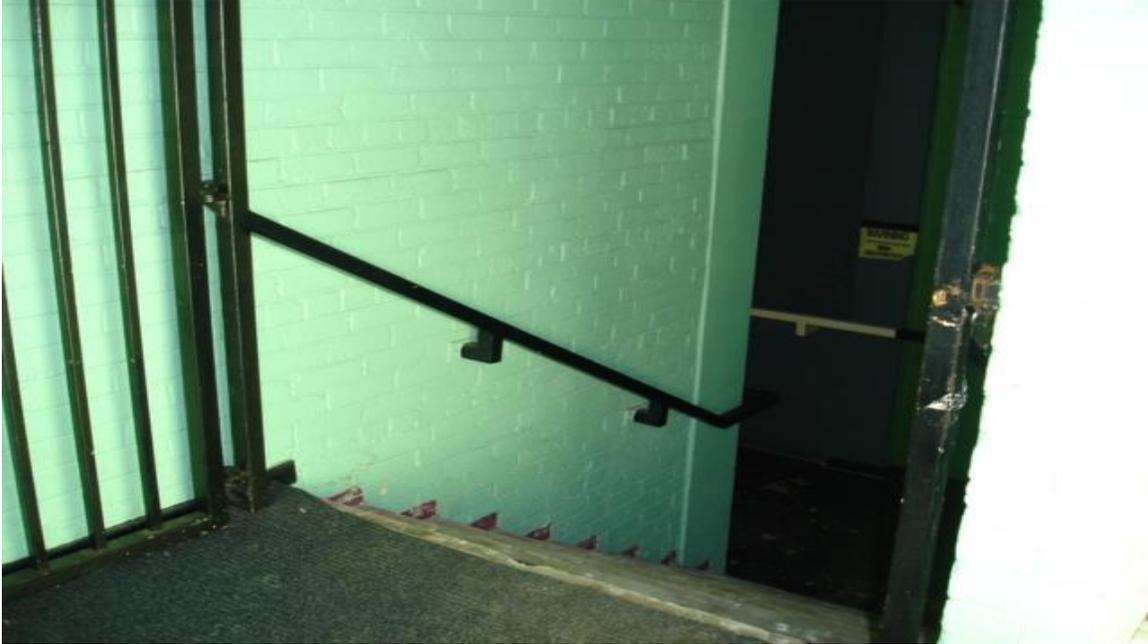
Figure 7.56: This staircase down to the disco foyer (CAVE 3) is reached from Summerland’s main entrance podium; see figure 7.5 (Photograph: Ricky Rooney and James Turpin)
