CHAPTER 3  
THIS IS TO BE THE DAWN OF A NEW ERA  
OF BRITISH LEISURE ARCHITECTURE

3.1 The Summerland design concept

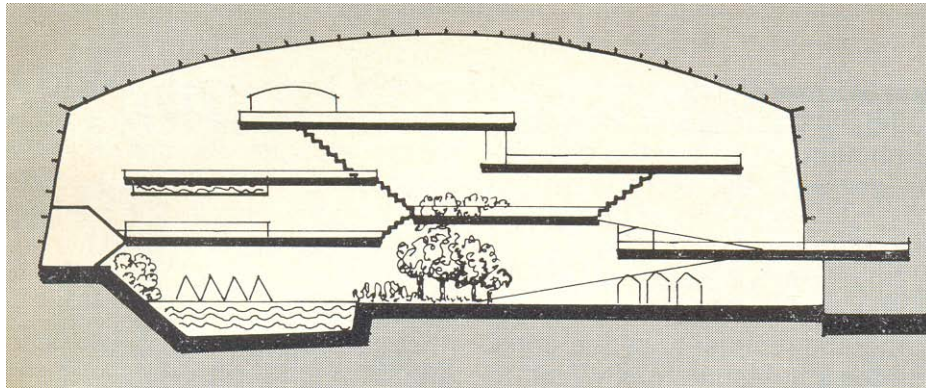
**Figure 3.1: The Summerland design concept**

**The basic idea was to create a transparent seaside village**

Report, Paragraph 10, Page 3). Accordingly, the architects' design objective was to create a climatically controlled indoor leisure space (**figure 3.1** and **figure 3.2**), the transparent walls and roof of which would convince the visitor into believing they were out-of-doors rather than inside a building:

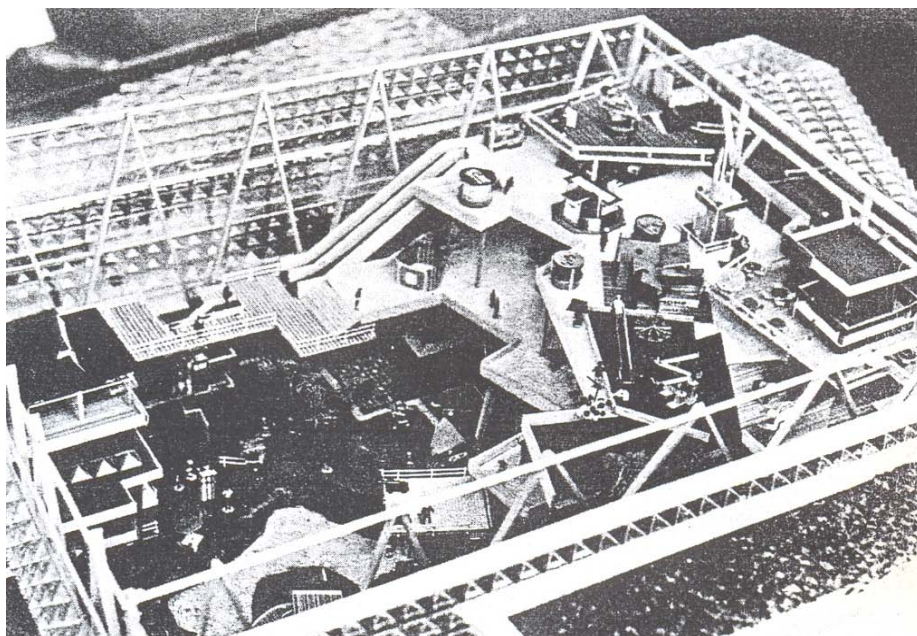
**Figure 3.2: A model of Summerland that was made before construction work began. This bird's eye view shows the original design concept of the Solarium and the three receding terraces. Whilst the final building conforms to this general design (Solarium and Terraces), the floor usage and shape of the terraces are markedly different from the model (Source: *The Summerland Story*, 1972)**

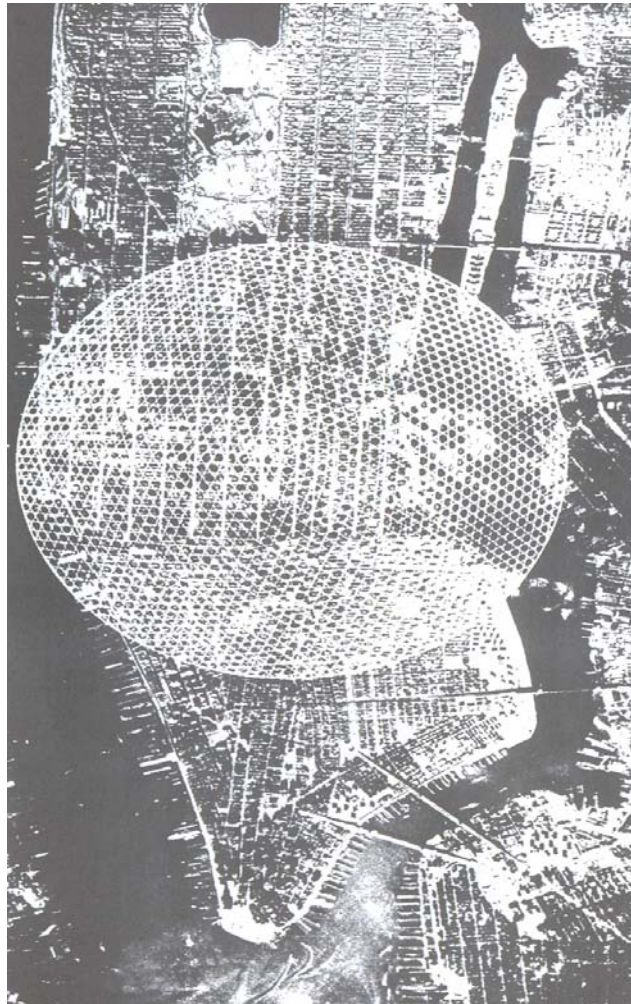
**Figure 3.3: Buckminster Fuller’s ambitious geodesic dome project for Manhattan Island (Source: Quarmby, 1974)**

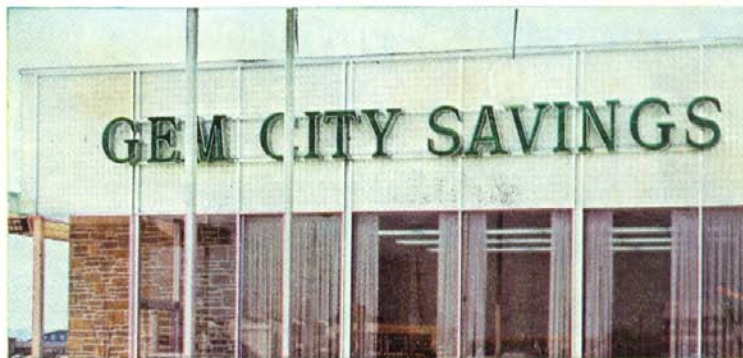
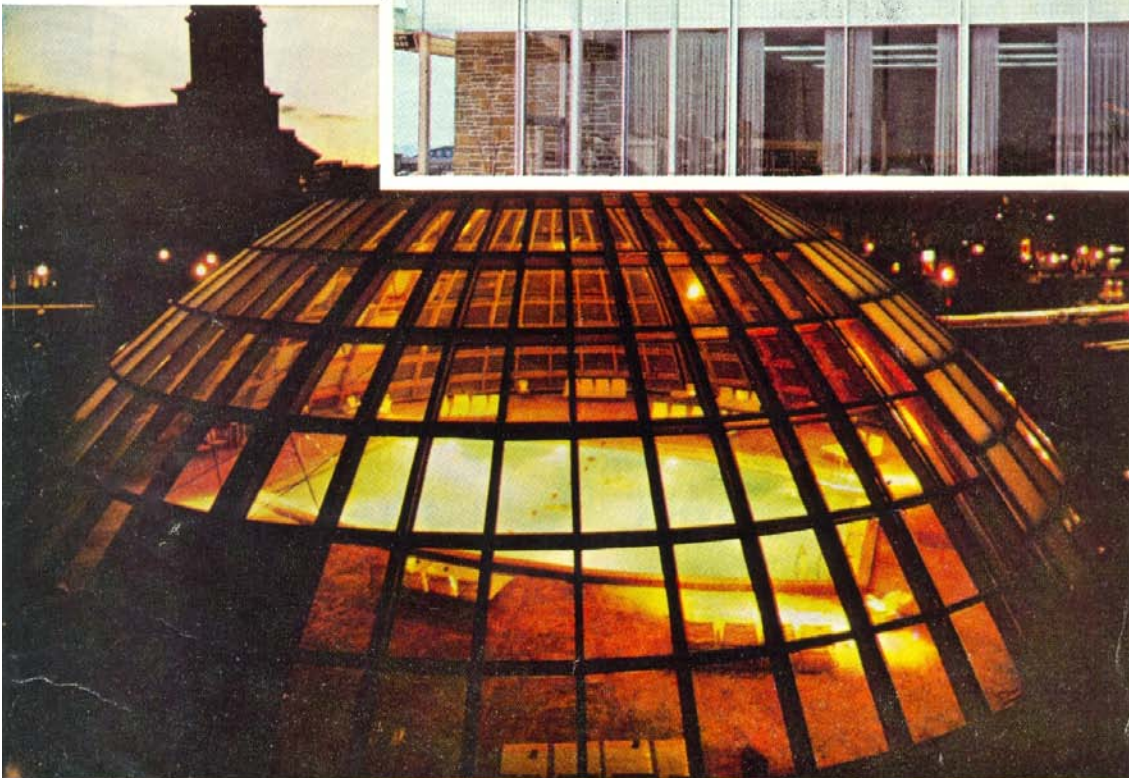
**Figure 3.4: Advertisement for Oroglas acrylic sheet**

TOP RIGHT Formed white Oroglas panels give an attractive background to the identification sign on this new Bank Building. The shape in the panels was easily and economically produced in Oroglas.

TOP LEFT The wide range of colours and patterns available in Oroglas give great flexibility in design of facing panels ranging from large deep sculptured patterns which produce highlights and shadows to precise geometric figures. Large or small numbers of panels can be formed to virtually

unlimited shapes with ease and economy. The time-proven weather resistance of Oroglas ensures a long maintenance-free life.

ABOVE This dome encloses the outdoor swimming pool of the new International Inn, Washington, DC. It is double-glazed with clear transparent and white translucent Oroglas acrylic sheets, which were cut into more than 400 different trapezoidal shapes for the aluminium-framed glazing units. The dome is 38 ft. high, 102 ft. in diameter.

Oroglas was the patented product of Rohm and Haas, an American company based in Philadelphia. The material – similar in its properties to Perspex - was developed by Dr Rohm in his laboratory near Frankfurt in Germany in the 1930s, with Dr Rohm later working with the American scientist Dr Haas. The material had been marketed in North America since 1936, but was not used in Britain until the early 1960s when Rohm and Haas set up a UK manufacturing subsidiary at Jarrow near Newcastle upon Tyne. An advertisement for Oroglas appeared in the Proceedings of a conference held by the Plastics Institute in London in June 1965 (**figure 3.4**). It claimed:

The advertisement was illustrated by a photograph of the swimming pool of the International Inn in Washington DC, which had been enclosed by transparent Oroglas acrylic sheeting cut into more than 400 different trapezoidal shapes. Oroglas had been used for the walls of several entertainment centres in North America before construction work began on Summerland in the late 1960s. The material had also been used in Japan, and for two-storey buildings in Germany. However, the use of Oroglas as a building's *main* cladding in the US and Canada was strictly limited. Such

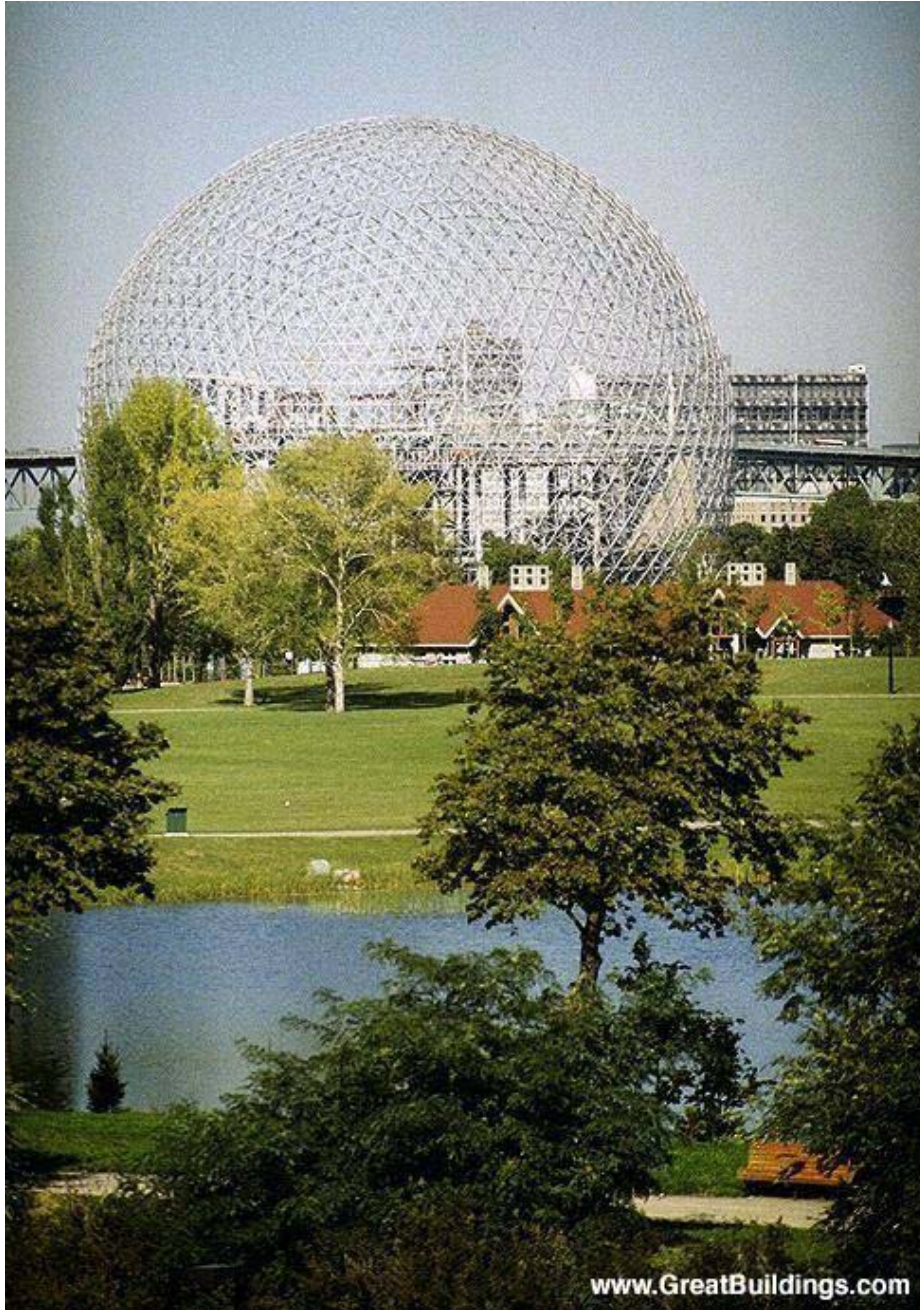
**Figure 3.5: The American Pavilion at EXPO 1967 in Montreal**

new trends in British leisure architecture. Summerland can also be interpreted as being a product of its times, as illustrated by the American Pavilion at Montreal's EXPO 1967. The Pavilion was designed in the form of a huge geodesic dome by Buckminster Fuller. Primarily, the architects were motivated by the advantages Oroglas had over standard glass despite its greater cost. As Summerland architect Derrick Byrom wrote, the material was selected “because of its high impact strength and light weight” (*The Architects' Journal*, 1971, page 336). Referring to Summerland, Quarmby (1974: 73) notes that “it is the structural transparency or translucency of plastics materials...which engenders their use”. Oroglas is more flexible than glass, and can be moulded into a variety of “visually dramatic” shapes. The panels used for Summerland’s roof and promenade wall had a diamond or pyramid profile, and measured 6 feet by 6 feet. The pyramidal panels were produced by W J Cox of Tring in Hertfordshire, who take the Oroglas sheets supplied by Rohm and Haas and mould them into different shapes. Summerland’s promenade wall measured 212 feet by 42 feet and was clad with 252 Oroglas panels; each panel was 0.19 inches thick, which is slightly thinner than the original sheet (**figure 3.6**). “Each panel catches the light to provide an interesting and varying pattern on the façade”, says the glossy promotional brochure for Summerland. Whilst Oroglas formed the majority of the promenade wall, many commentaries on the fire (including the SFC Report) surprisingly omit the fact the lowest 10 feet of the wall was in fact constructed out of glass windows in hardwood frames and not the acrylic pyramids (**figure 3.7**). Mr Cyril Pearson, the Isle of Man’s Chief Fire Officer (CFO), informed the Fire Research Station (FRS) Team investigating the disaster that glass had been used for the lowest levels to avoid the potential for anything at ground level igniting the Oroglas cladding

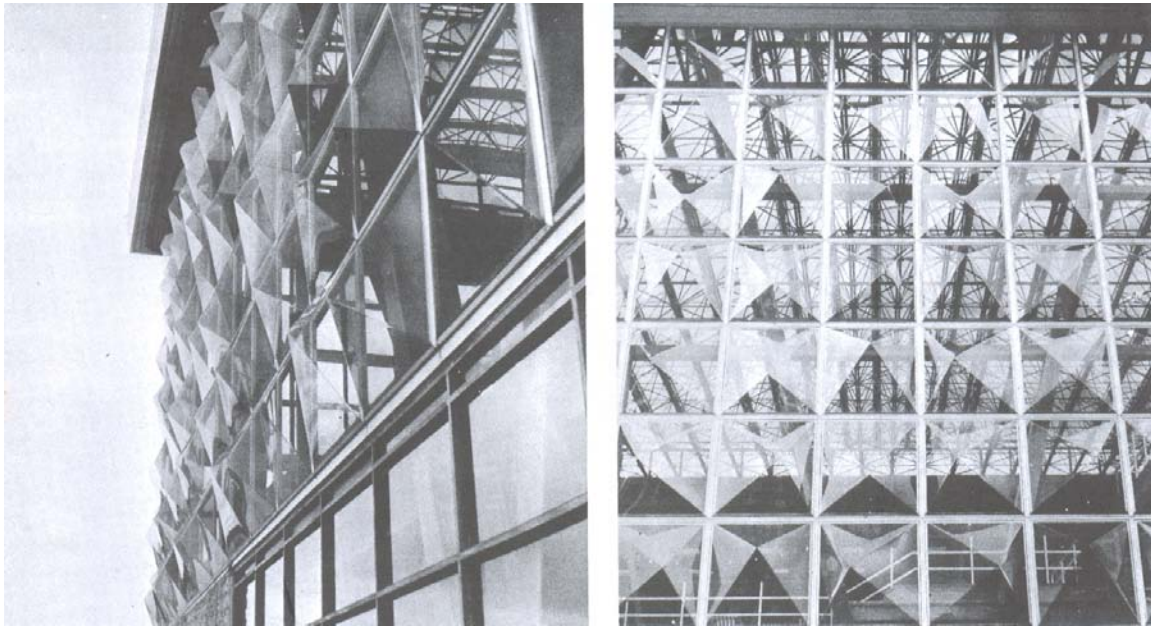
**Figure 3.6: Summerland's Oroglas Promenade Wall**

(John Webb, FRS, Personal Communication). Summerland's roof was almost entirely glazed with Oroglas. The Oroglas panels were tinted in bronze to transform natural sunlight into golden sunrays, and to prevent glare and overheating from the Sun.

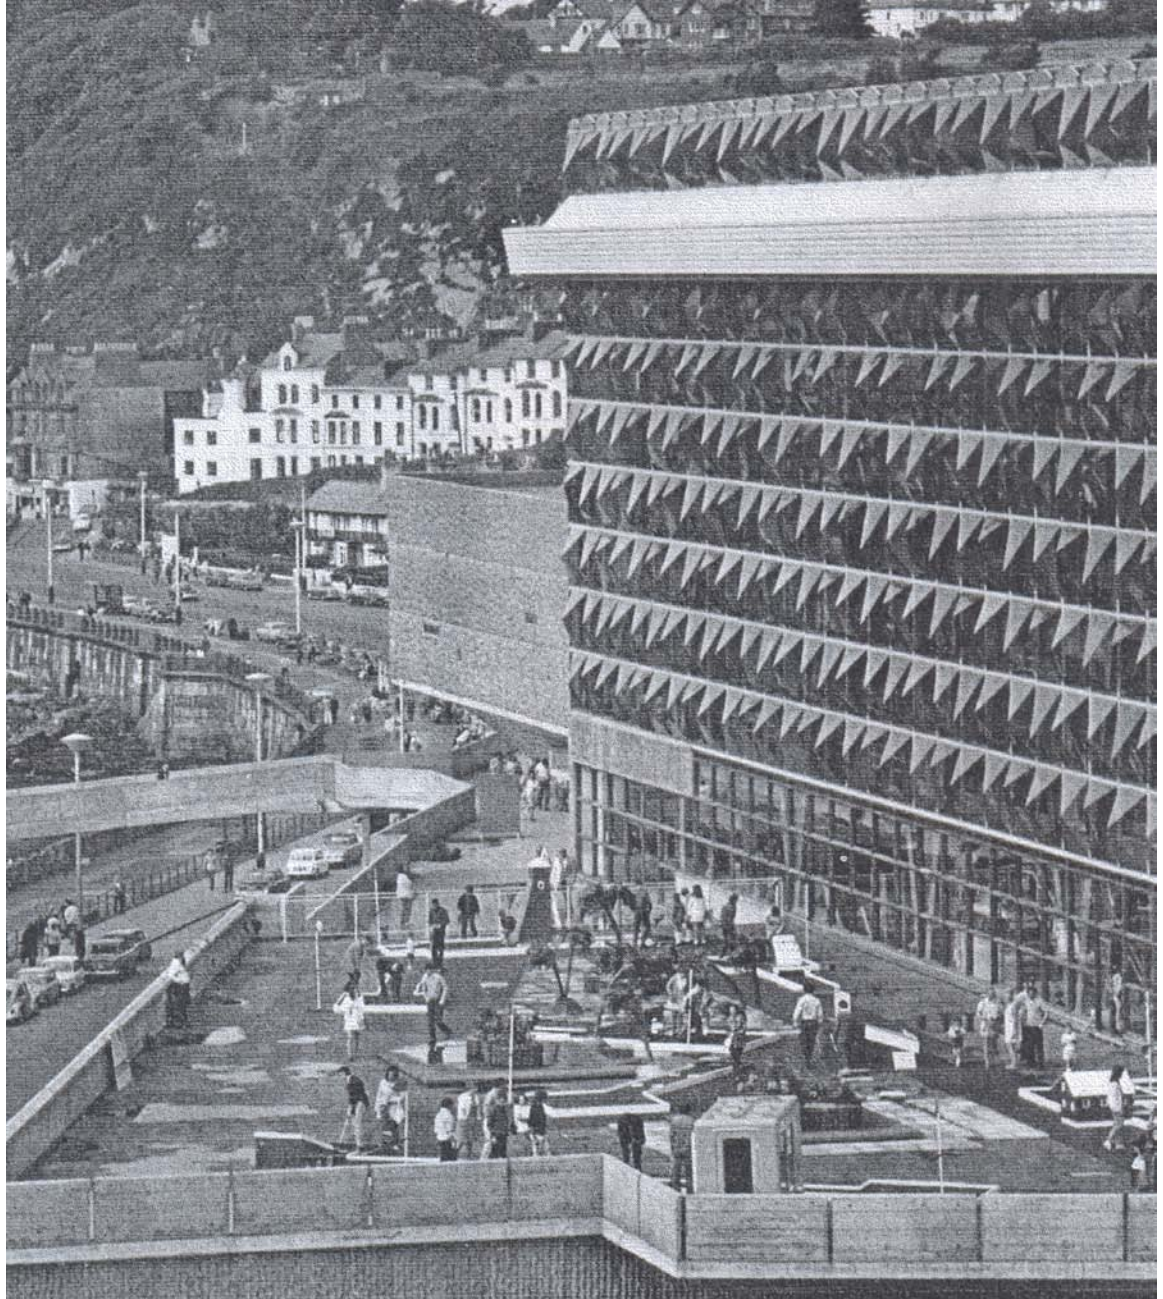
**Figure 3.7: Summerland's sea-facing/promenade wall. On this photograph, the glass panels forming the lowest 10ft of the wall can be clearly seen**

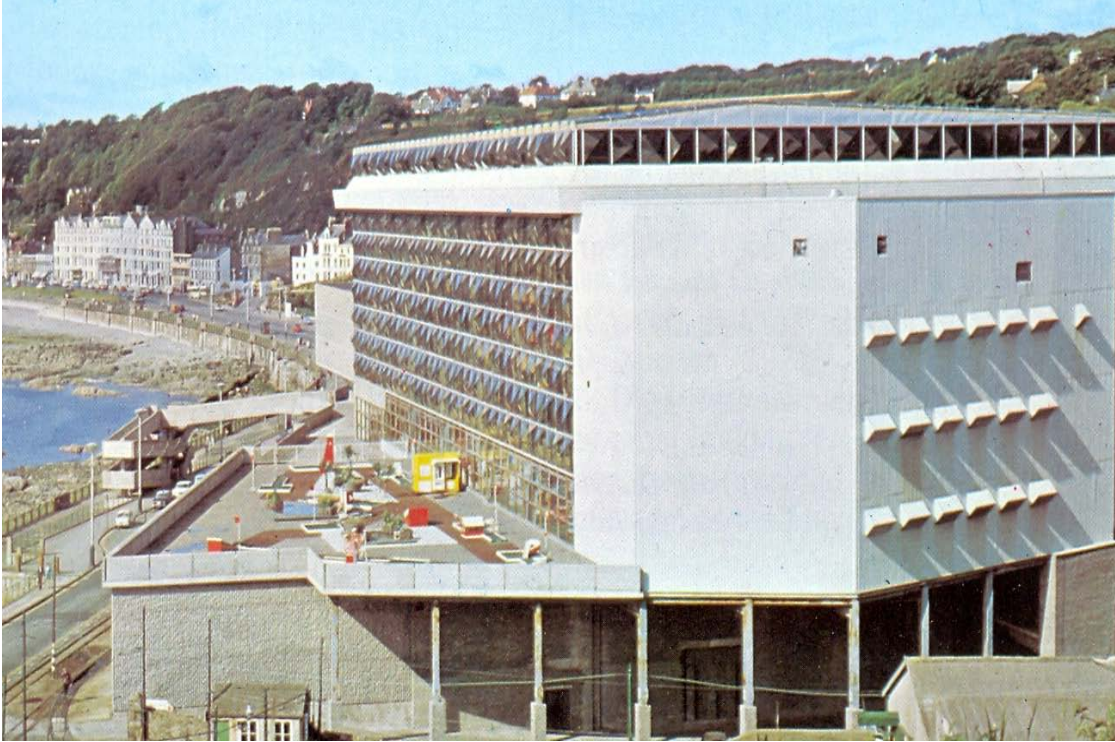
**Figure 3.8: The Galbestos wall at the eastern end of the complex**  
**(Source: THF Promotional Booklet)**

In order to reduce costs, plastic coated steel sheeting known as Colour Galbestos was substituted in place of reinforced concrete (which appeared in the architects' original plans) or conventional steel sheeting for the building's eastern elevation and for around 35 feet of the promenade wall (**figure 3.8**) at Solarium floor level and above. The Galbestos was supported on steel angle rails, which in turn were supported by the building's main steelwork.

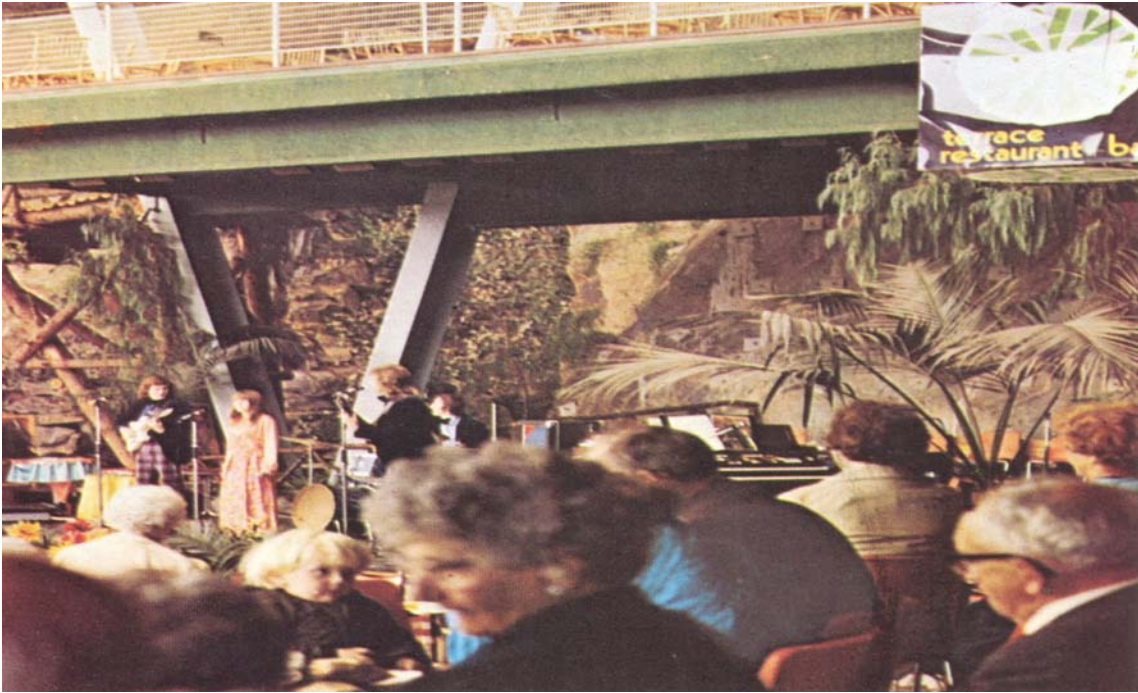
**Figure 3.9: The tower supporting the Rustic Walkway is visible on the extreme left-hand side of the photograph**  
(Source: THF Promotional Booklet)

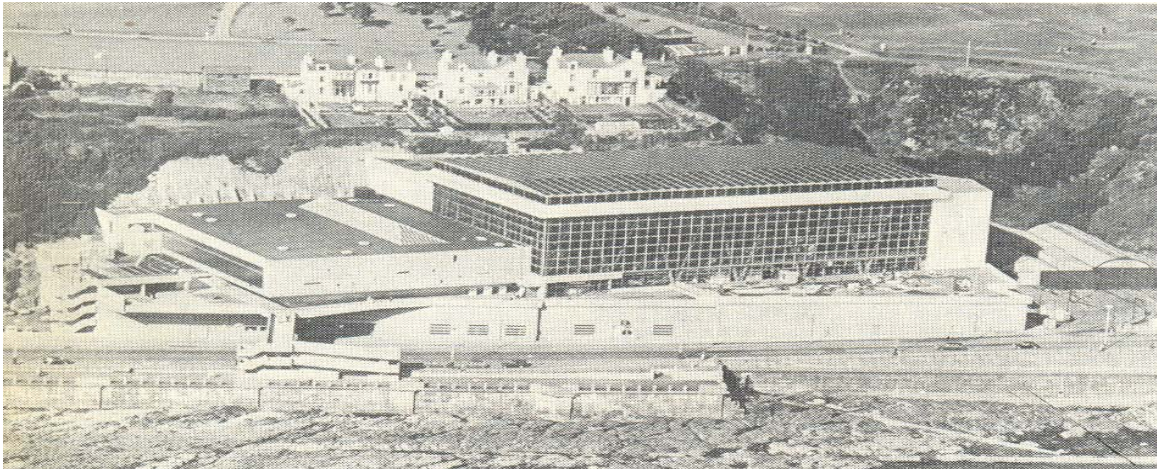
**Figure 3.10: Summerland and the Aquadrome**

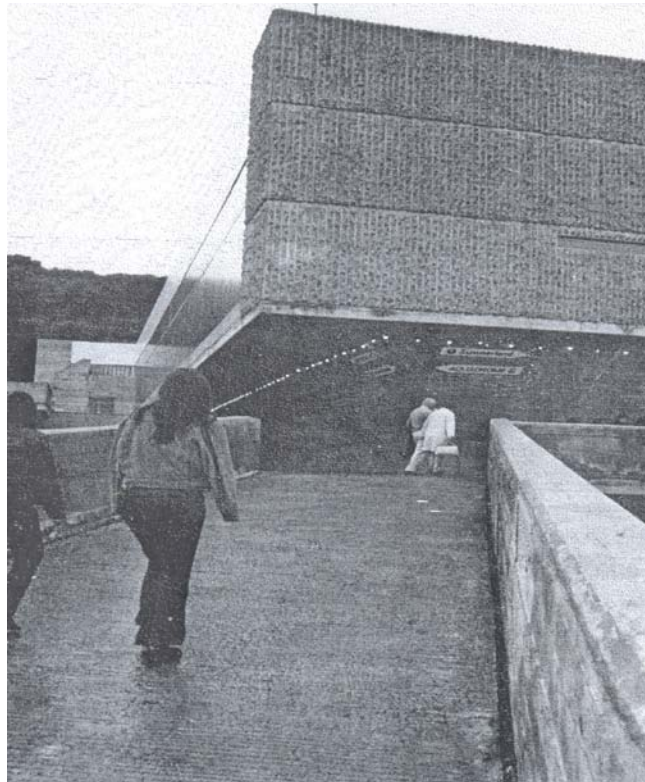
**Figure 3.18: The footbridge providing access to Summerland across King Edward Road and the Manx Electric Railway (see also figure 3.7)**

With the exception of the underground disco, all members of the public entered Summerland at Level 4. The building's main entrance was thus not at street level, but was reached either by ascending an external staircase by the Aquadrome or by means of a footbridge over King Edward Road (**figure 3.18**). The footbridge was built because public access to Summerland and the Aquadrome was not permitted across the Manx Electric Railway. The footbridge was served by a ramp as well as steps to allow disabled access into the building.

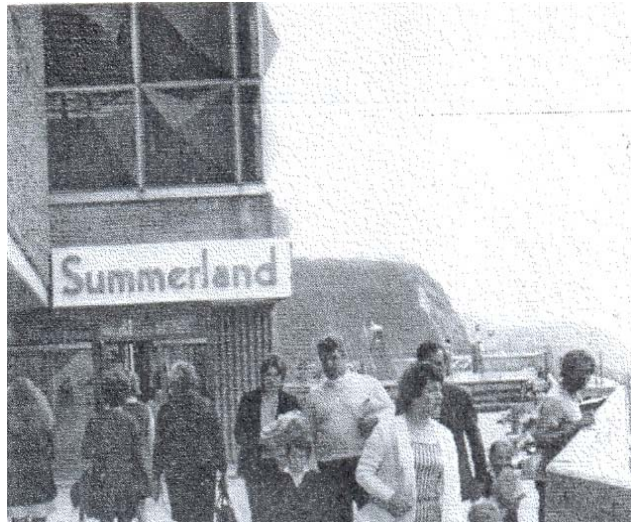
**Figure 3.19: The main entrance**

Entry into Summerland was by means of two sets of double doors (**figure 3.19**); each door measured 5 feet 8 inches wide.

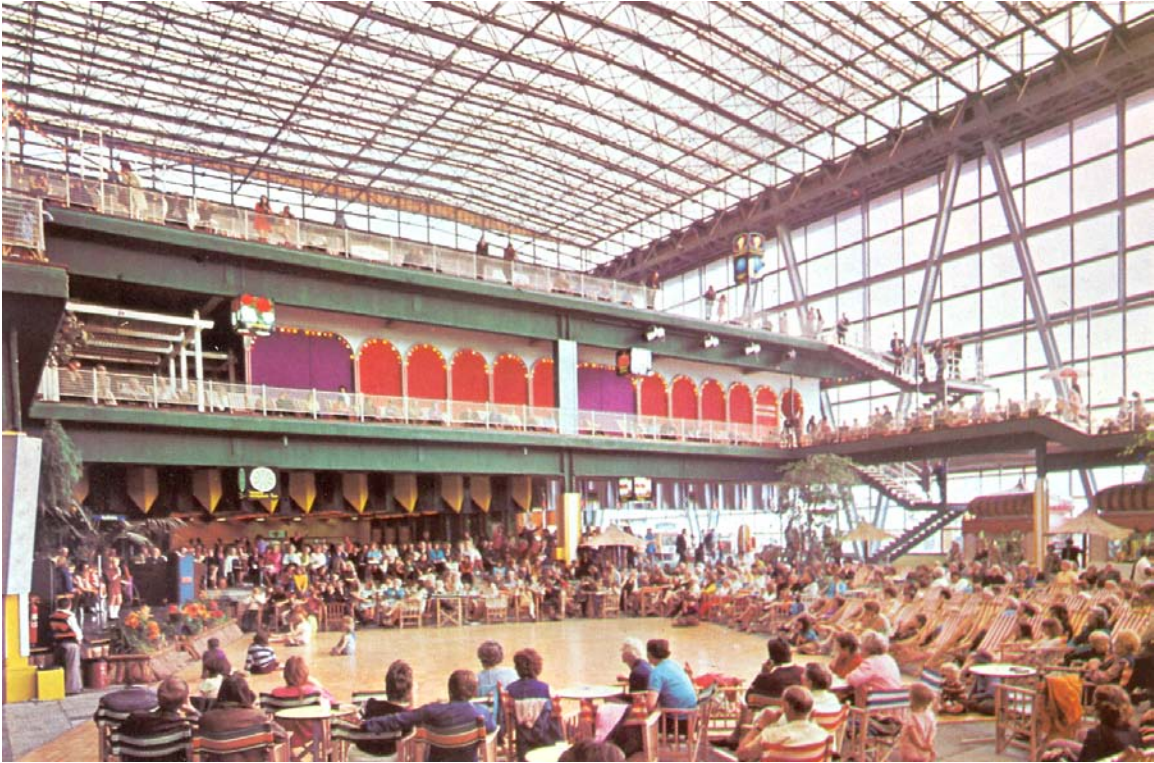
**Figure 3.21: The Solarium and the upper-level terraces**

The Solarium was a large enclosed space, which was open to natural daylight (**figure 3.21**). The Solarium's roof was 67 feet high and was mostly glazed with transparent Oroglas acrylic sheeting designed to withstand wind speeds of 120mph; the same material was used for all but the lowest 10ft of the building's south facing promenade wall (section 3.2). The pigment intensity of the Oroglas increased towards the roof in order to control for solar heating and glare (Byrom, 1971). A promotional brochure for Summerland claimed the Solarium would "set the architectural world alight for nothing had ever been designed to include so much of the transparent sheeting" (*The Summerland Story*, 1972, page 25).

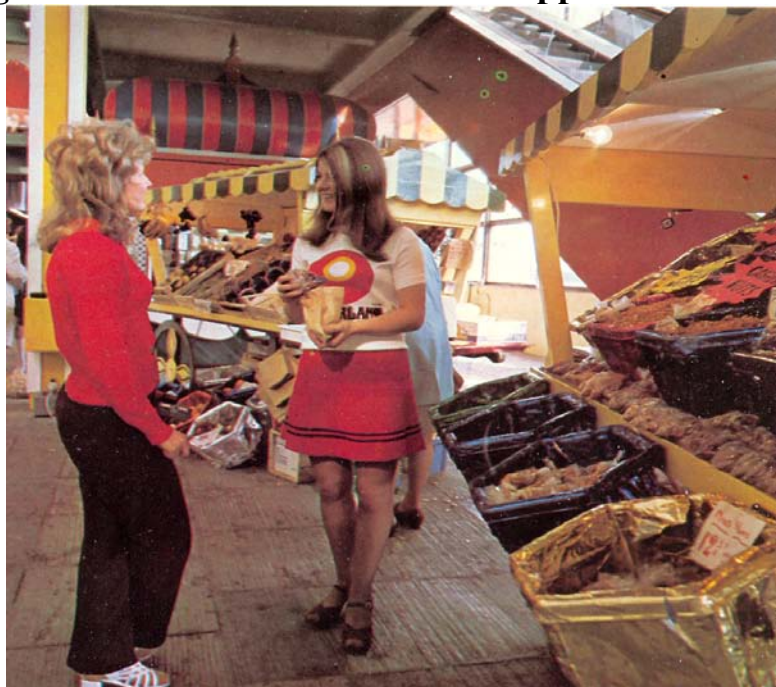
**Figure 3.22: Shop units on the Solarium floor near the main entrance**  
**The escalator giving access to the first terrace can be seen in the top right-hand corner. Note the use of concrete for the Solarium floor.**

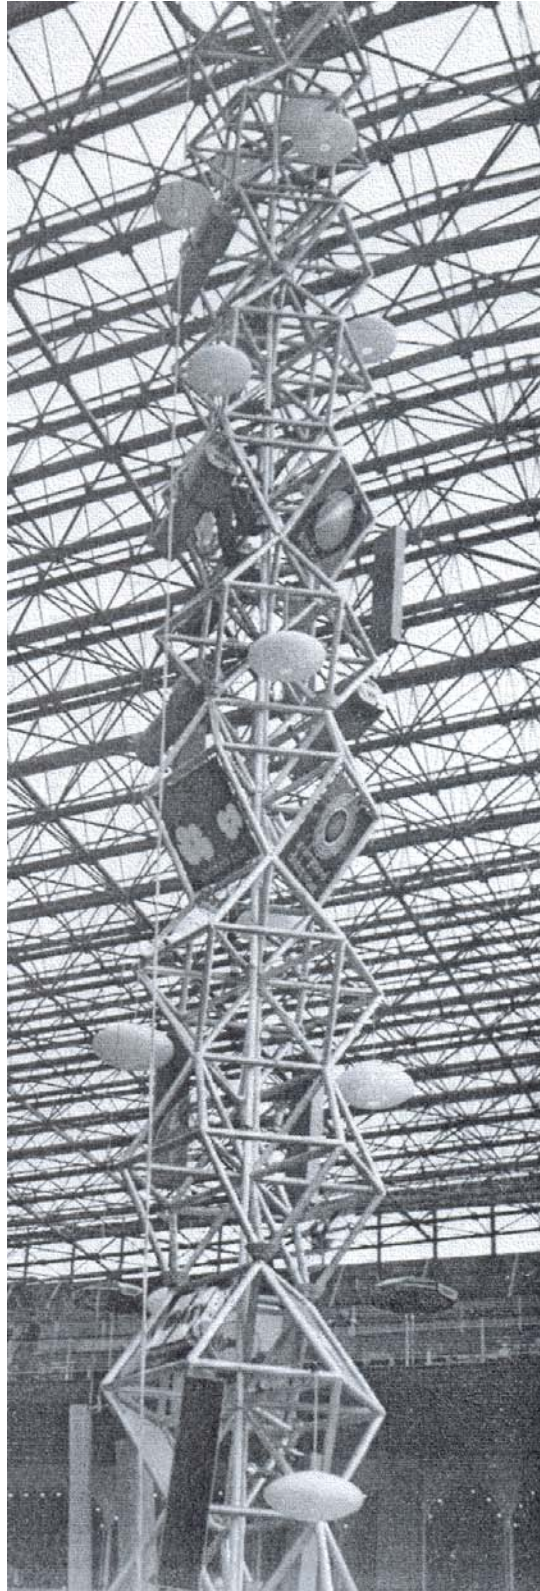
**Figure 3.24: The Communications Tower**  
(Source: *Architects' Journal*, 1971, page 641)

Communications Tower – a geodesic space frame structure – that extended to the building's roof (**figure 3.24**).

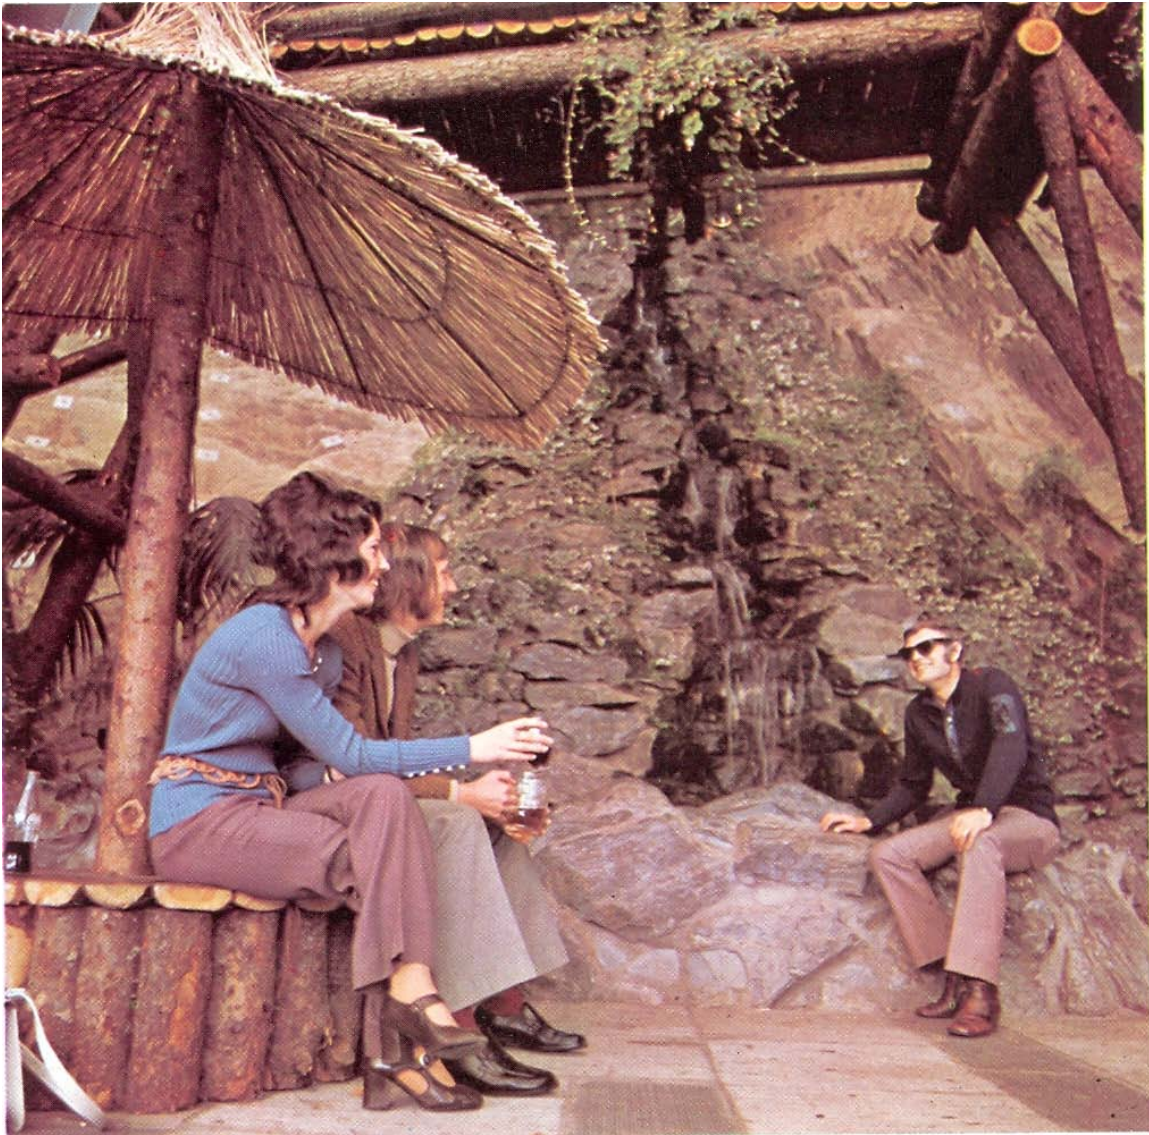
**Figure 3.25: The man-made waterfall with the Rustic Walkway above  
(Source: THF Promotional Booklet)**

to the top of the cliff before being released through the soil. The designers even introduced wild birds into Summerland

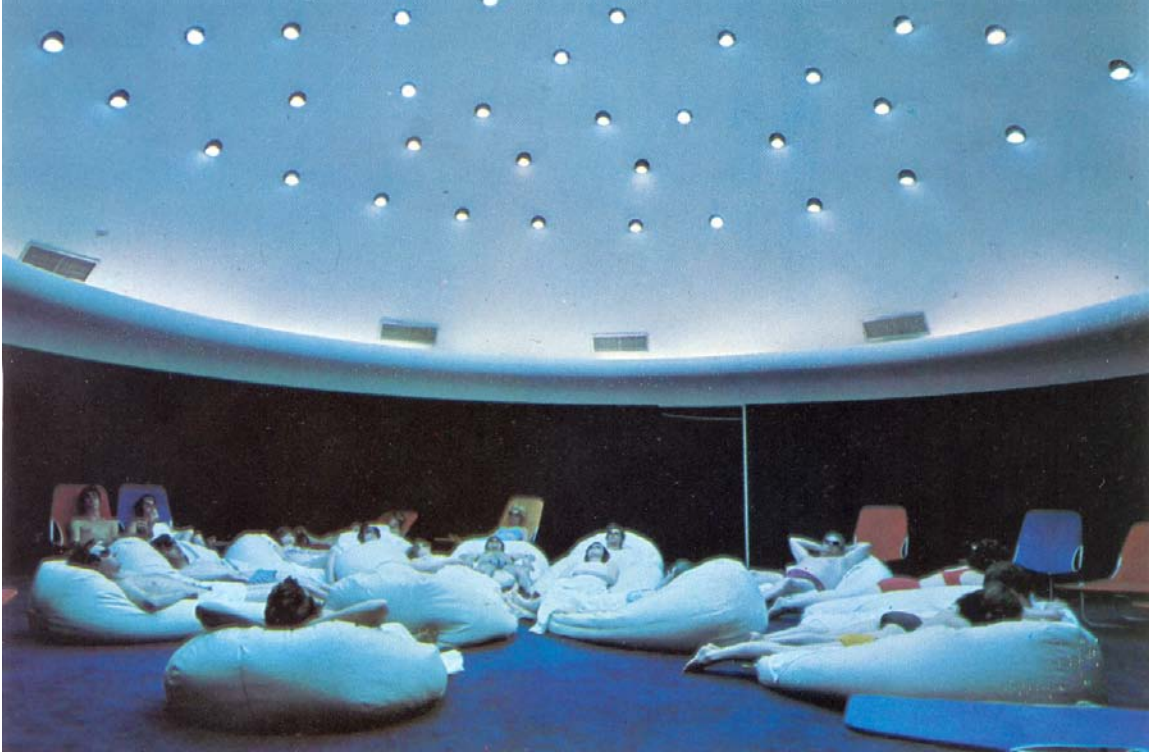
**Figure 3.34: The Sundome**  
**(Source: THF Promotional Booklet)**

However, this plan had to be shelved after consultation with medical experts. The system finally installed in Summerland consisted of rows of ultra-violet (UV) and infrared (IR) lights that were fixed in the fibreglass convex roof of the Sundome. The carpeted circular Sundome measured 40 feet in diameter and was capable of accommodating up to 50 bathers. People lay on polystyrene filled beanbags and were required to wear special goggles to protect their eyes from the light. Although the sunbathing sessions lasted for one hour, bathers were actually exposed to only 20 minutes of artificial sunlight. Customers were advised not to take a second bathing session on the same day. The Sundome unit also contained male and female saunas (**figure 3.35**) and 'rest areas'. The Sundome came in for harsh criticism from the *Summerland Fire Commission* (Paragraph 76, Page 25):
